CK-2117B

COGBURN CREEK km

2016 Inspection

| Crossing Name | North Fork |

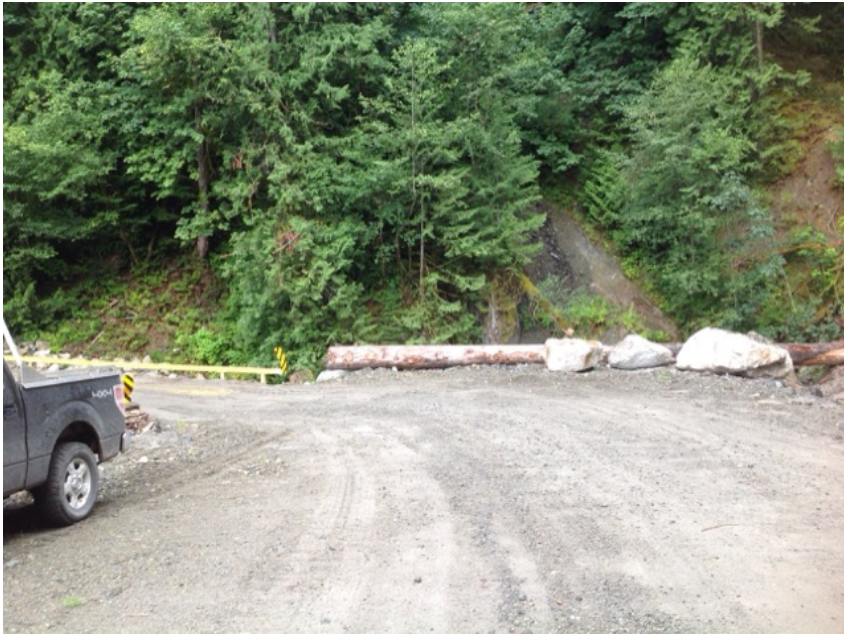
Approach from Left Bank when facing downstream

Bridge Ahead Signs  
Missing ☐ 0 ☐ 1 ☒ 2

| 2 | Medium | pot bridge ahead signs |

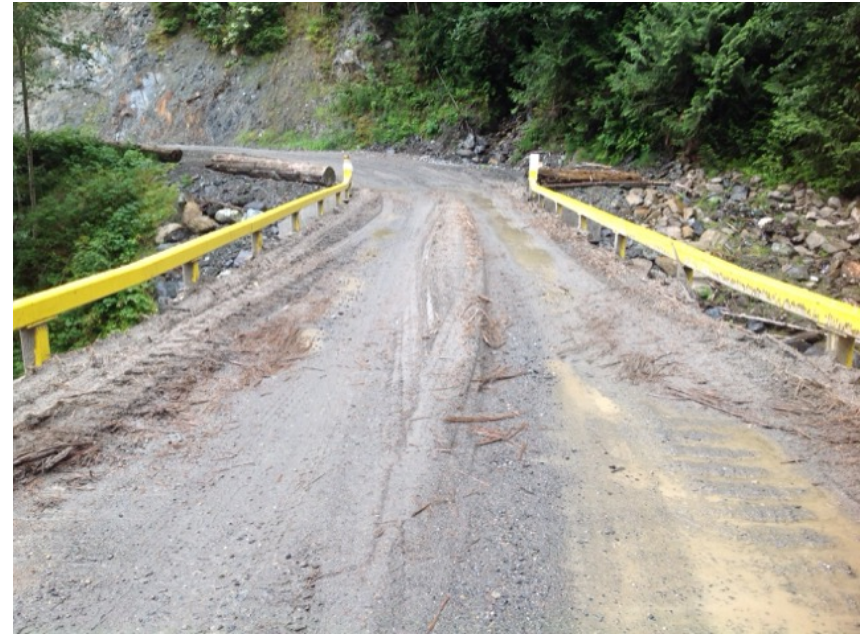
| Concrete Deck | Unrated | too much sediment on deck to properly assess |
| Overall Deck Condition | Poor | due to sediment/debris on deck |

| 1 | High | clean sediment/debris from deck |
