CK-2125

SHOVEL CREEK 11.1km

2016 Inspection

| Structure Class | Major Culvert |

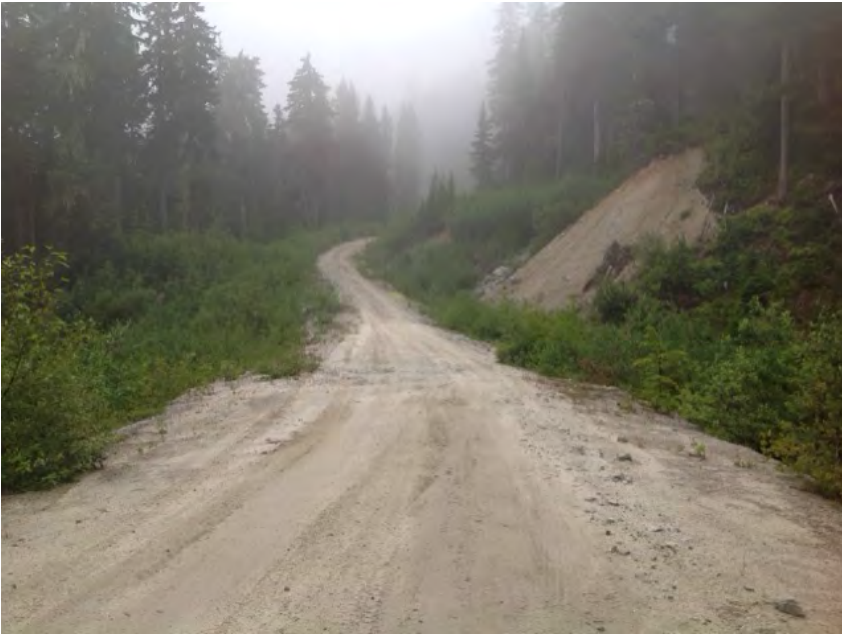
Road Surface Fair road not being used and should be graded prior to industrial work

Approach from Left Bank when facing downstream

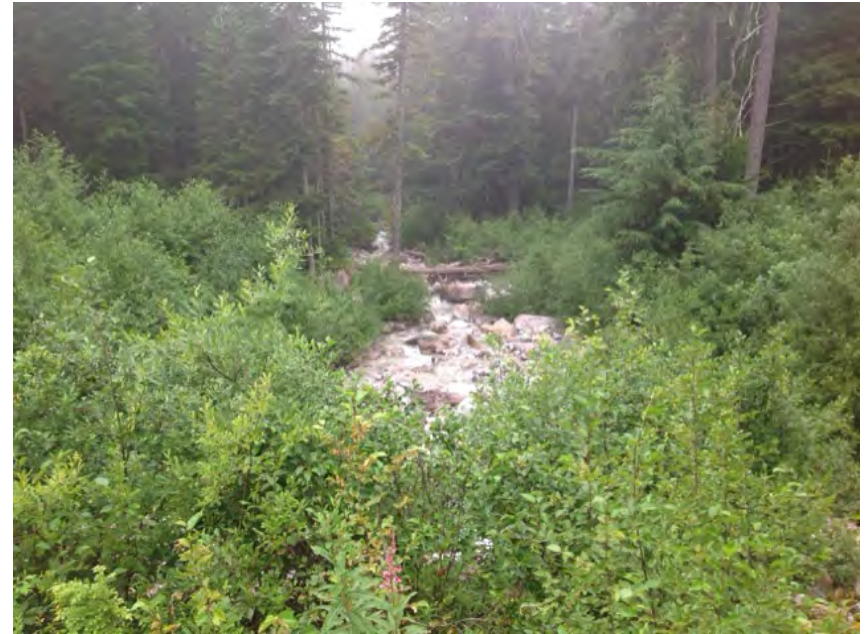
looking downstream from road

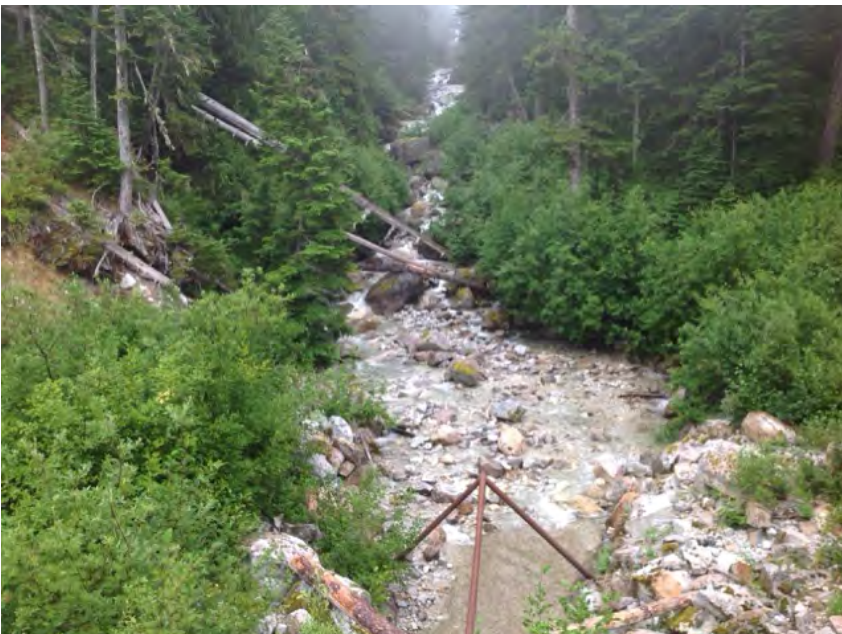
looking upstream from road

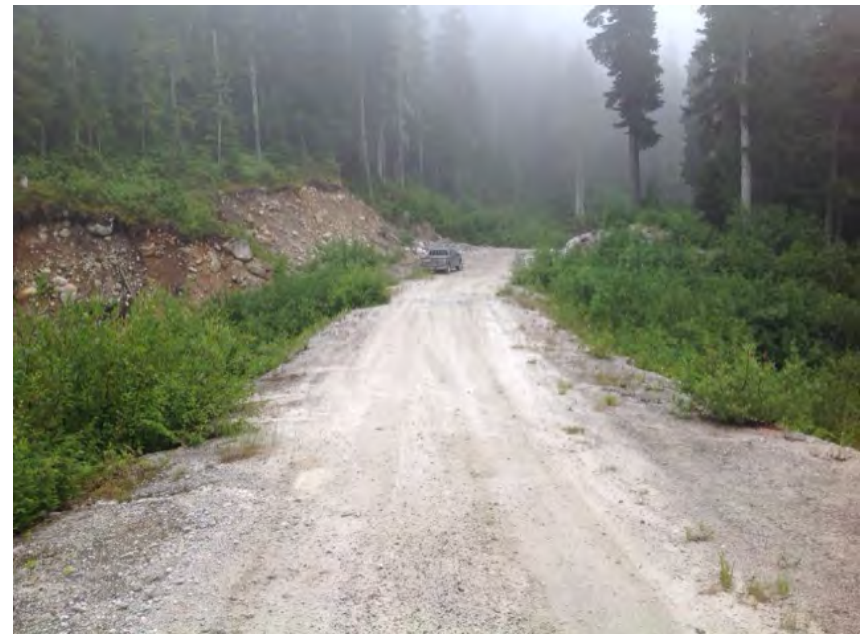
Approach from Right Bank when facing downstream

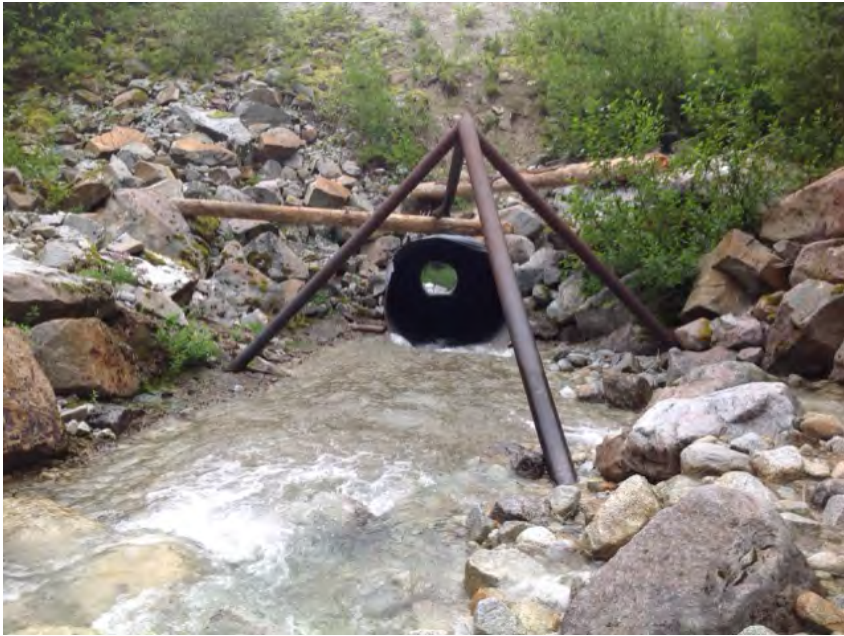
| Inlet | Fair | minor damage, most likely from install |

| 1 | monitor debris accumulations at the inlet and scour at the outlet | |

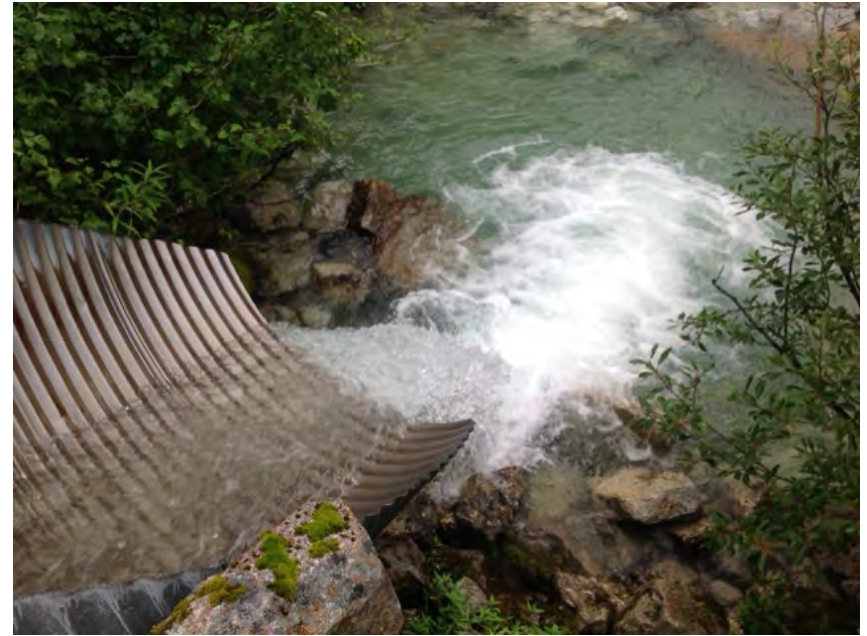
| Outlet | Fair | 1.0m plunge pool |

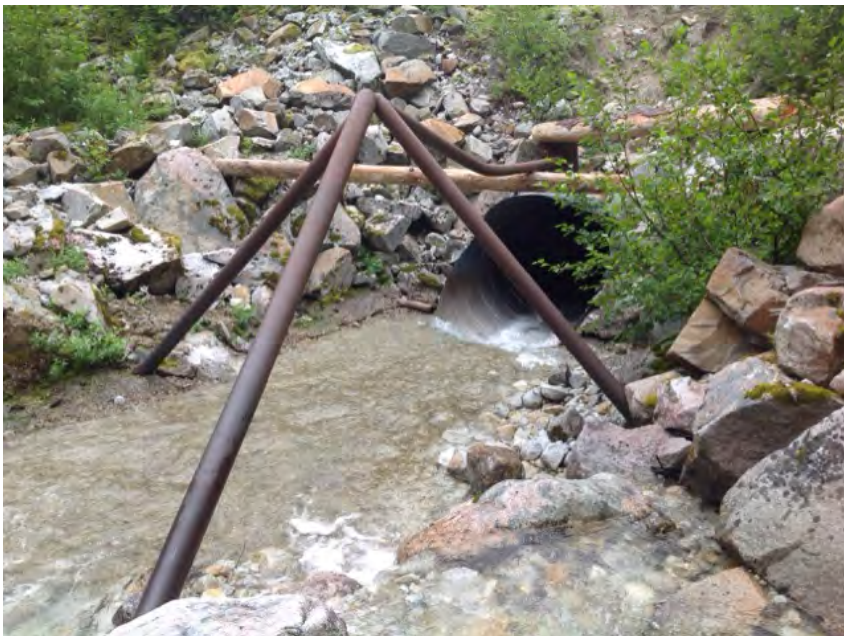
debris catcher

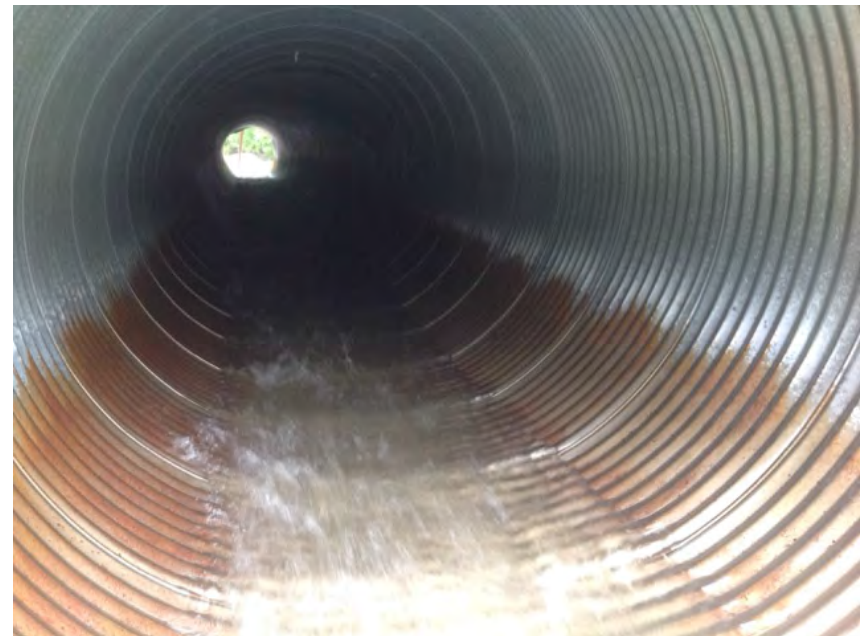
| Roof | Fair | minor damage, most likely from install |

looking through culvert from outlet
