CK-2130

STS'AILES 12.8km

2016 Inspection

| Crossing Name | Wells Creek |

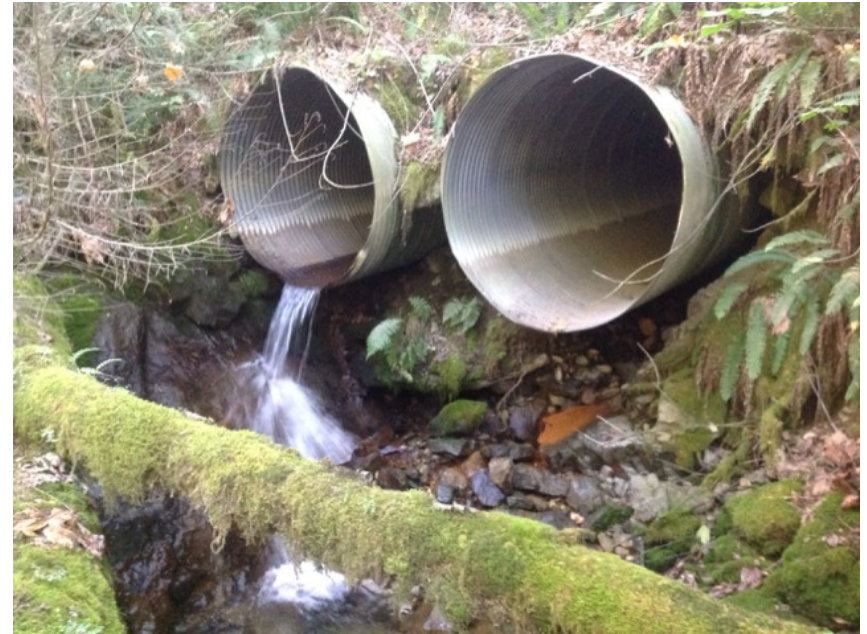
| Outlet | Fair | 1.5m drop |

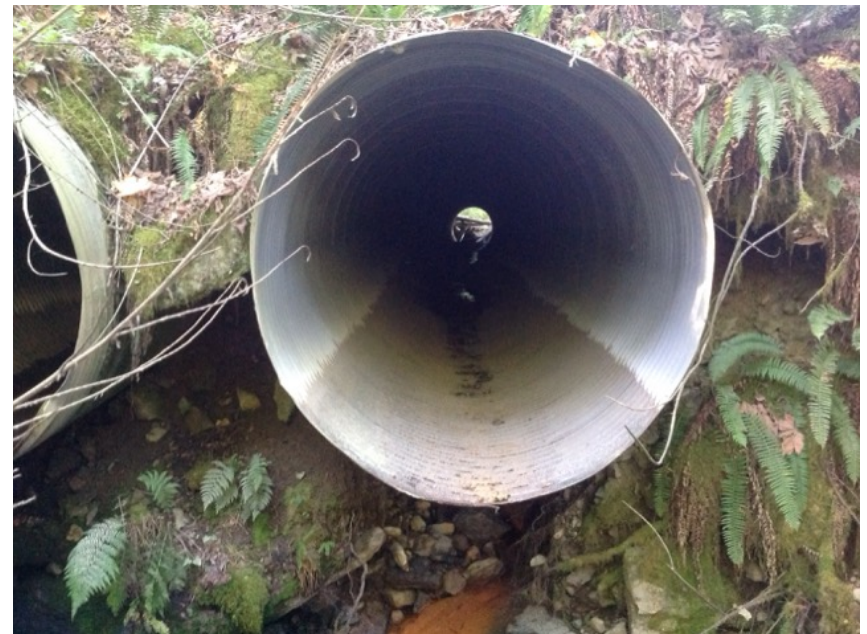
looking through from outlet

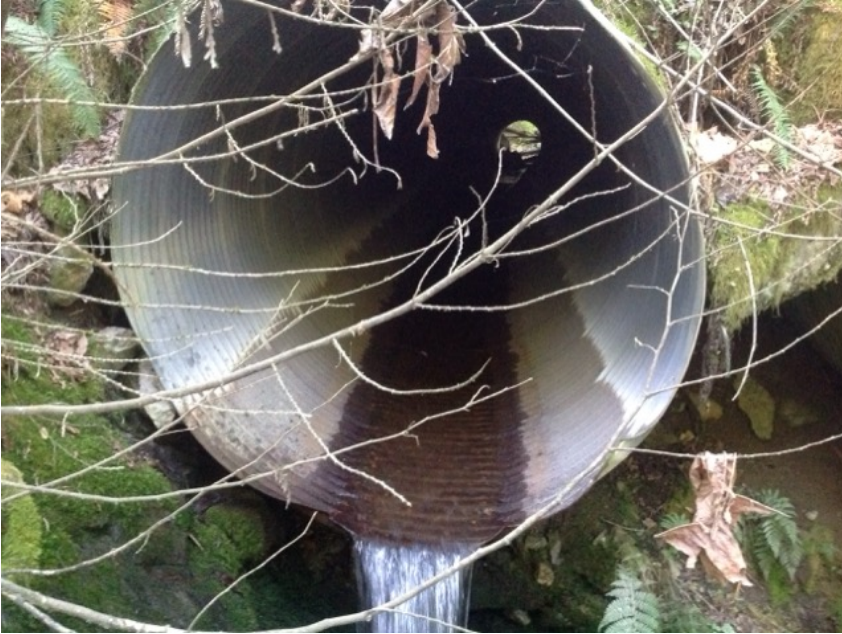
looking through from outlet

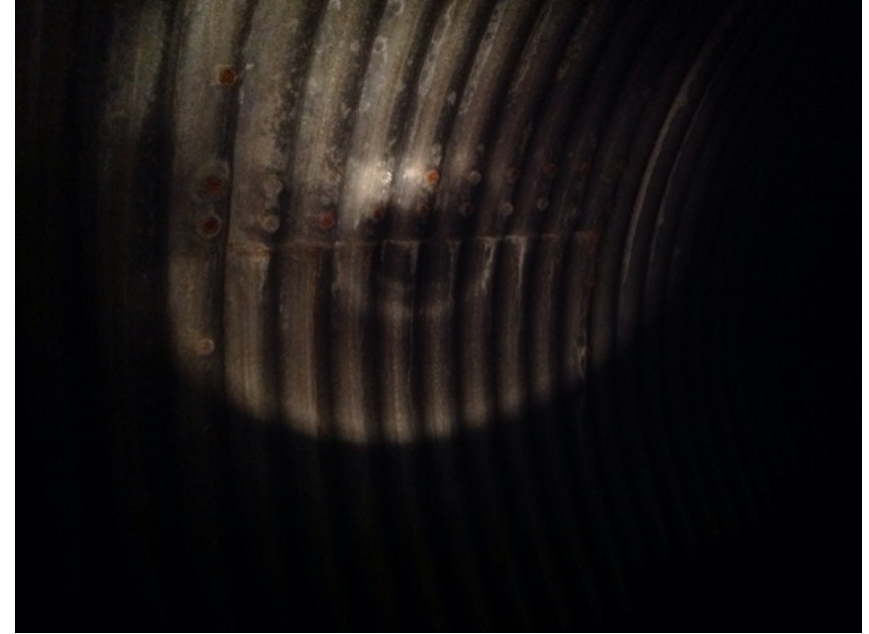
middle section of left culvert is a multiplate - coupled at both ends to CSP

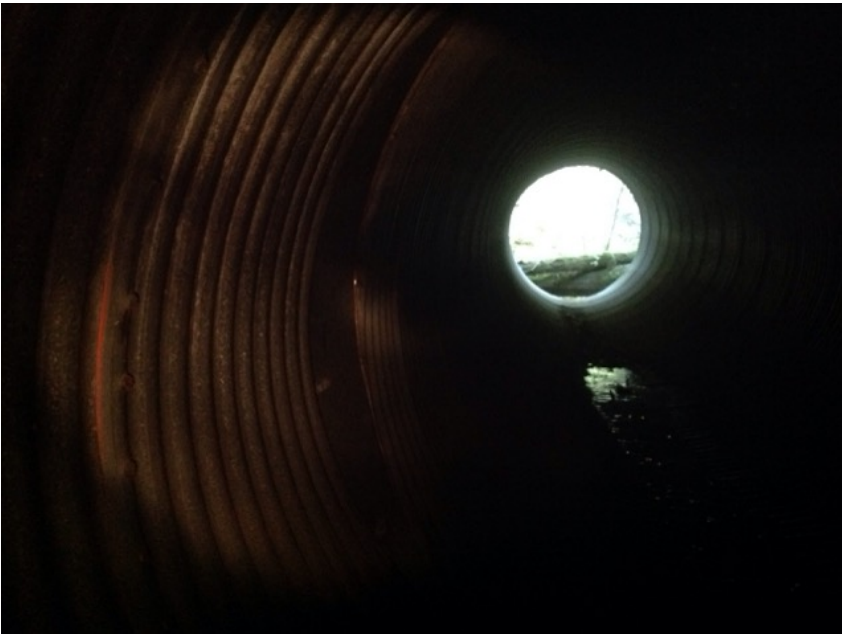
coupler

| Coupled Connections | Fair | |

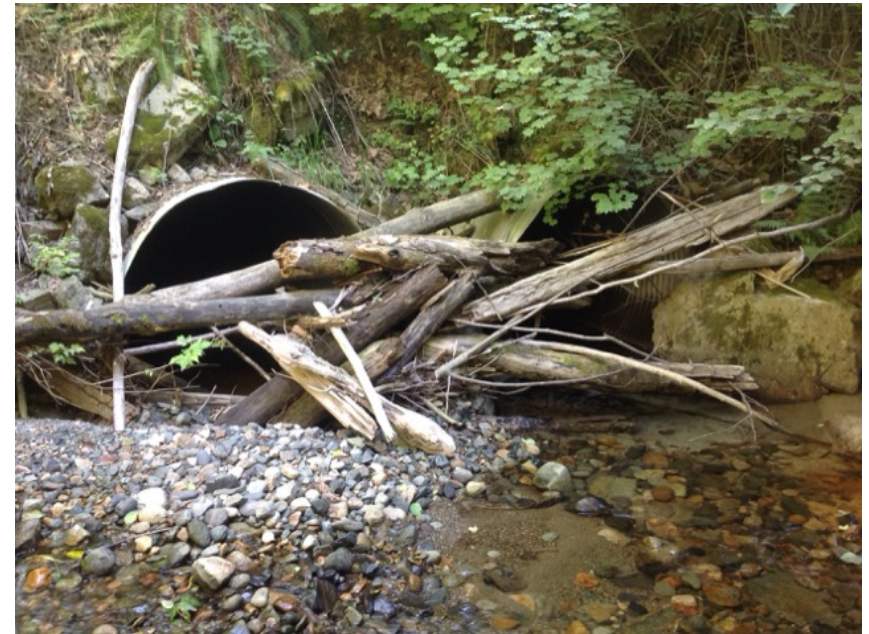
| Inlet | Poor | debris accumulating at inlet - monitor |

Clean debris from inlet and monitor accumulations. Present load rating of L150 or 136 tonnes to continue.

| 1 | High | clear debris accumulations at inlet |
