CK-2131

STS'AILES 16.4km

2016 Inspection

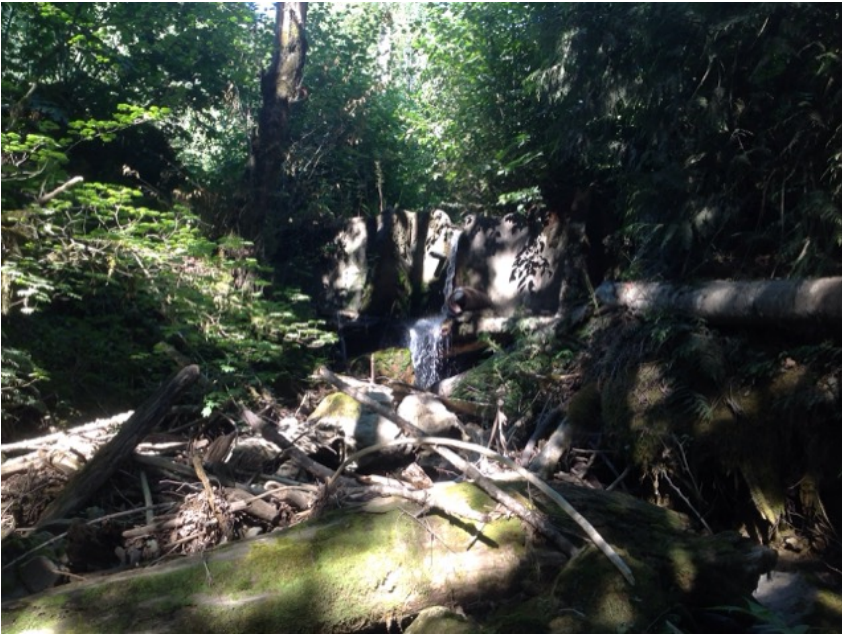
weir located 25 meters upstream from culvert

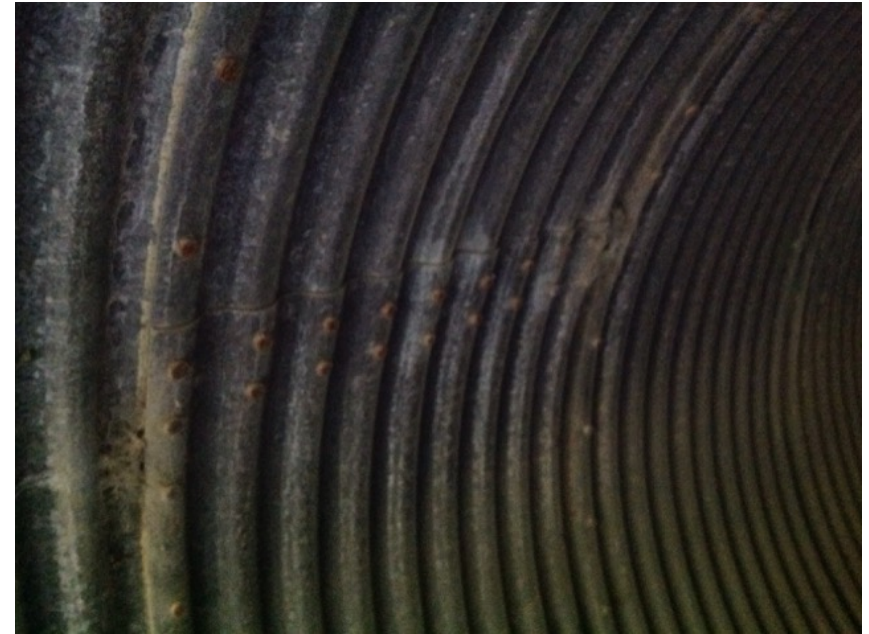
multiplate

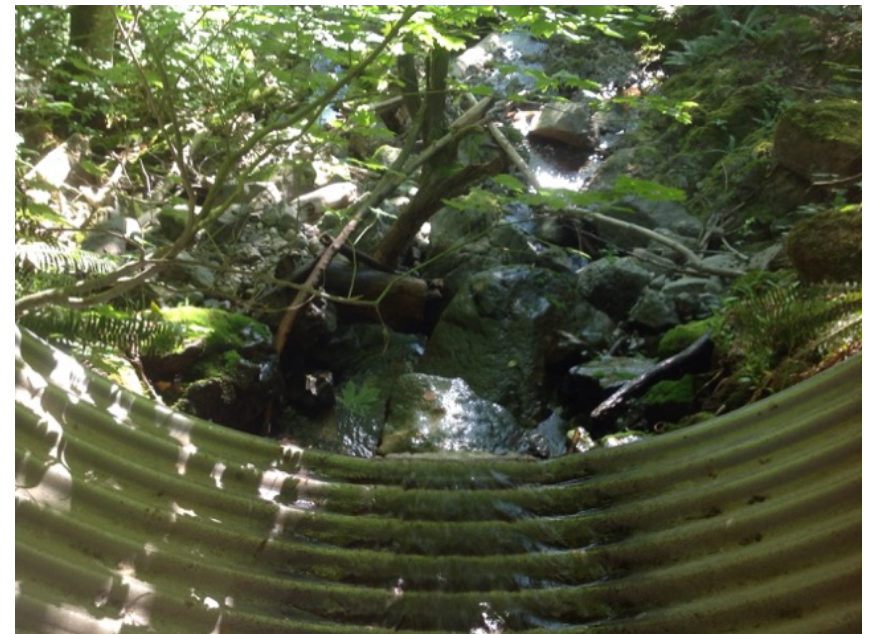
| Outlet | Fair | 2.0m drop |

outlet from inside culvert

Culvert is only 1800mm diameter, inspect with regular road inspections. Present load rating of L150 or 136 tonnes can continue. Monitor outlet scour.
