CK-2135

STS'AILES 25km

2016 Inspection

| Crossing Name | Sunrise Creek |

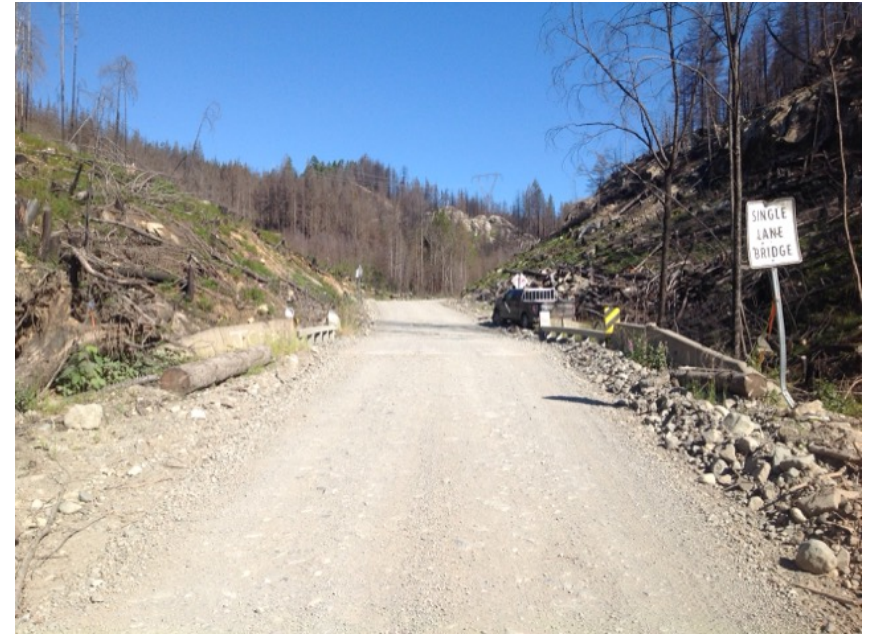
Approach from Right Bank when facing downstream

Concrete Deck      Fair      worn on right approach and on wheel path

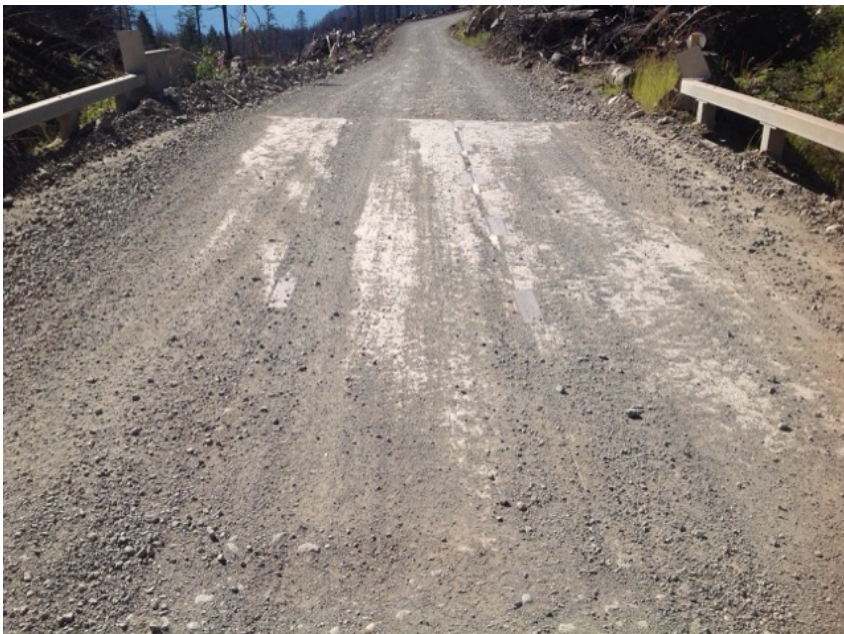
Overall Deck Condition      Fair
