CK-2144

STS'AILES 56.3km

2016 Inspection

| Crossing Name | Bremner Creek |

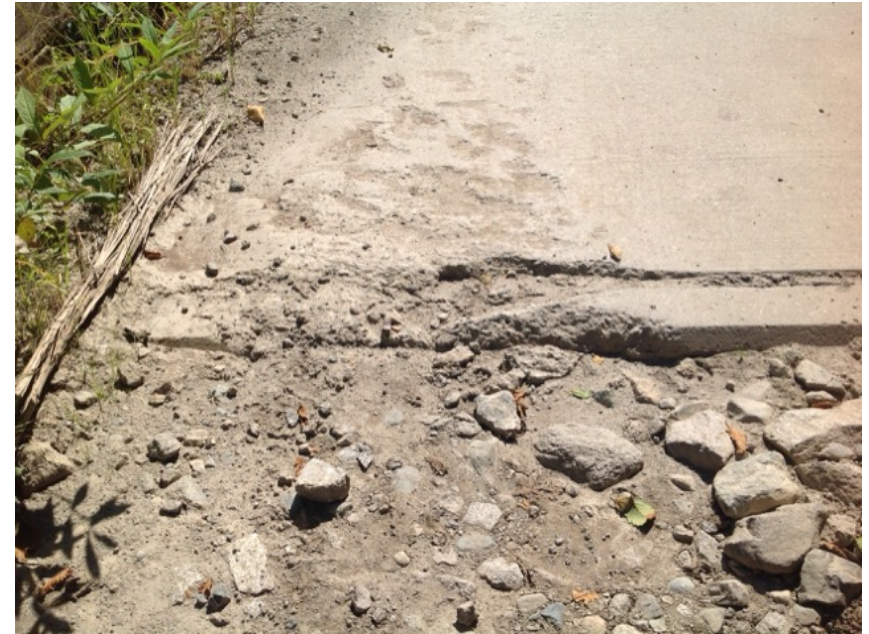
Ballast Wall Fair some damage on tops due to tracked machinery

| Concrete Deck | Fair | damage due to tracked machines |

ballast wall and deck wear due to poor road conditions

| 3 | Medium | repair damage to deck panels and ballast wall |

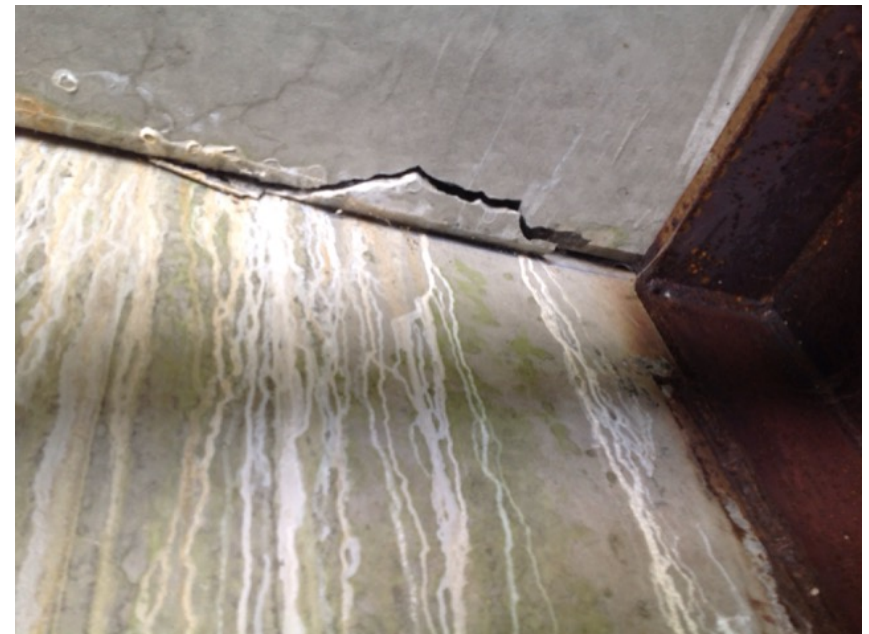
damage visible to deck from underneath
