CK-2145

STS'AILES 61.2km

2016 Inspection

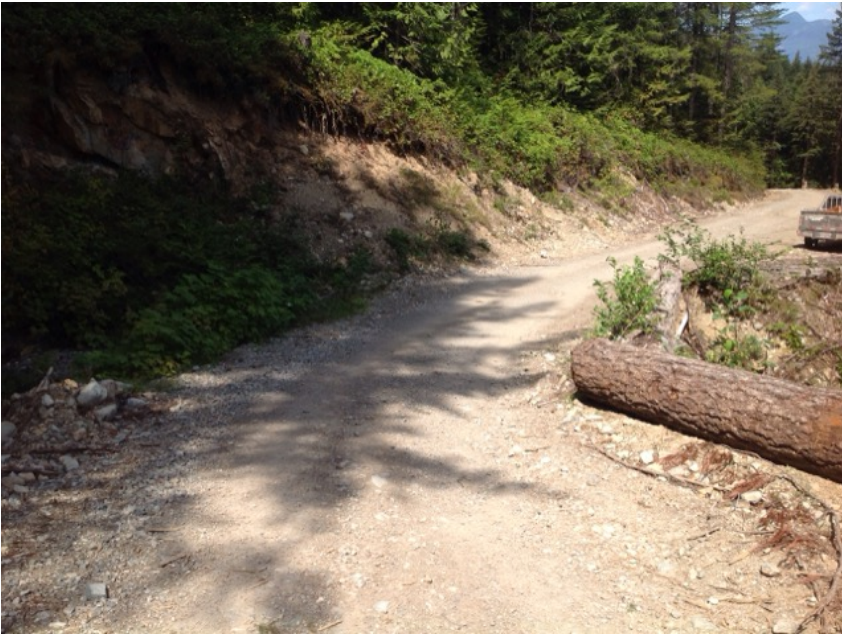
Approach from Right Bank when facing downstream

VC and HC right bank approach

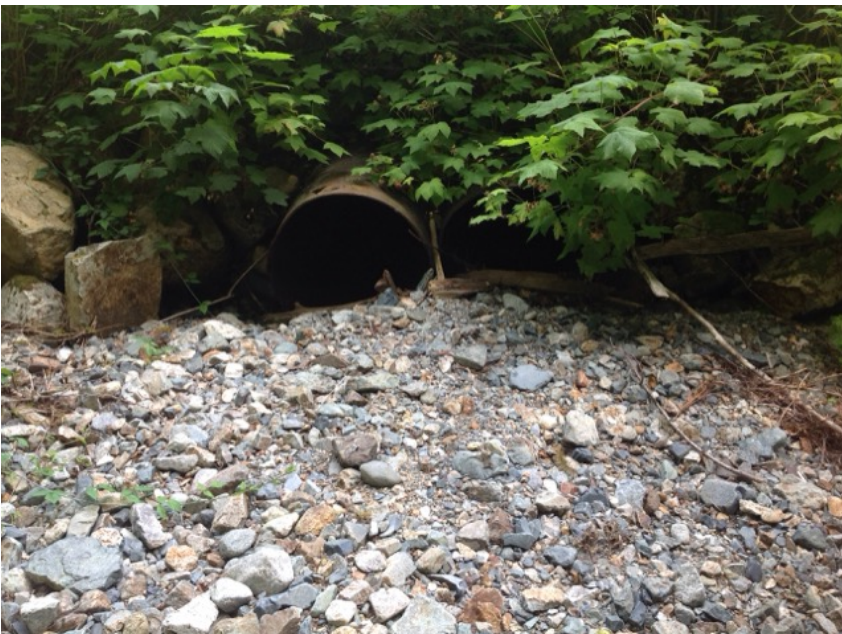
Inlet

| Item | Monitor Description | Frequency |
|---|---|---|
| 1 | aggradation at inlet | Routine inspection |

Clean inlet and monitor aggradation. Remove site from inventory and inspect with regular road inspections.

| Repair Item | Priority | Repair Description |
|---|---|---|
| 1 | High | Clean inlet |
