CK-2147

STS'AILES 66.9km

2016 Inspection

| Crossing Name | Tretheway Creek | | |

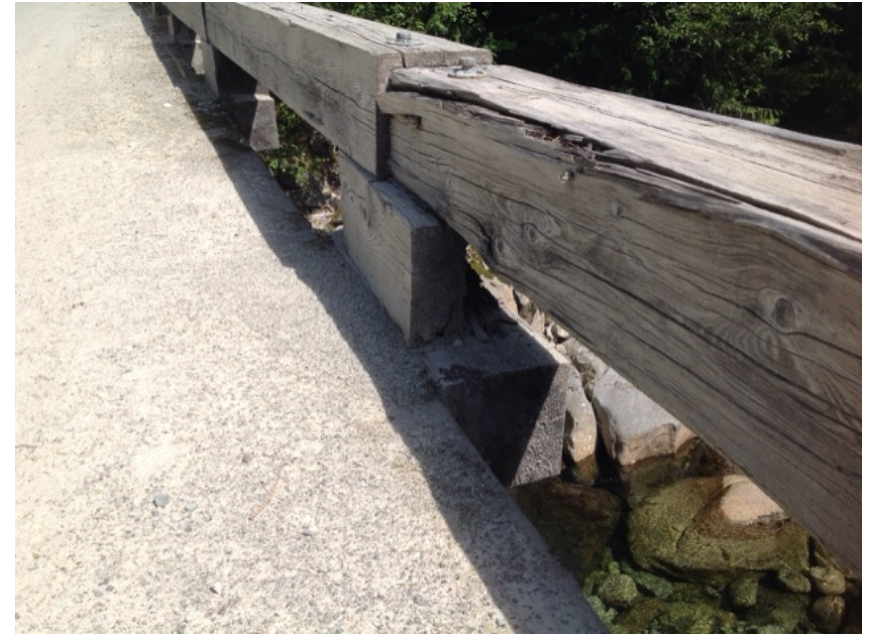
| Curb Rail/Blocks/Posts | Poor | rotten risers and blocks |
| Overall Deck Condition | Poor | due to rail |

guardrail/riser condition

Replace guardrail, risers and blocks. Replace missing delineator and post bridge ahead signs. Brush approaches. Present load rating of L100 or 91 tonnes to continue.

| Repair Item | Priority | Repair Description |
|---|---|---|
| 1 | Medium | replace guardrail, risers and blocks |

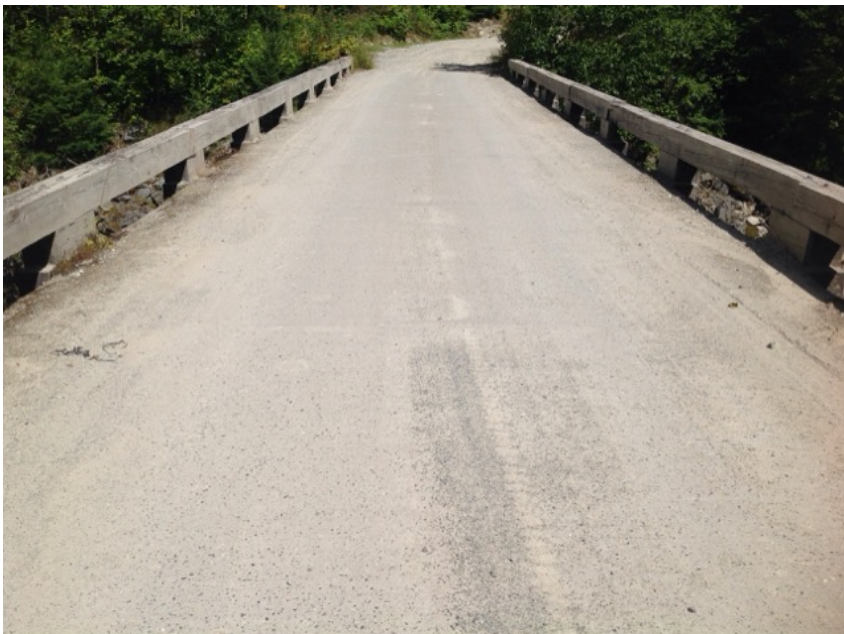
| Concrete Deck | Fair | some damage to surface from tracked machinery |

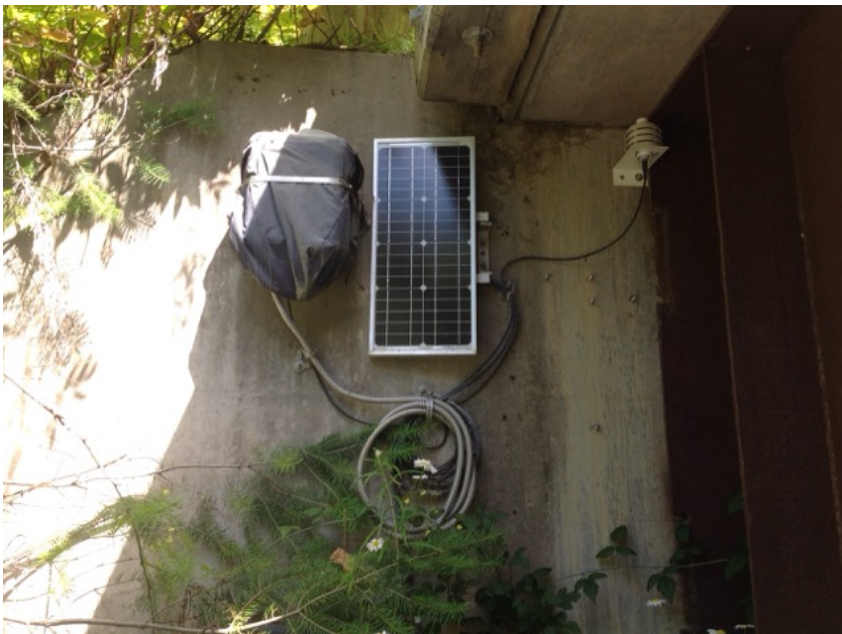
monitoring station fixed to left bank ballast wall
