CK-2148

SIMMS CREEK 8.6km

2016 Inspection

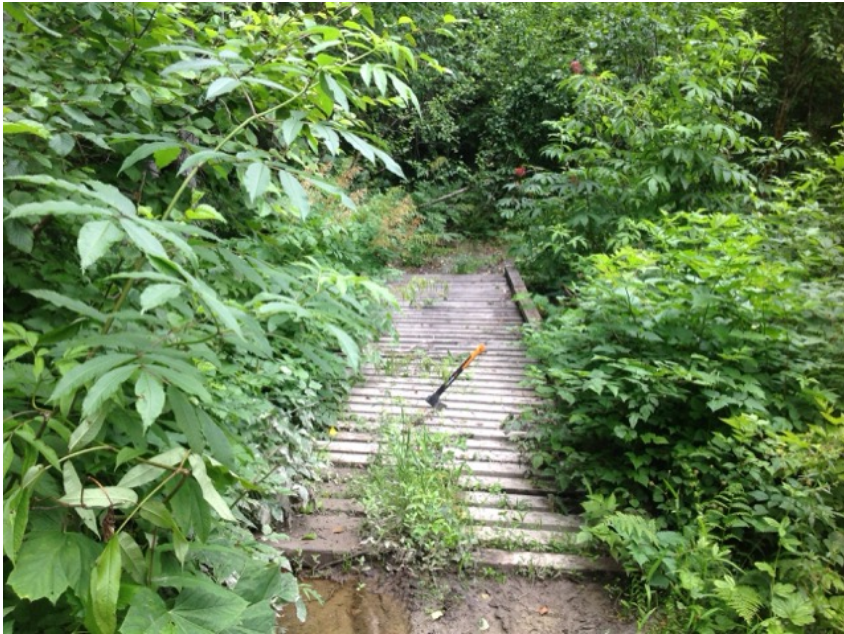
Approach from Right Bank when facing downstream

Alignment Poor grown over and HC

Road Surface Poor grown over

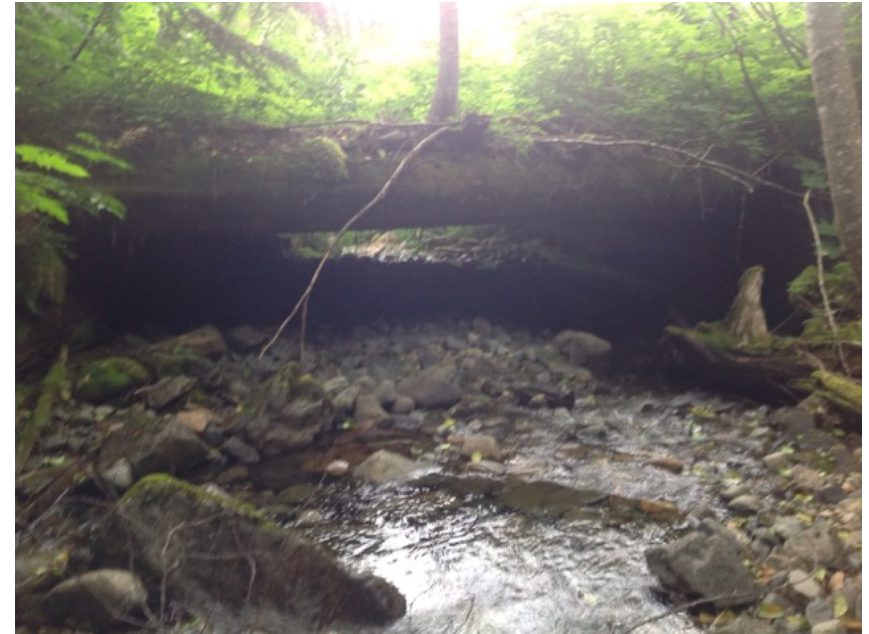
Upstream Profile

| Overall Deck Condition | Poor | rotten and overgrown |

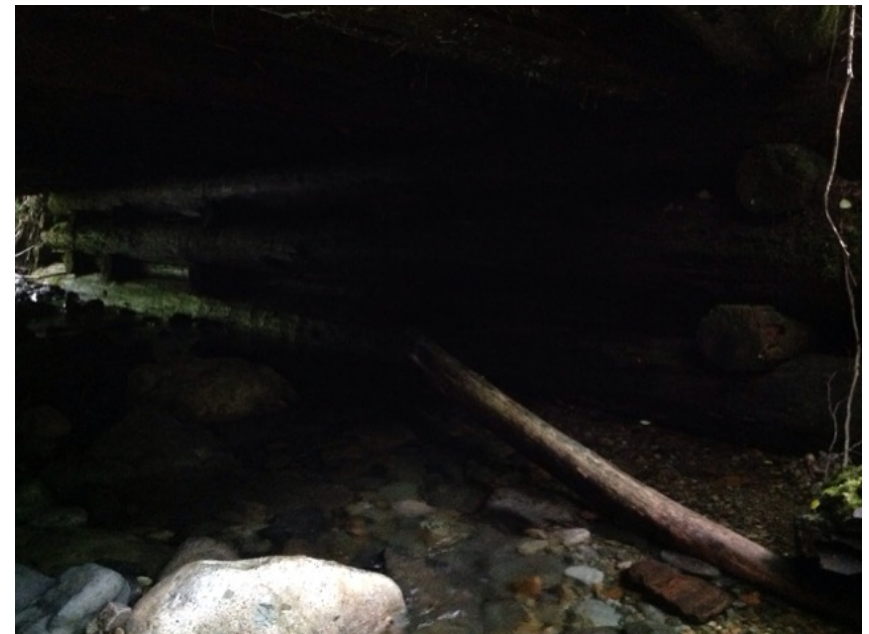
Right Bank Abutment when facing downstream

Log/Timber Cribs Poor rotten

Tie Backs Poor rotten

Bearings Poor uneven

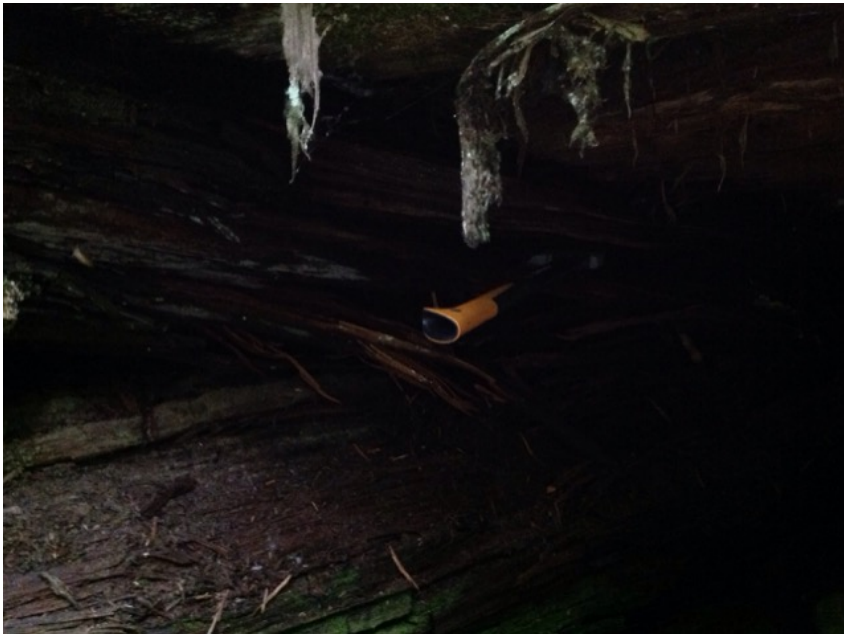
top crib log on left bank crushed
