CK-2149

WALIAN CREEK 7.2km

2016 Inspection

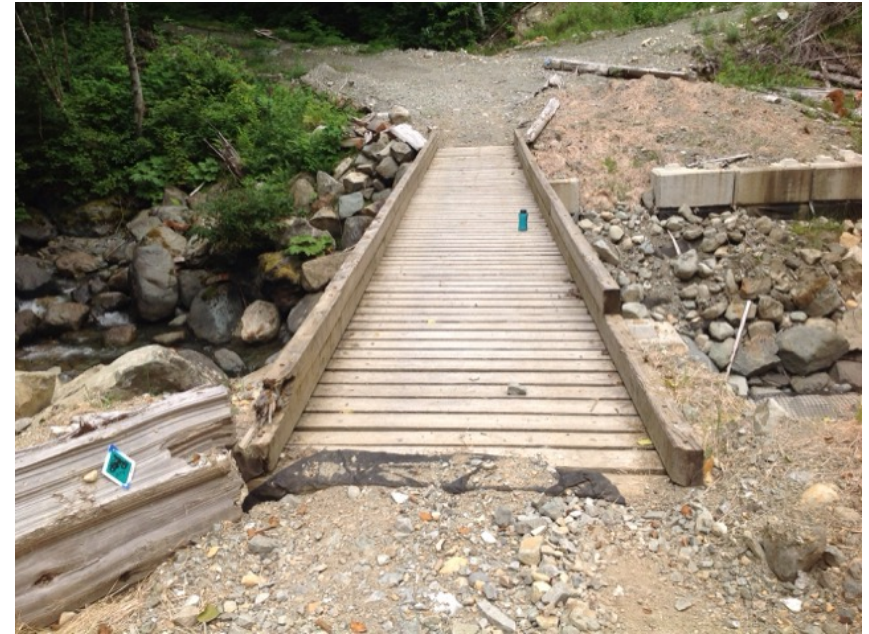
ATV bridge

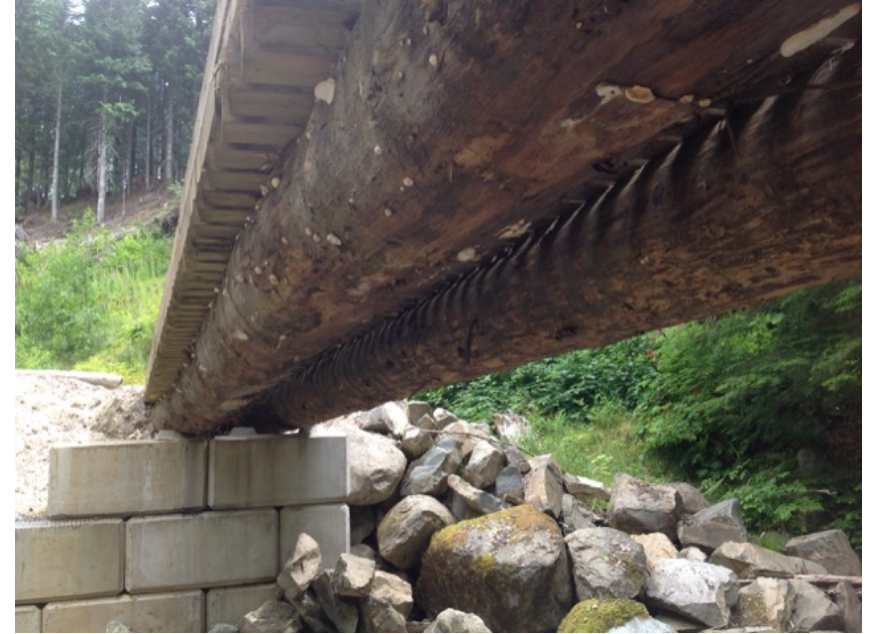
Stringers

stringers have numerous small conks and will not last long  
bearing on right bank is partially on blocks -10.6m span, otherwise 14.5m span

| Needle Beam to Crib (m) | | | Needle Diameter (mm) | | | |
|---|---|---|---|---|---|---|
| 1 | Fd | Y | 520 | 20 | Fair | small conk starting to show |
| 2 | Fd | Y | 520 | 50 | Fair | lots of small conks present with localized rot |

Bridge condemned, 0 tonnes load rating. Remove structure and block access ASAP.

| Repair Item | Priority | Repair Description |
|---|---|---|
| 1 | High | Remove structure and block access to site |

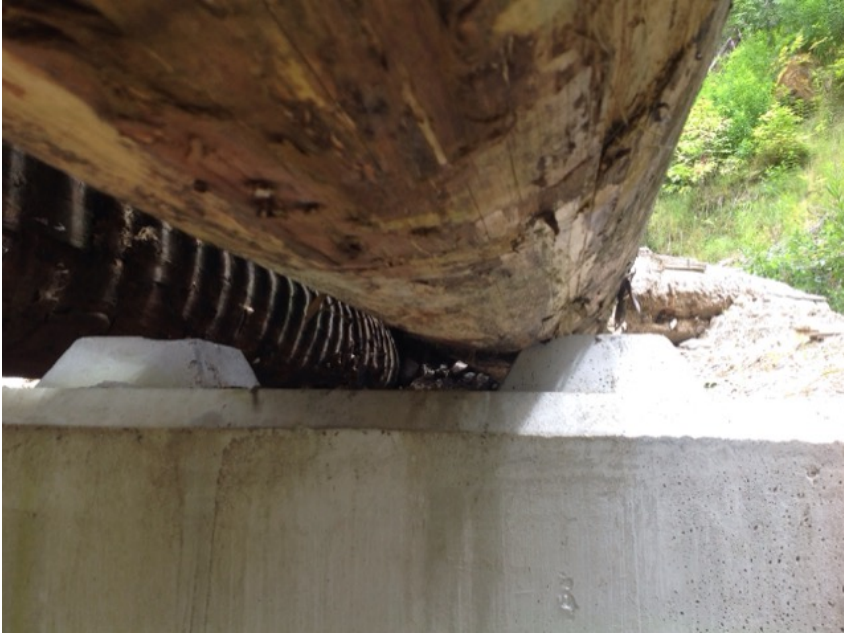
partial bearing on right bank
