CK-2163

LOST CREEK 1.1km

2016 Inspection

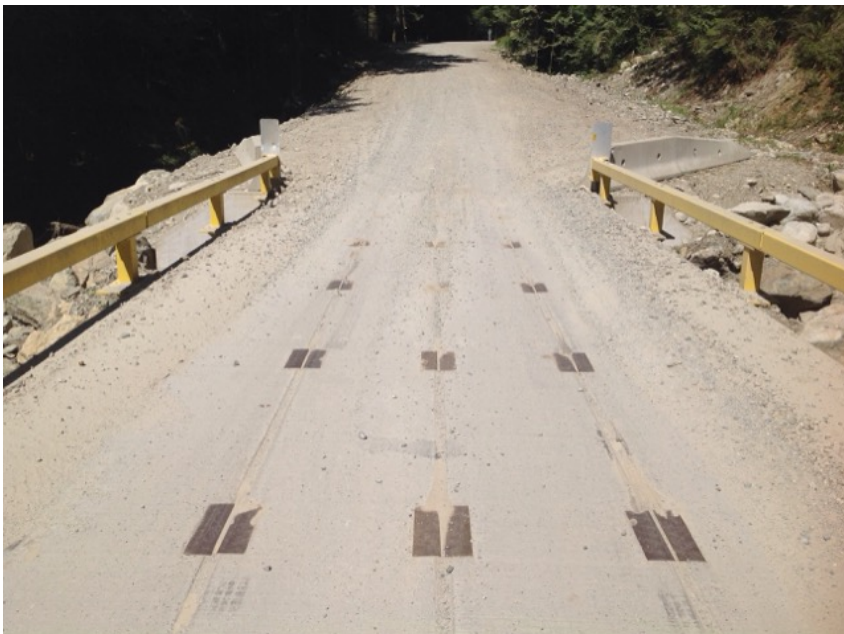
Overall Deck Condition      Good
