CK-2165

LOST CREEK 2.2km

2016 Inspection

| Crossing Name | Murdo Creek |

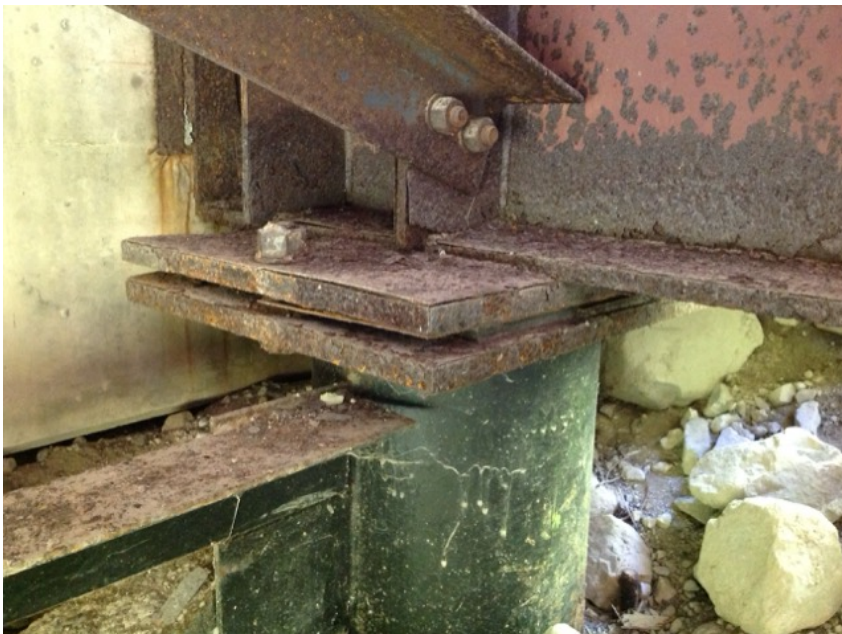
Caps or Sills Fair minor delamination on right bank

Bearings Fair

bearing plates delaminating - typical right bank

Monitor minor steel delamination. Present load rating of L75 or 68 tonnes to continue.

1 monitor delamination

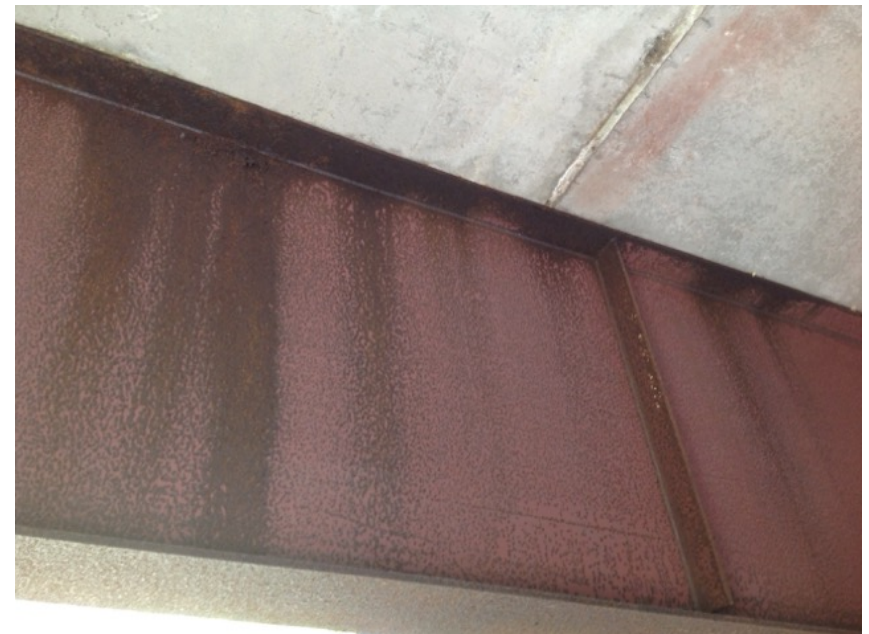
indication that moisture is getting through deck joints

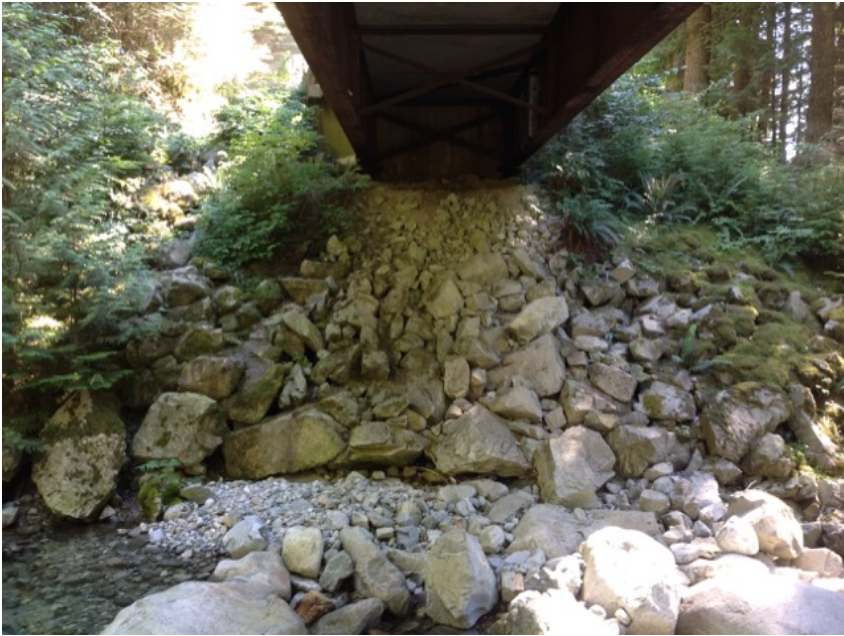
Left Bank Abutment when facing downstream

Bracing Good only right bank, left bank columns approx 300mm height
