CK-2166

LOST CREEK 5km

2016 Inspection

| Crossing Name | Weatherhead Creek |

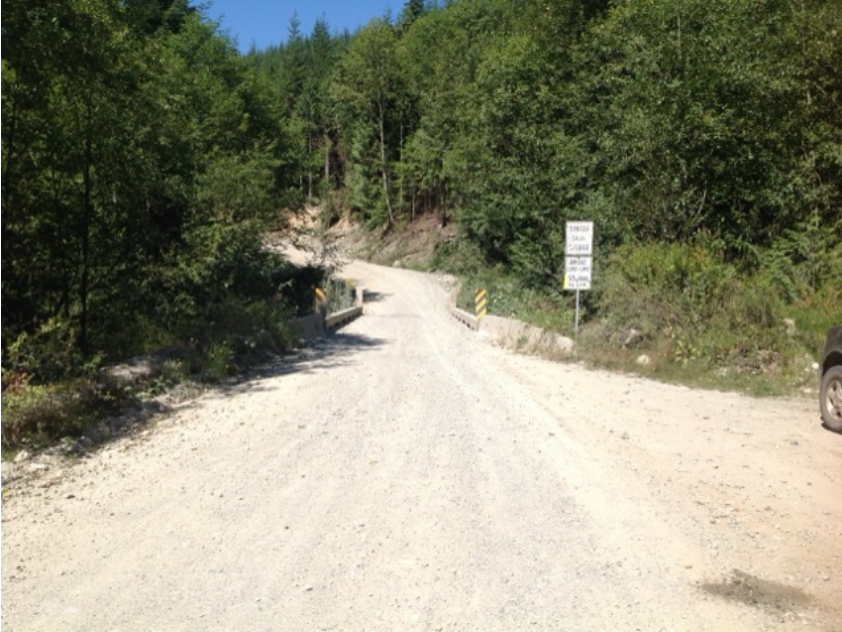
Approach from Left Bank when facing downstream

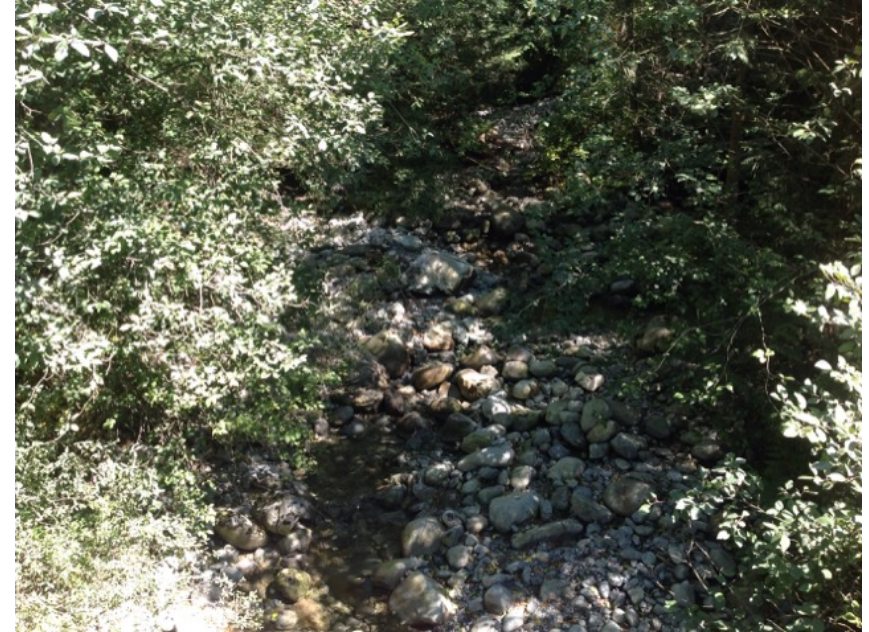
looking upstream from deck

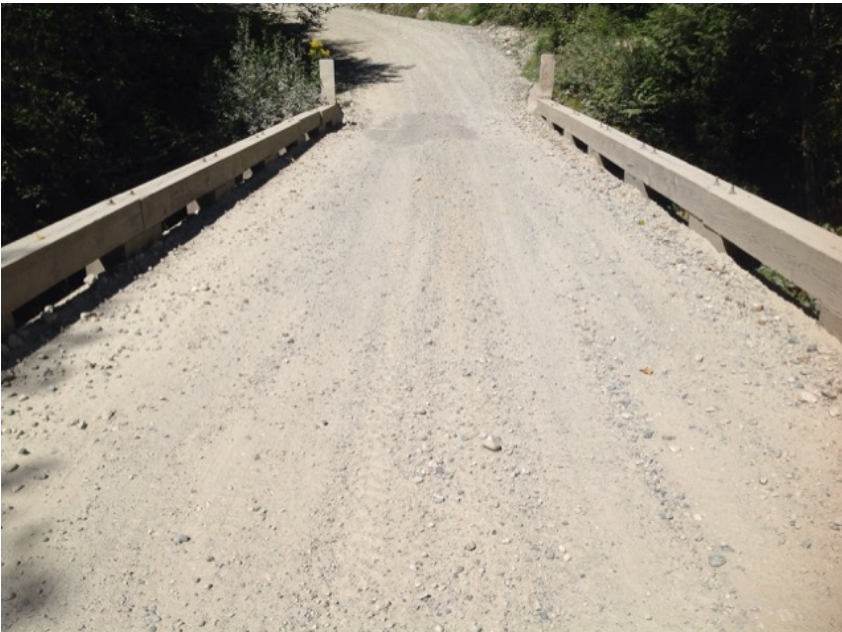
Deck

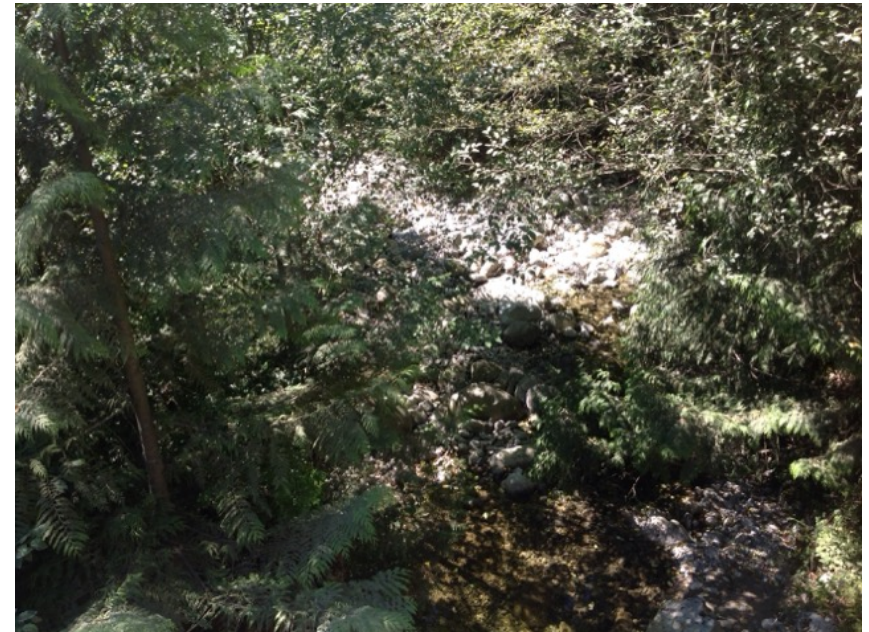
looking downstream from deck

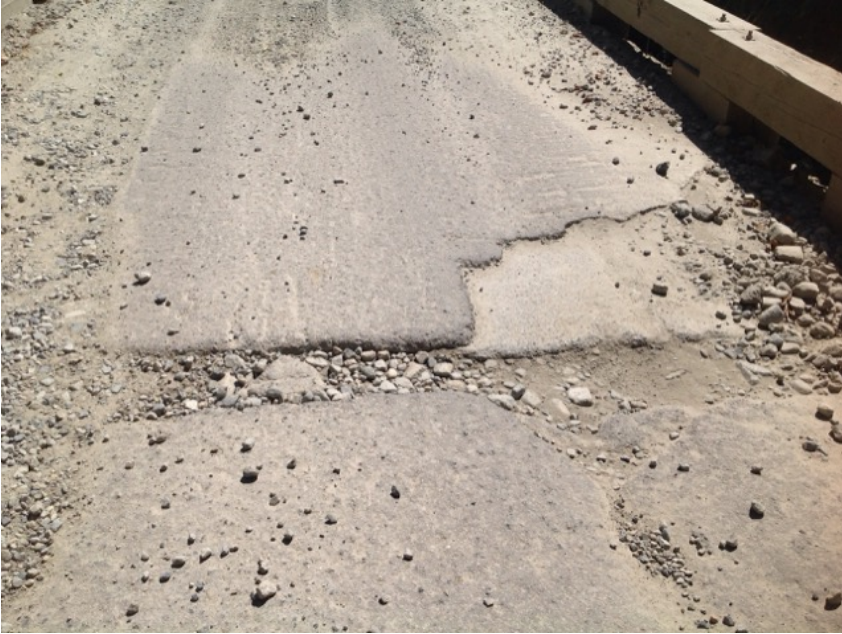
50mm asphalt overlay

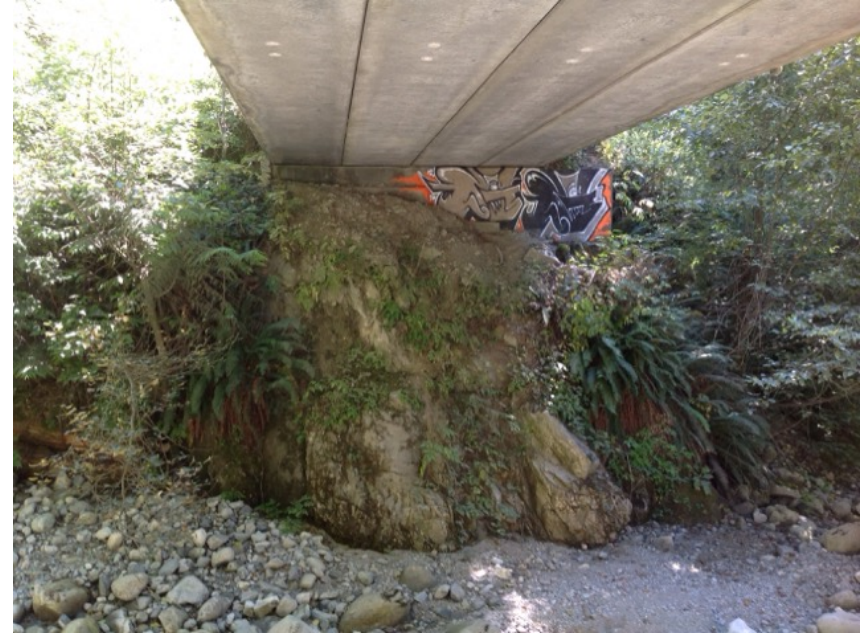
Left Bank Abutment when facing downstream

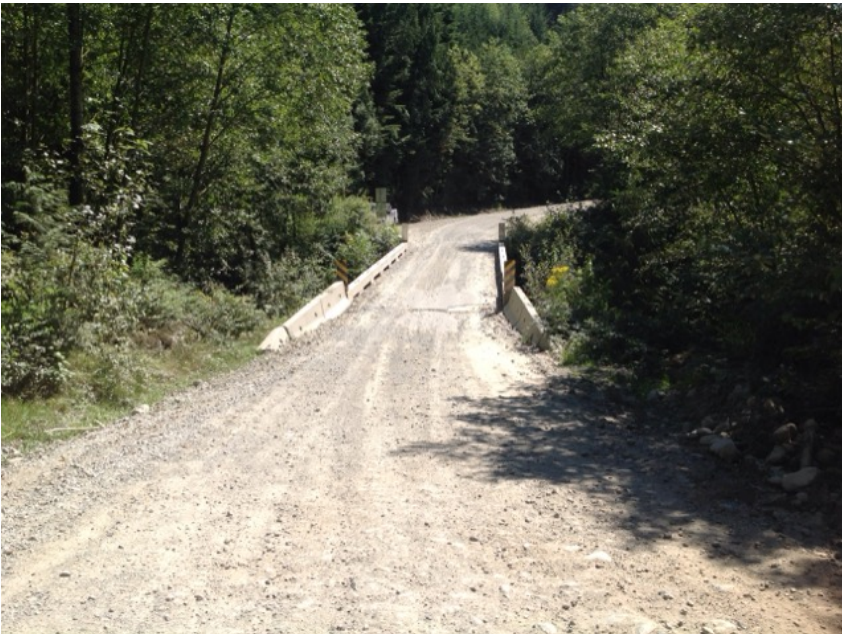
Approach from Right Bank when facing downstream

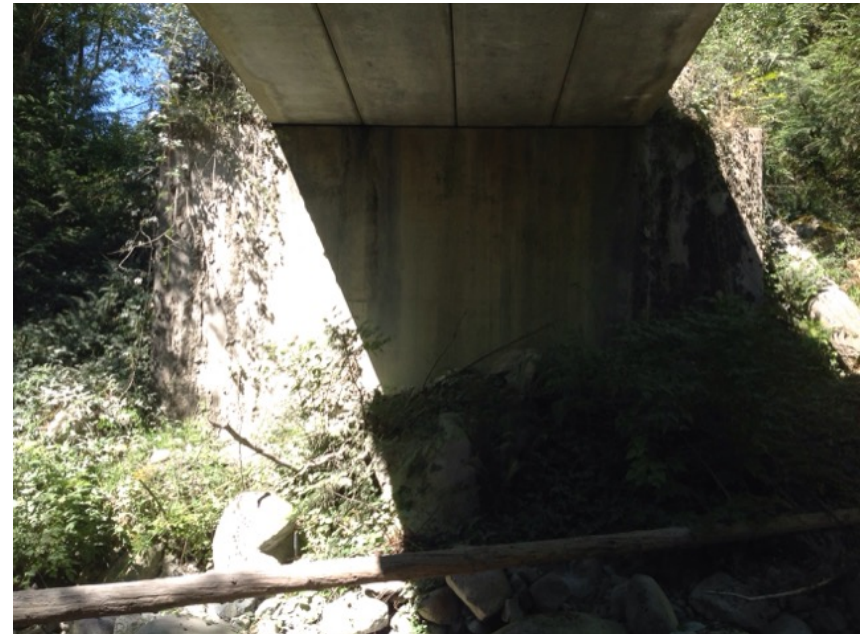
Right Bank Abutment when facing downstream

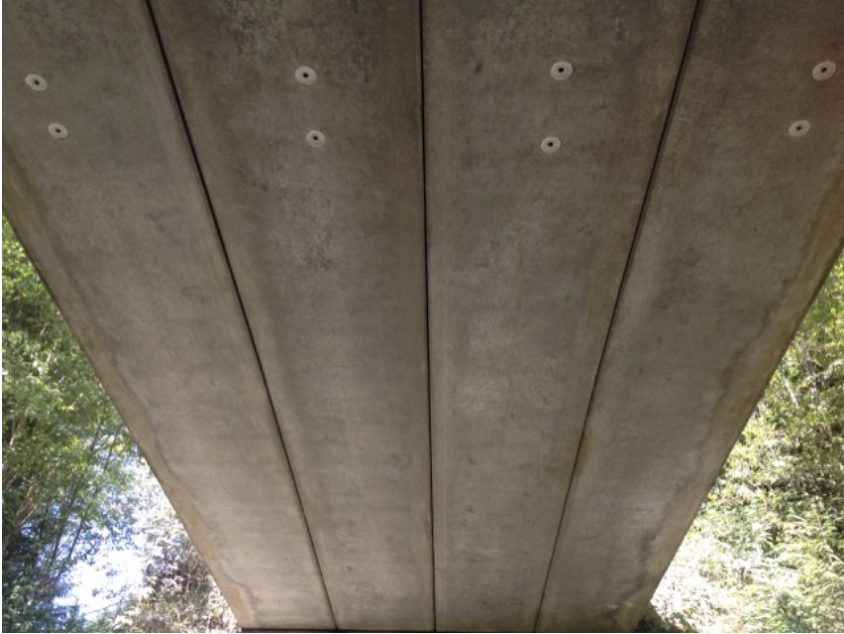
superstructure
