CK-2167

LOST CREEK 8km

2016 Inspection

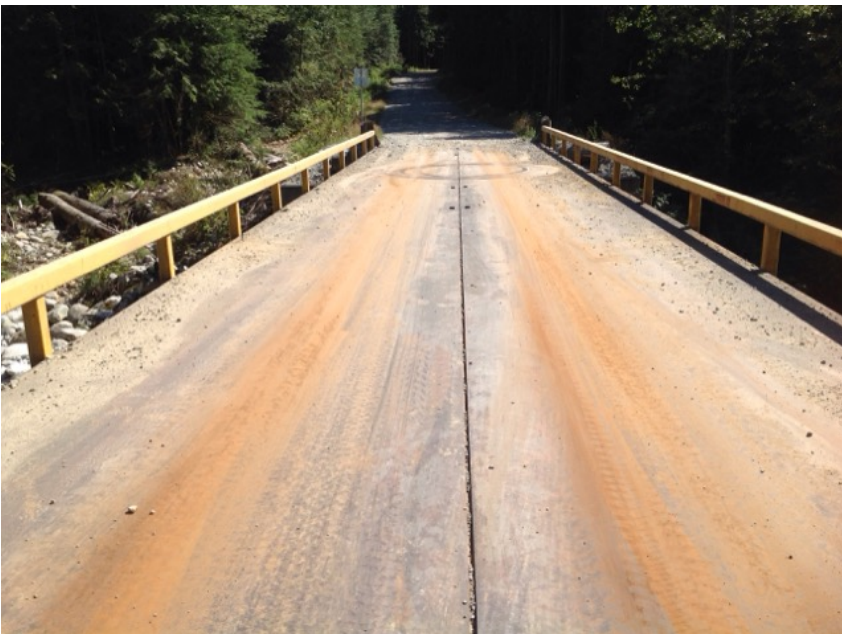
Steel Deck Plate      Fair

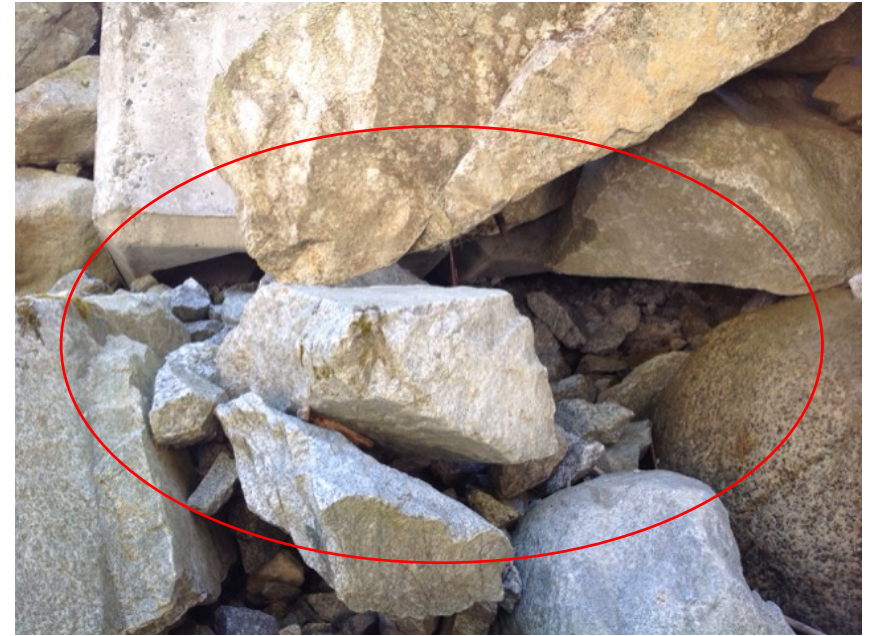
Concrete Fair scour under upstream left bank

Wing Wall Fair scour noted under upstream left bank

upstream left bank lock block (abutment scour)

Repair scour under left upstream lock blocks ASAP and place riprap in front to protect. The riprap on the right upstream abutment is also starting to scour, repair that at same time. The present load rating of L75 or 68 tonnes can continue for now. Inspect again prior to heavy rains.

| Repair Item | Priority | Repair Description |
|---|---|---|
| 1 | High | repair scour under left bank blocks ASAP |

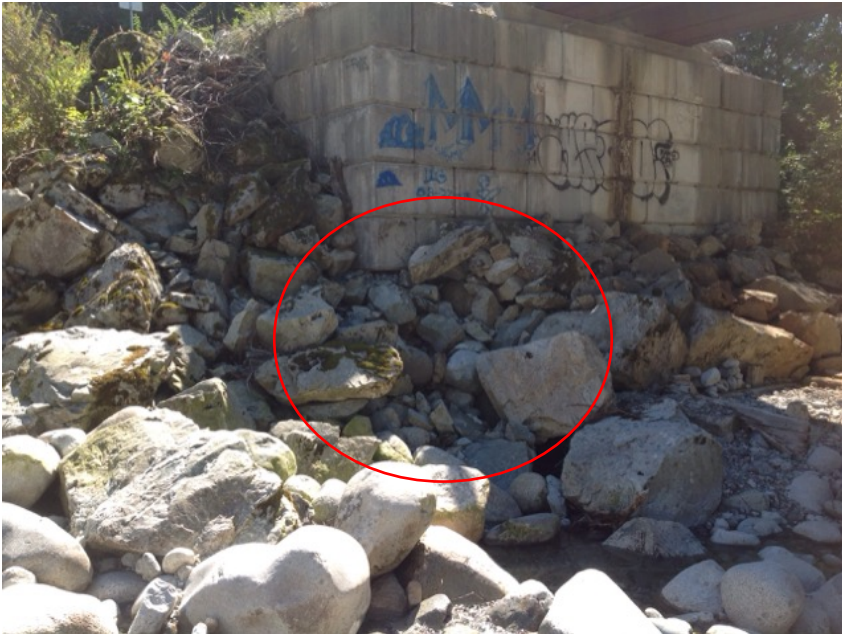
Riprap Fair upstream corners starting to scour

upstream left bank riprap scour - lock block scour

| Repair Item | Priority | Repair Description |
|---|---|---|
| 2 | High | repair scoured riprap at both upstream abutments |

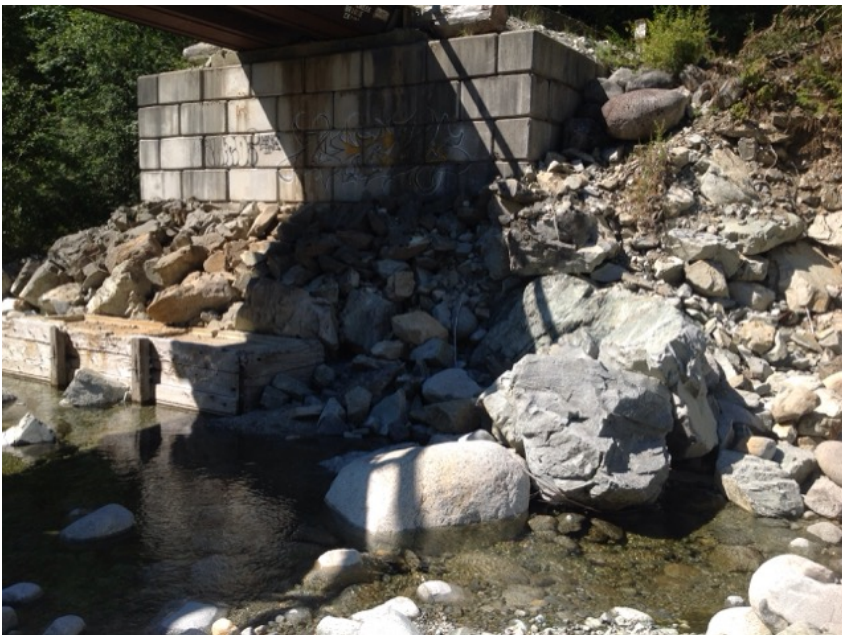
upstream right bank riprap scour
