CK-2168

LOST CREEK 8.6km

2016 Inspection

| Crossing Name | Twin Lakes Creek |

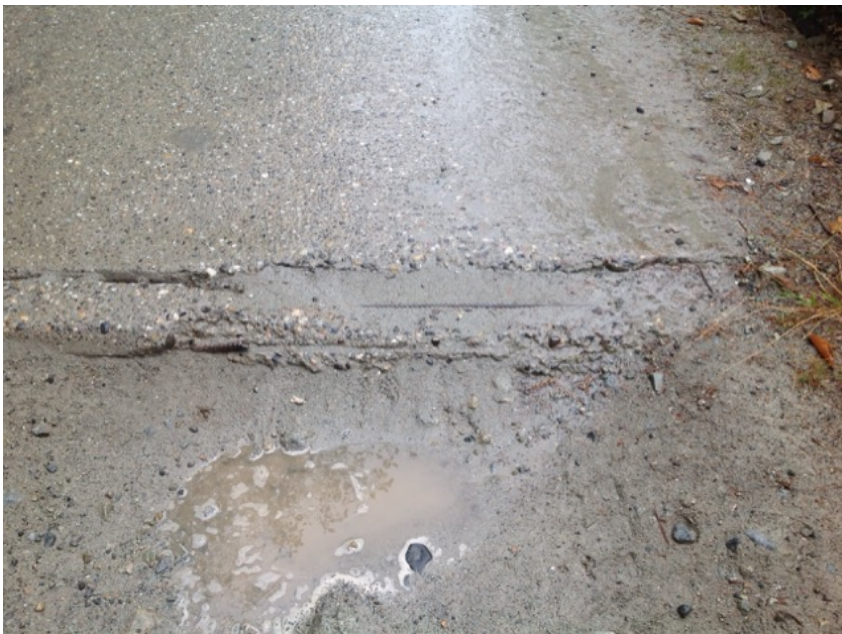
Ballast Wall Poor good left bank, poor right bank

right bank ballast all damage

Repair damaged ballast wall and grade approaches. Present load rating of L75 or 68 tonnes to continue.

| 1 | Medium | repair right bank ballast wall |

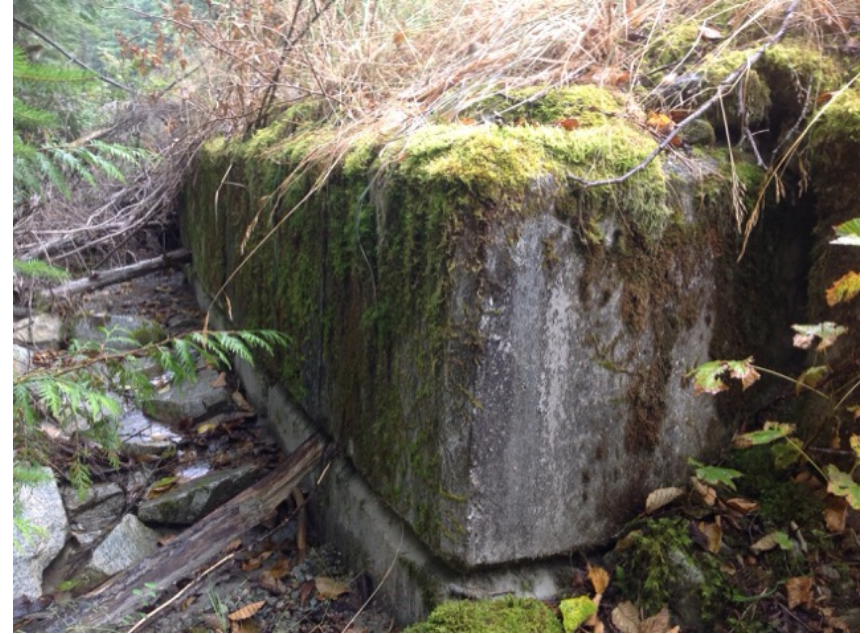
left bank upstream wing wall

Wing Wall Good lock blocks upstream left bank, downstream right bank
