CK-2169

LOST CREEK 14.6km

2016 Inspection

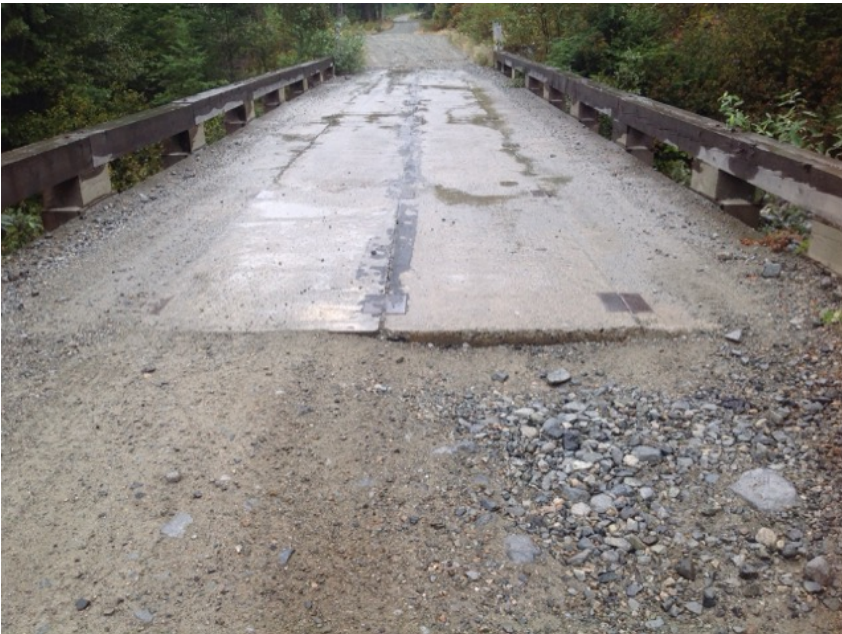
potholes at approach

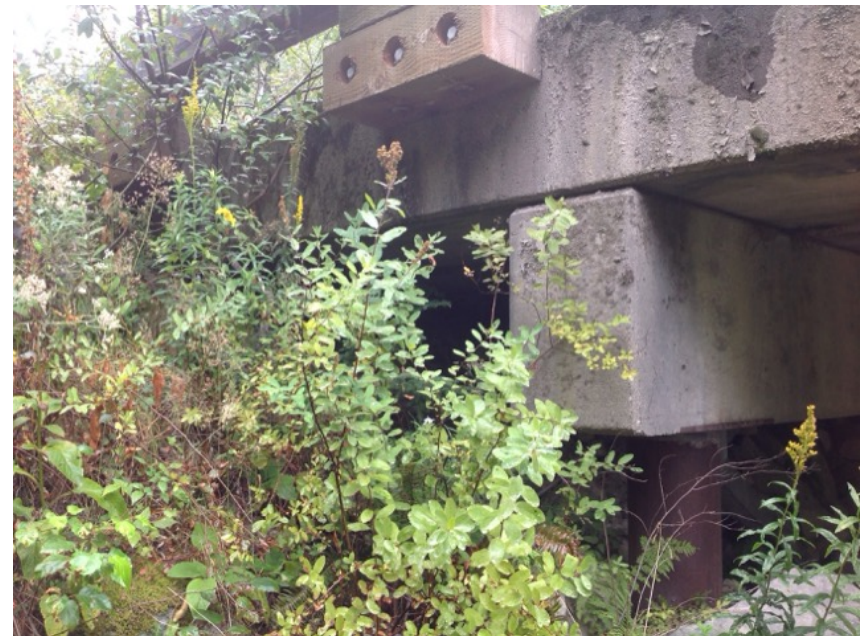
cantilevered abutment

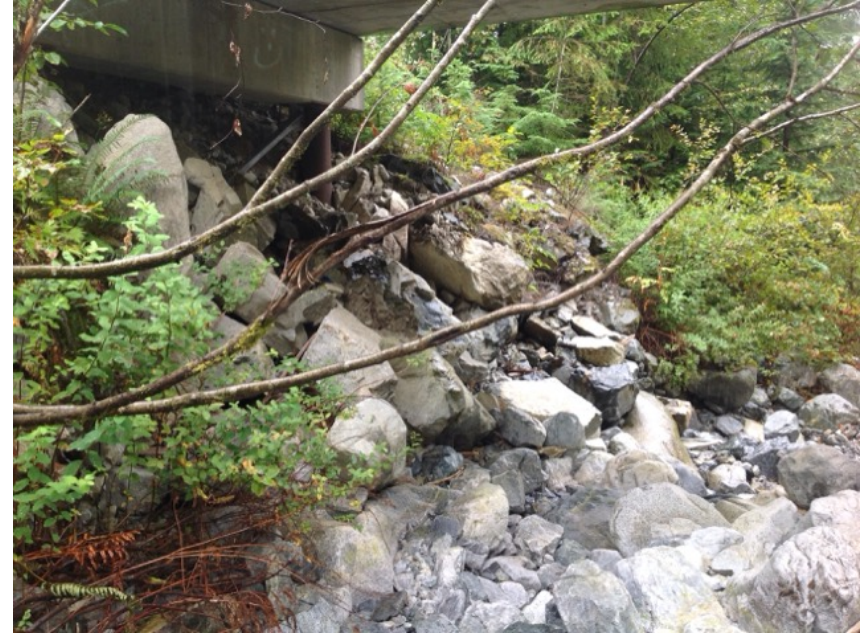
Riprap Fair poor on left bank as scour noted

riprap scour on left bank

| 1 | Medium | repair riprap scour prior to heavy rains |

| 2 | scoured riprap | annual |

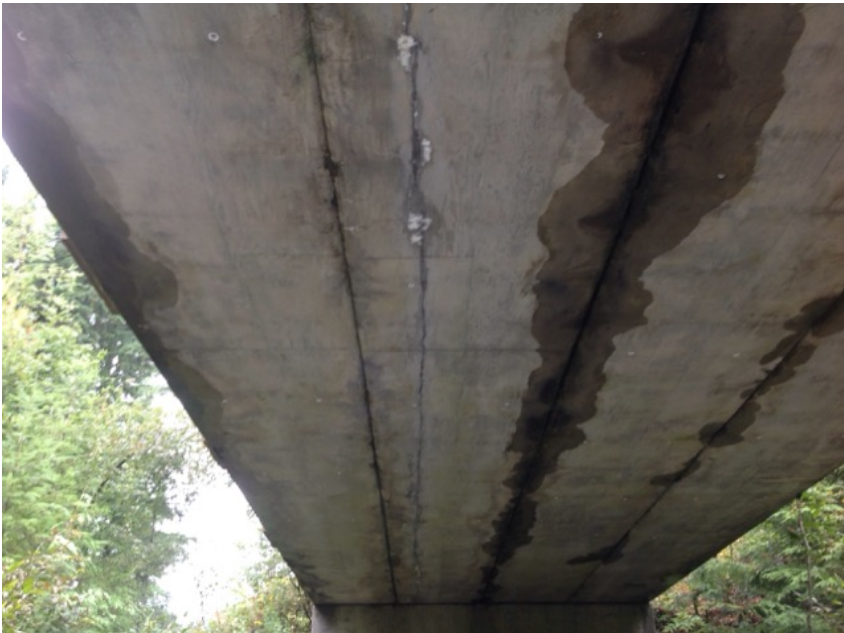
Girders Fair 4 concrete slabs - 3rd slab has crack along entire span

crack along underside of 3rd slab - no apparent change

| 1 | crack on 3rd slab | Routine Inspection |
