CK-2170

LOST CREEK 17.1km

2016 Inspection

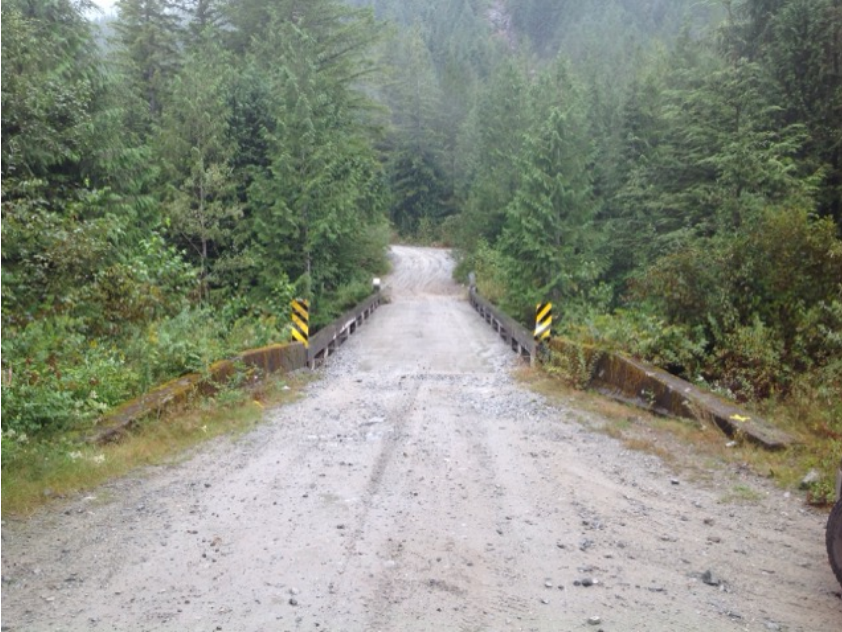
Approach from Left Bank when facing downstream

Bridge Ahead Signs  
Missing ☐ 0 ☐ 1 ☒ 2

Post bridge ahead signs. Present load rating of L60 or 54 tonnes to continue.

| Repair Item | Priority | Repair Description |
|---|---|---|
| 1 | Medium | post bridge ahead signs |
