CK-2171

LOST CREEK 17.8km

2016 Inspection

| Crossing Name | Kenyon Creek |

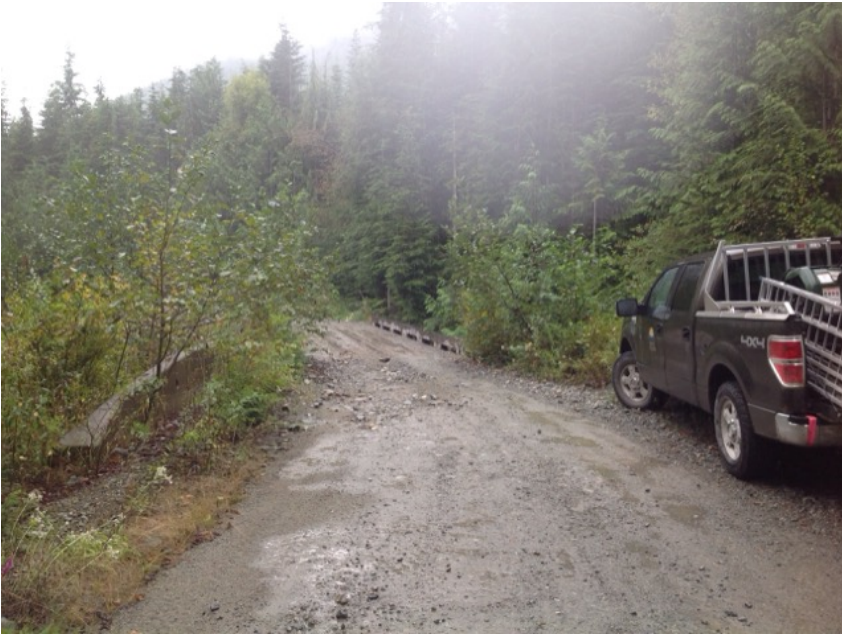
Approach from Left Bank when facing downstream

Bridge Ahead Signs  
Missing ☐ 0 ☐ 1 ☒ 2

Delineator Missing  
Left ☐ 0 ☒ 1 ☐ 2Delineator Missing  
Right ☐ 0 ☒ 1 ☐ 2

The entire timber deck system is rotting and requires replacement prior to industrial use. Limit loading to 40 tonnes until the entire deck system has been replaced. Please post load rating. Replace missing delineators and post bridge ahead signs.

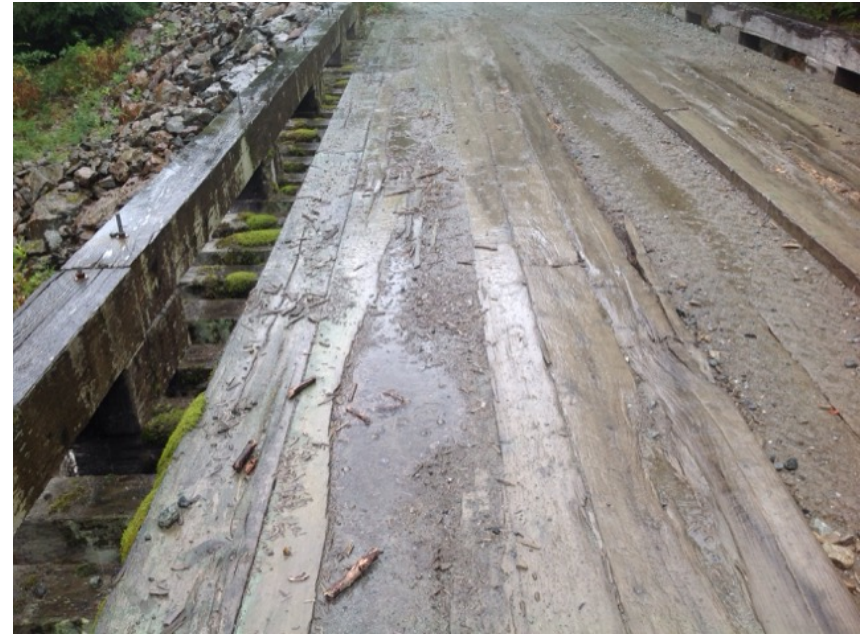
| Running Planks | Poor | rotten |
| Sub Deck | Poor | rotten |
| Ties | Poor | rotten |
| Overall Deck Condition | Poor | replace deck system prior to use |

| Repair Item | Priority | Repair Description |
|---|---|---|
| 1 | High | replace deck prior to industrial use |

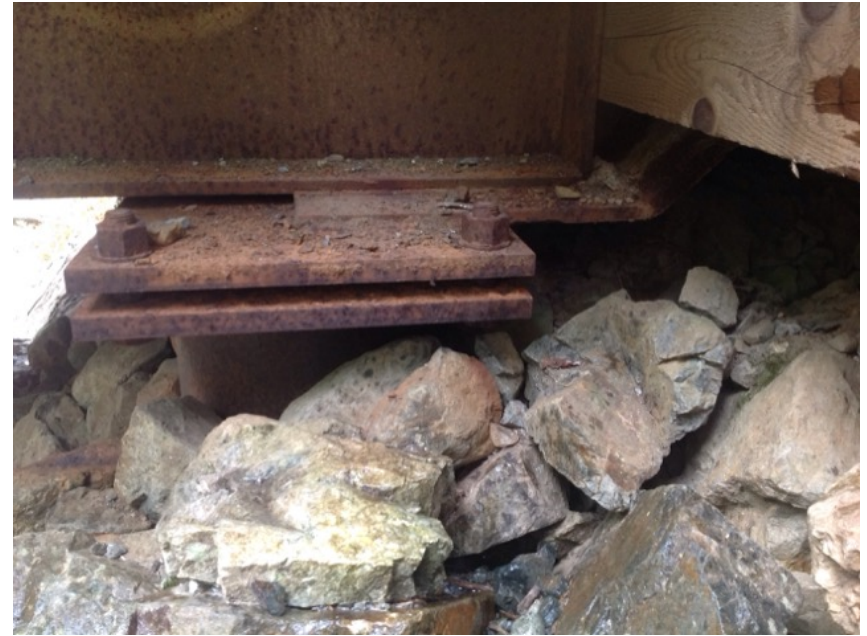
right upstream bearing

Bearings Fair

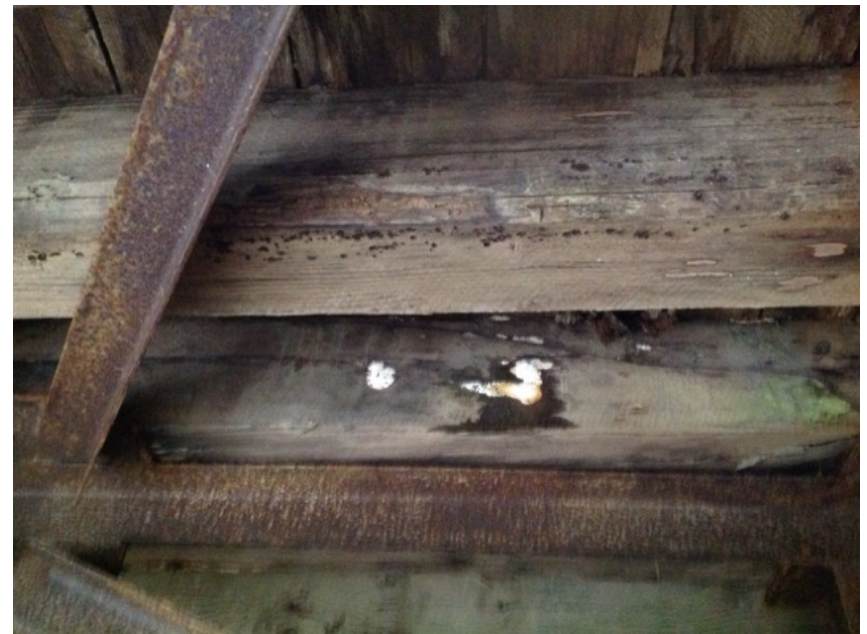
ties showing signs of decay - up to 40%

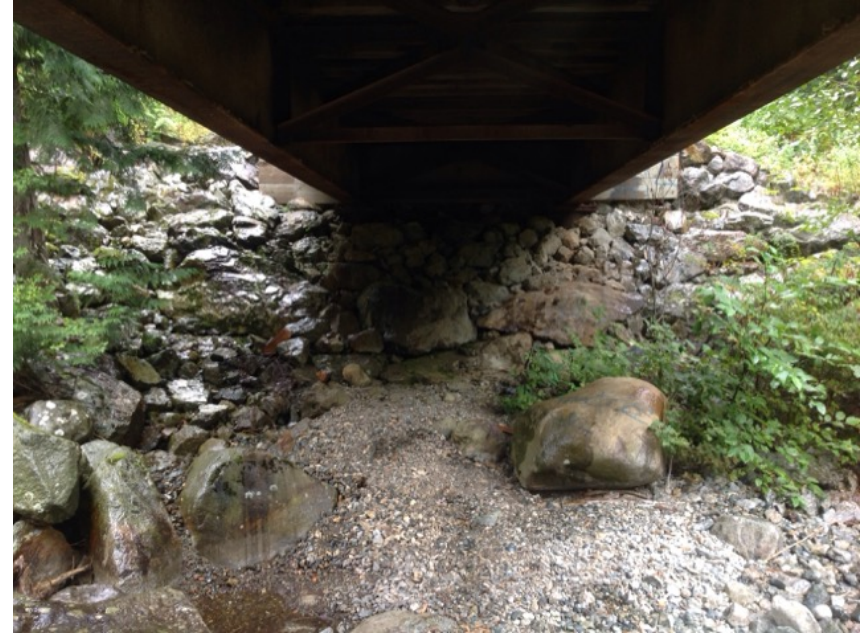
Left Bank Abutment when facing downstream

Hardware Poor loose rail bolts

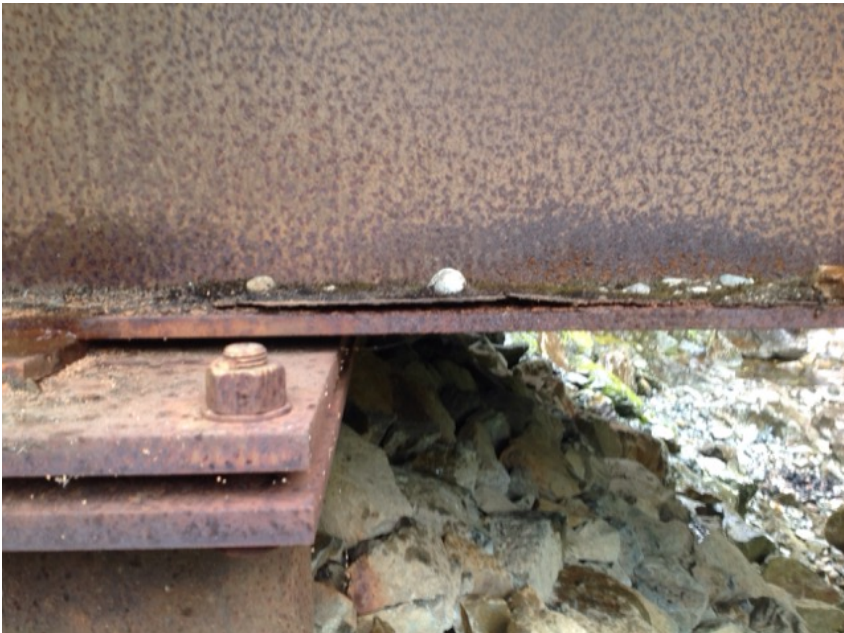
Girders Fair minor corrosion

minor delamination of bottom flange
