CK-2172

LOST CREEK 18.8km

2016 Inspection

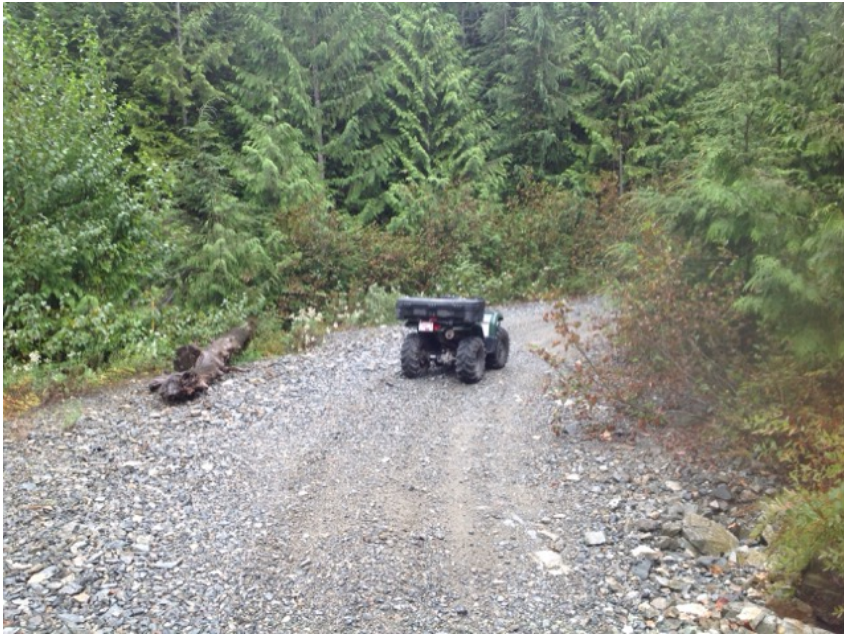
Approach from Right Bank when facing downstream

entire branch in very poor condition

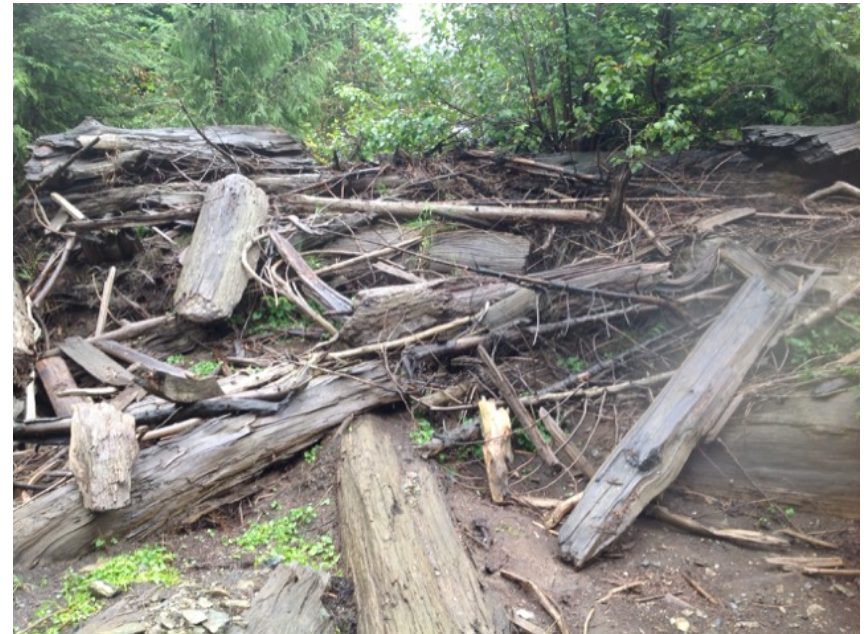
Inlet

The structure could still not be properly inspected due to the plugged inlet and the limited access underneath. Remove and/or replace the structure. The 10 tonnes load limit can continue - post load rating sign. The road accessing the structure is in extremely poor condition and requires maintenance.

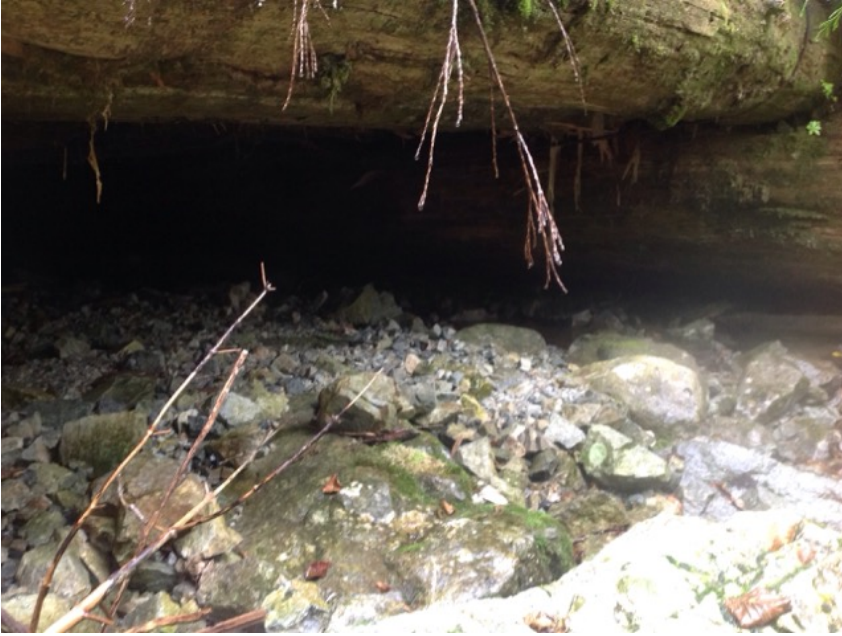
Left Bank Abutment when facing downstream

single logs sill both sides
