CK-2174

LOST-MURDO 0.7km

2016 Inspection

| Structure Class | Temporary Bridge |

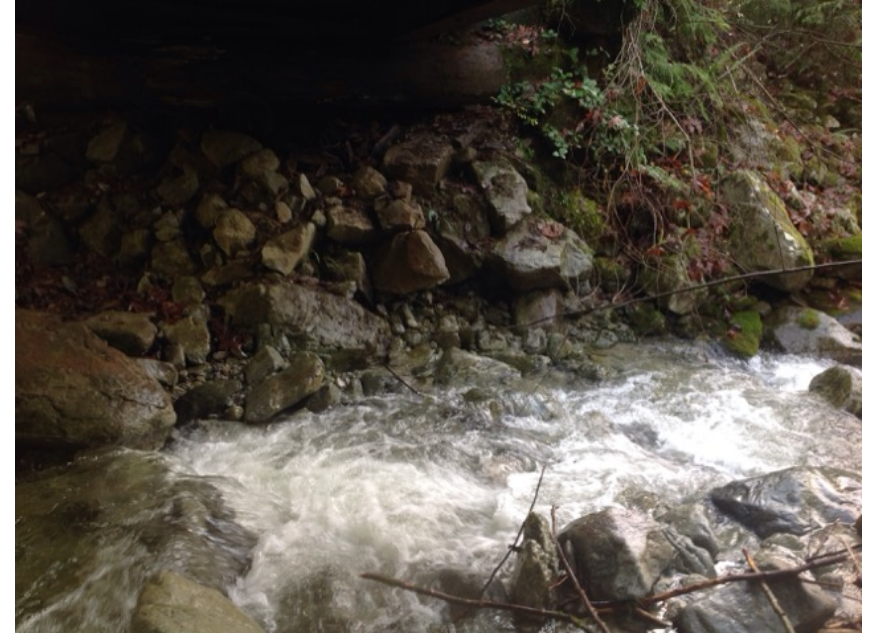
Riprap Fair scouring downstream left bank

left bank D/S riprap scour

| 1 | riprap scour | Anually |
