CK-2175

LOST-MURDO 1.2km

2016 Inspection

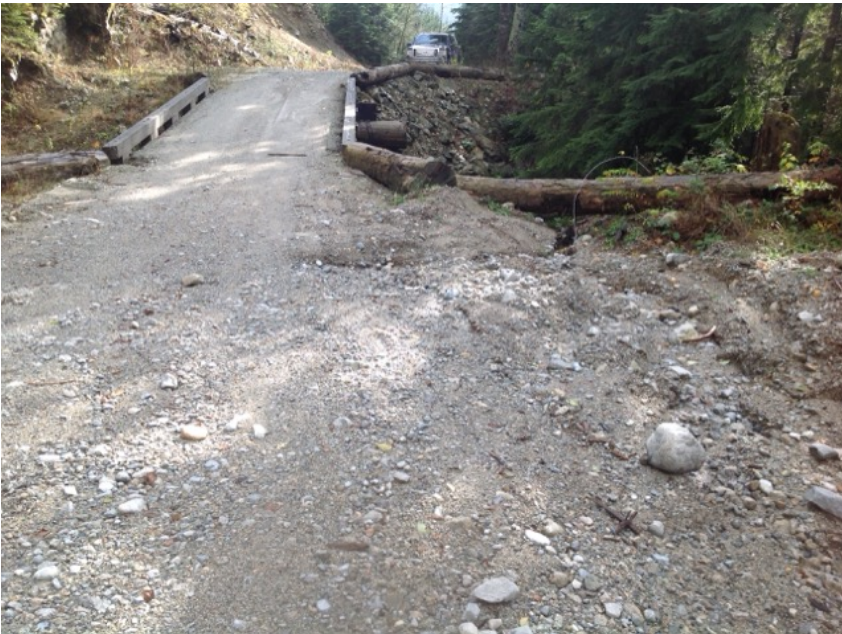
Road Surface Poor surface erosion both approaches

surface erosion

| 2 | High | control road surface water to prevent erosion |

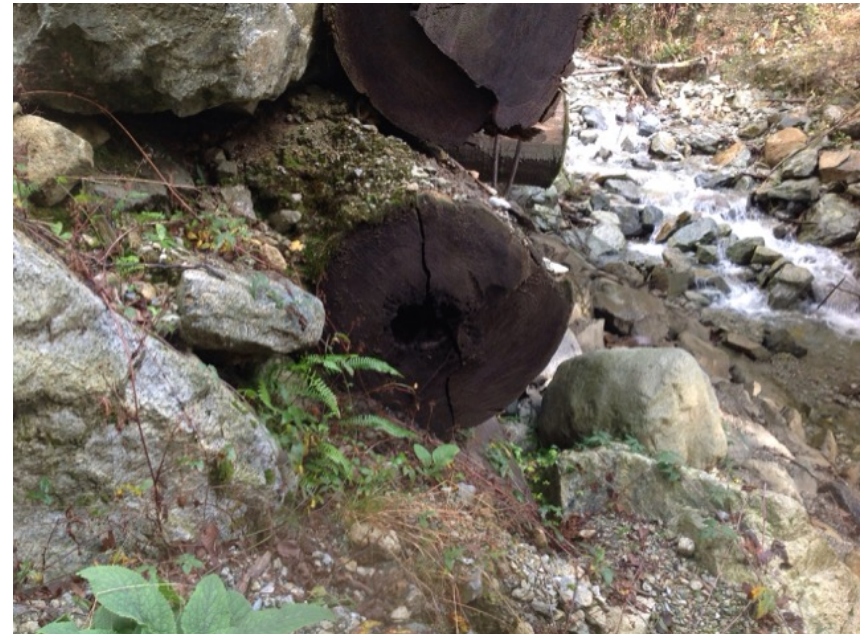
crack in face log on right bank

Replace missing delineators. Monitor the fill on the right approach and control surface water drainage in this location. Also, monitor the vertical crack in the top crib log on the right abutment - no apparent change from last year. Present load rating of L60 or 54 tonnes to continue.

| 1 | crack in right bank face logs - downstream | Anually |
