CK-2189

LOST-BLACKLOCK 2km

2016 Inspection

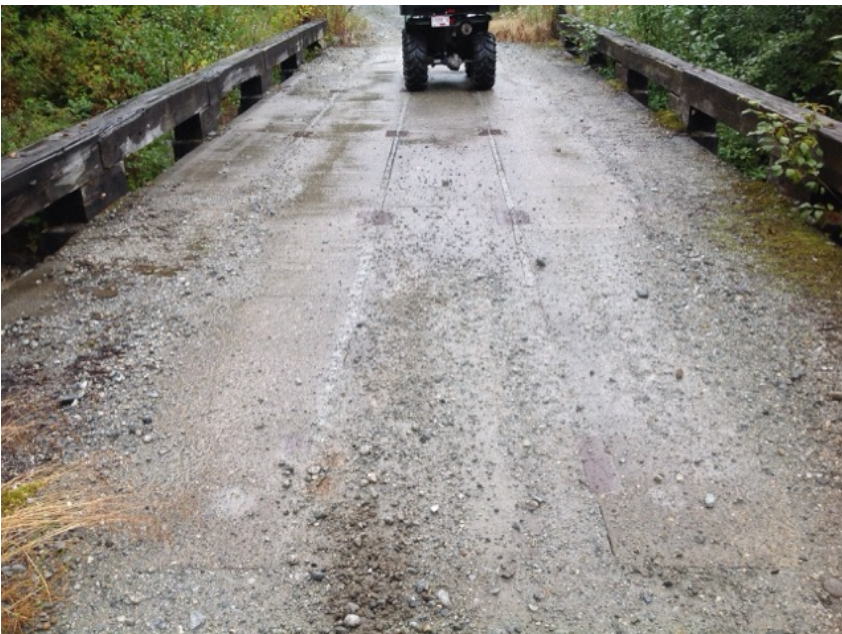
| Curb Rail/Blocks/Posts | Poor | rotten |
| Overall Deck Condition | Poor | due to rail condition |

| Repair Item | Priority | Repair Description |
|---|---|---|
| 1 | Medium | replace rail system prior to activity |
