CK-2190

LOST-BLACKLOCK 2.2km

2016 Inspection

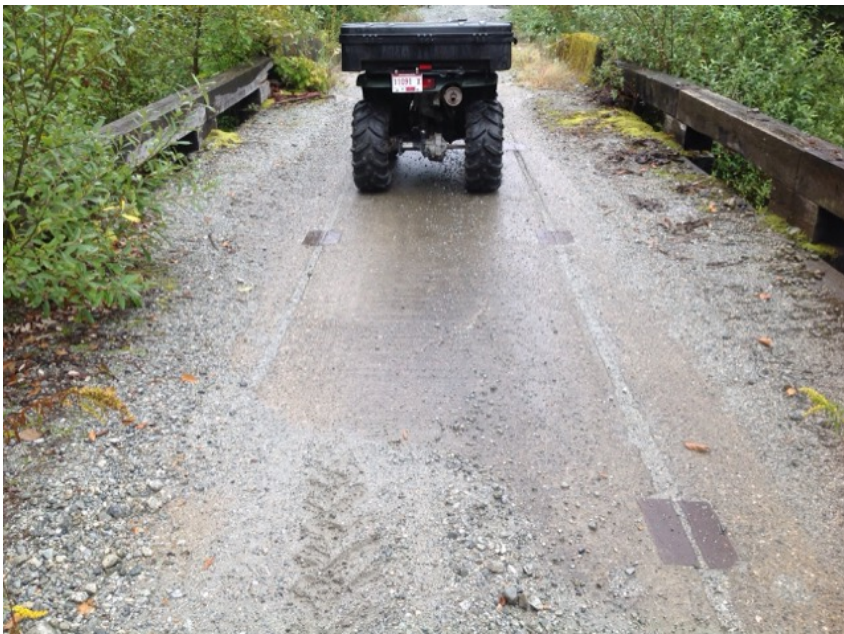
| Curb Rail/Blocks/Posts | Poor | rotten |
| Overall Deck Condition | Poor | due to rail condition |

| Repair Item | Priority | Repair Description |
|---|---|---|
| 1 | Medium | replace rail system prior to activity |
