CK-2191

LOST-BLACKLOCK 2.5km

2016 Inspection

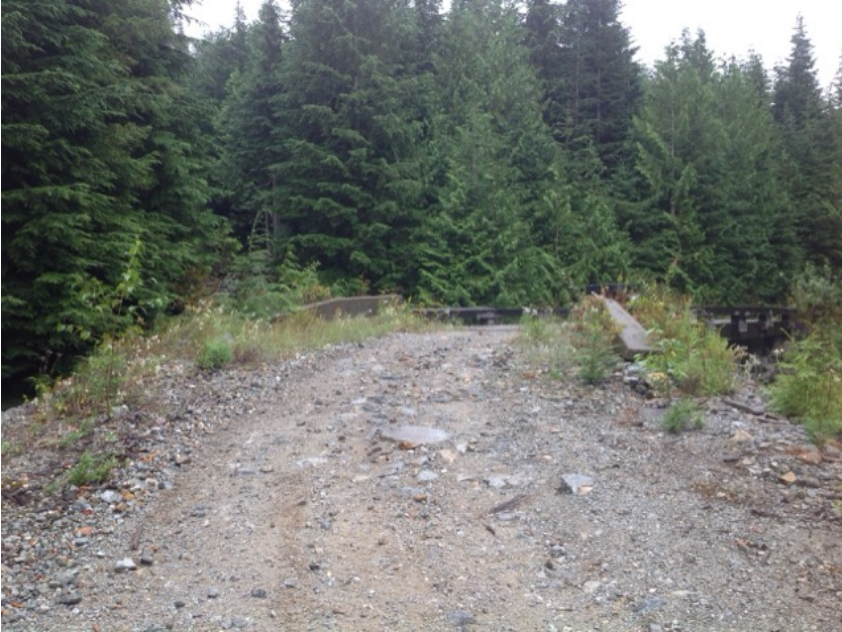
Approach from Right Bank when facing downstream

HC right approach

| Item | Priority | Repair Description |
|---|---|---|
| 2 | Medium | post bridge ahead signs and replace missing delineators |
| 3 | Medium | brush approaches |

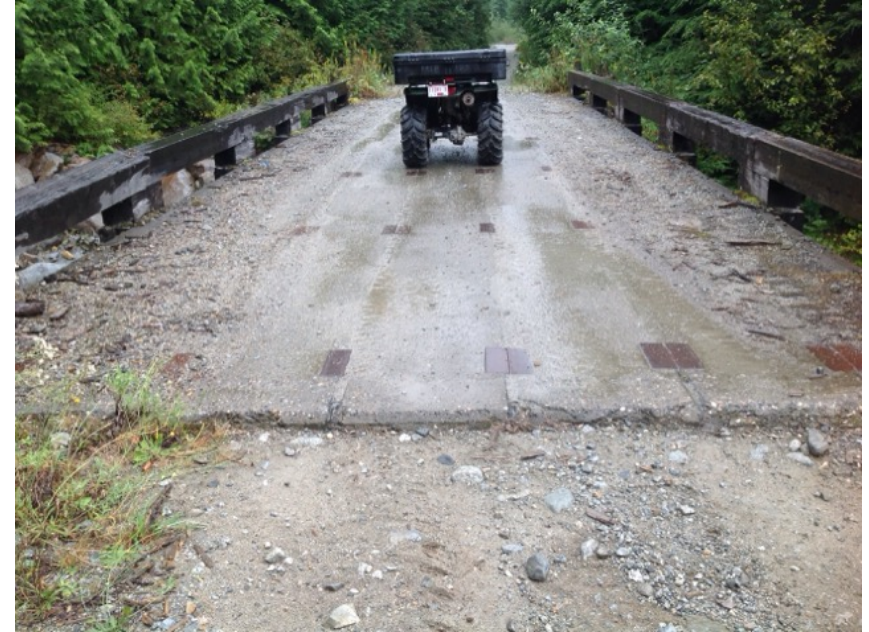
| Curb Rail/Blocks/Posts | Poor | rotten |
| Overall Deck Condition | Poor | due to rail condition |

| Item | Priority | Repair Description |
|---|---|---|
| 1 | Medium | replace guardrail, riers and blocks |

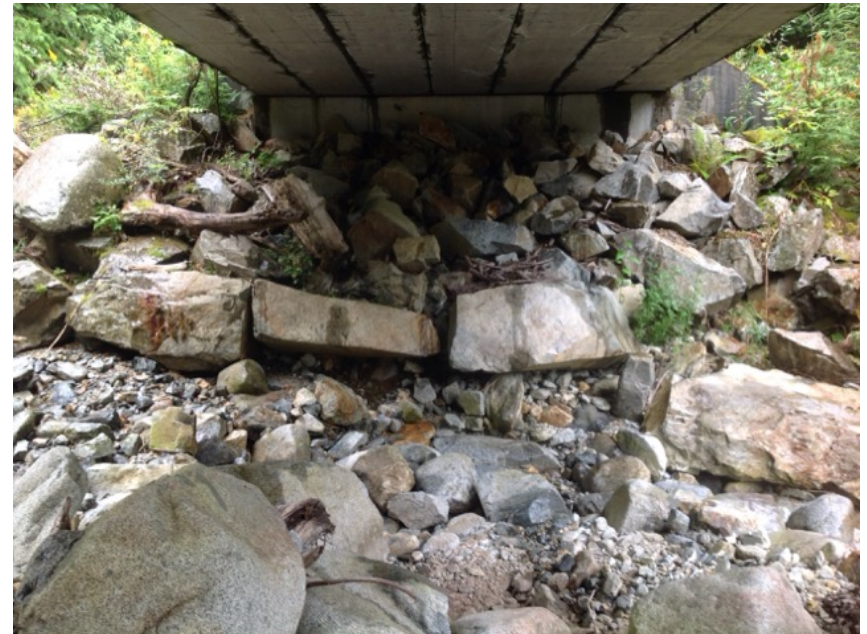
Left Bank Abutment when facing downstream

Riprap Fair scour noted on left bank

| Item | Monitor Description | Frequency |
|---|---|---|
| 1 | riprap scour | regular bridge inspection |

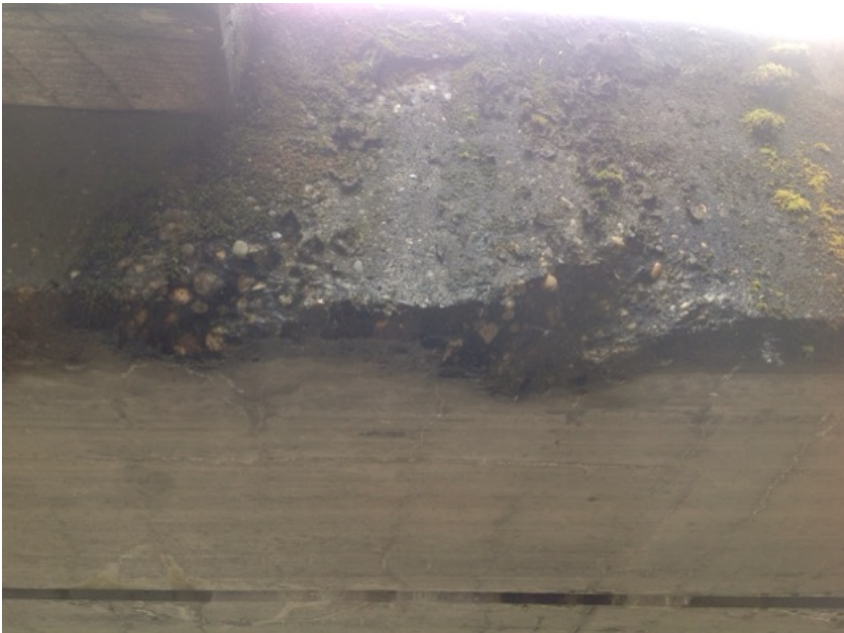
upstream slab damage

| Item | Monitor Description | Frequency |
|---|---|---|
| 2 | damage to upstream girder | regualr bridge inspections |
