CK-2201

KOOKIPI CREEK 3.2km

2016 Inspection

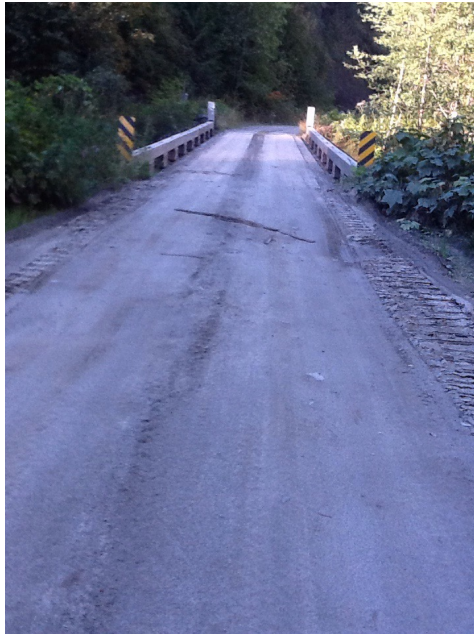
Right approach facing structure

3 percent grade on right introduces silt to deck

Fine-grained soils flow onto deck

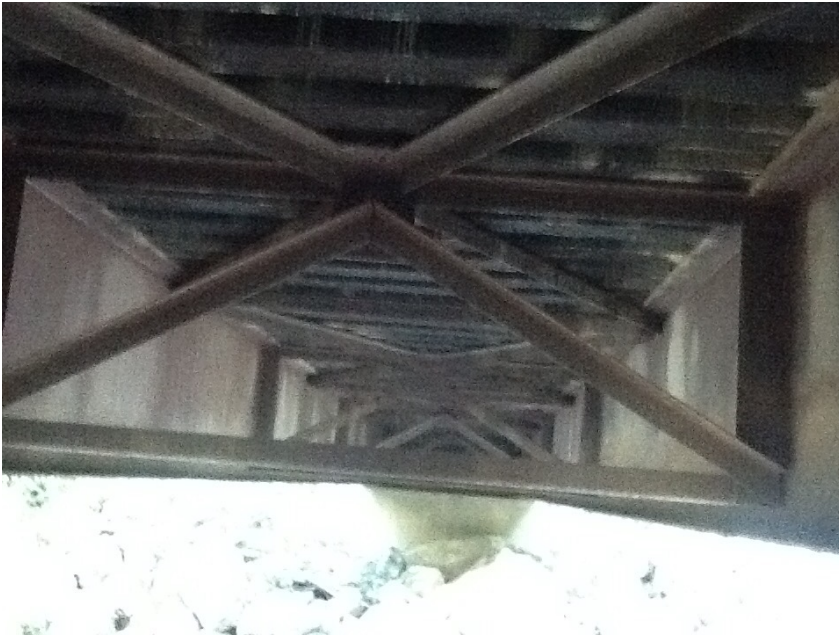
Underside of bridge

Girders Fair Light rust.

Diaphragms Fair Minor damage to left end

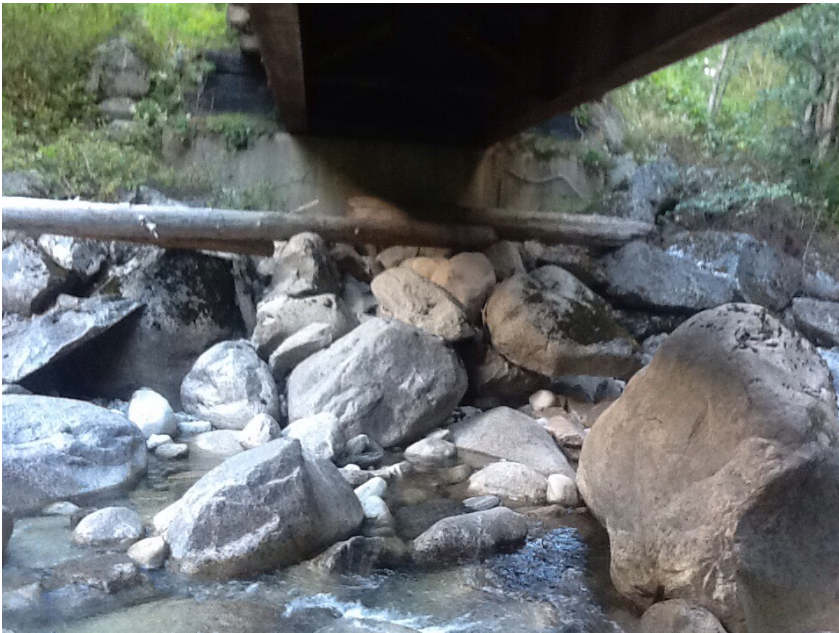
Left Bank Abutment when facing downstream

Comments Large debris noted under bridge on left abutment. Large debris may be a high water hazard.

| Item | Priority | Repair Description |
|---|---|---|
| 1 | Medium | Remove large debris noted under bridge on left abutment |
