CK-2202

KOOKIPI CREEK 15.8km

2016 Inspection

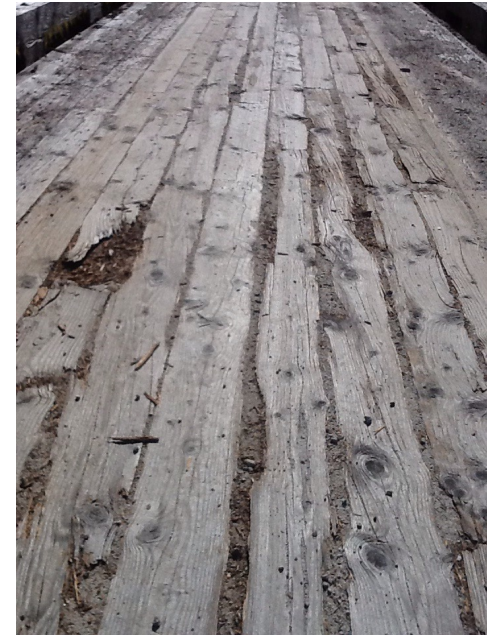
Running planks and curbs are rotting and need replacement for industrial use. They are sufficient for light traffic.

| Running Planks | Poor | Splitting, rotting. Need replacing for industrial use |
| Curb Rail/Blocks/Posts | Poor | Rotten and downstream left corner has broken off |
| Overall Deck Condition | Poor | Running planks and curbs poor and need replacement |

Replace running planks and guardrail system prior to activity. Brush approaches and replace missing delineators and bridge ahead signs. Limit loading to 40 tonnes until deck work has been completed. Post load rating signs.

| Item | Priority | Repair Description |
|---|---|---|
| 1 | Medium | Replace curbs and running planks. Rails 250x250mm x 24.5m x 2. Riser blocks 250x250mm x 60cm x 24 pieces. Planks 75x250mm x 24.4m x 15 runs. Existing curb hardware appears to be re-usable. |

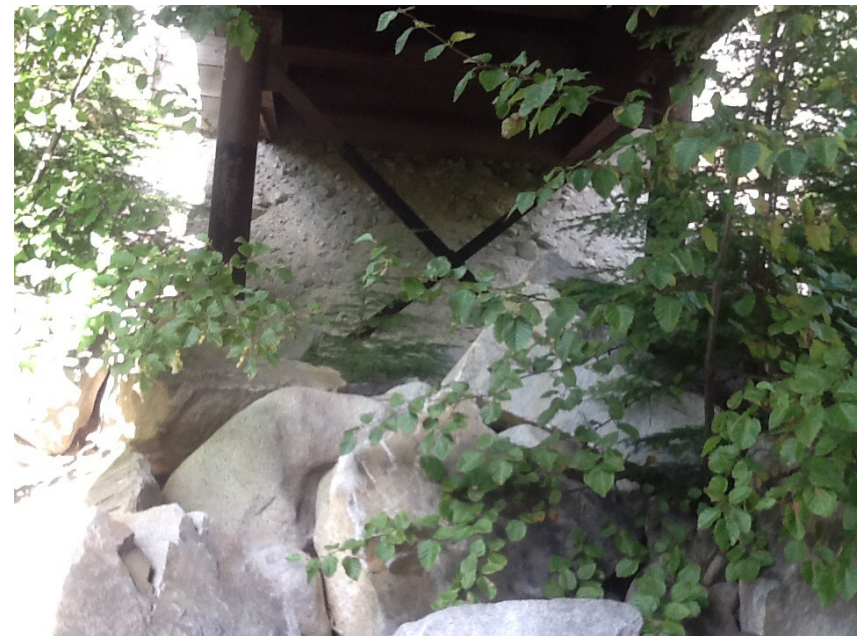
Right Bank Abutment when facing downstream

Ballast Wall Fair Fill ravelling underneath due to 10cm gap

Fill Fair fill ravelling underneath wall both abutments

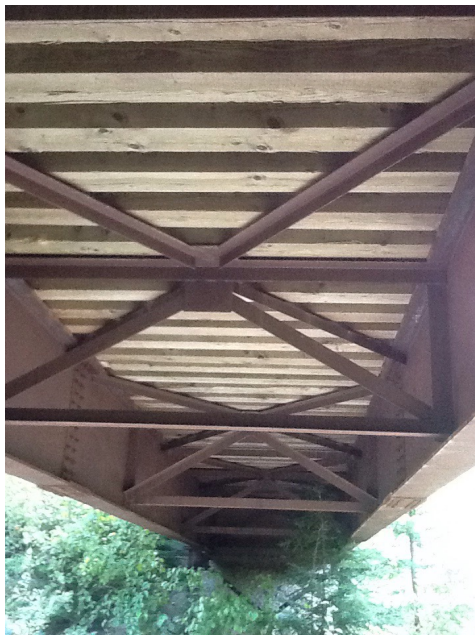
Underside of bridge

Girders Fair Light rust
