CK-2206

NORTH AINSLIE CREEK 19.4km

2016 Inspection

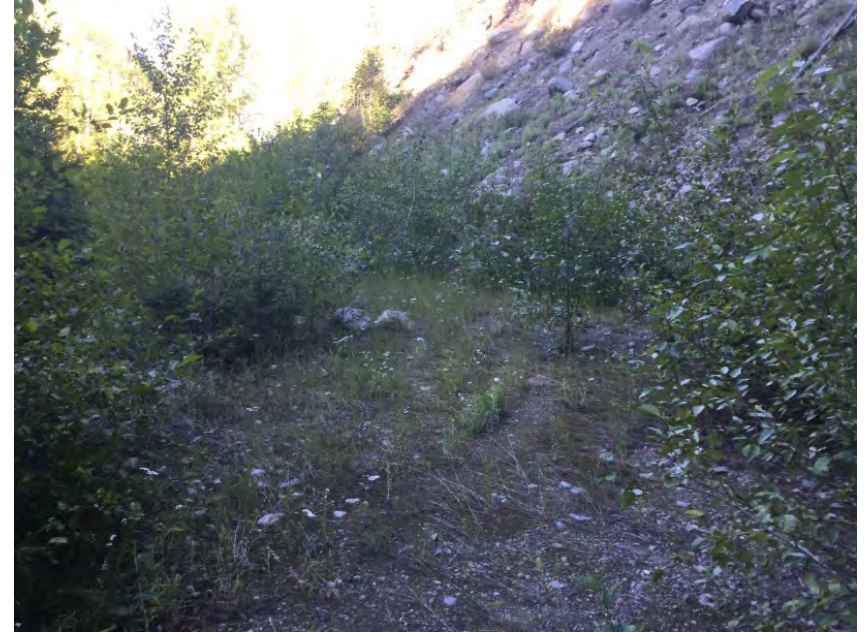
Right Approach Facing Away From Bridge

Large boulders and small trees block road.

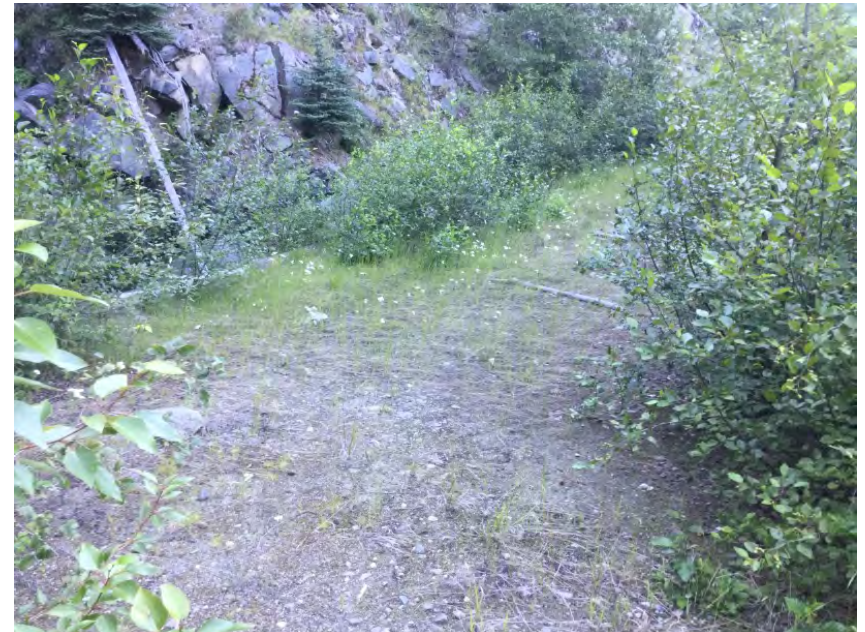
| Gravel Surface | Poor | Grass and trees grow out of deck. |
| Overall Deck Condition | Poor | No functional guardrail logs, vegetation growing out of deck. |

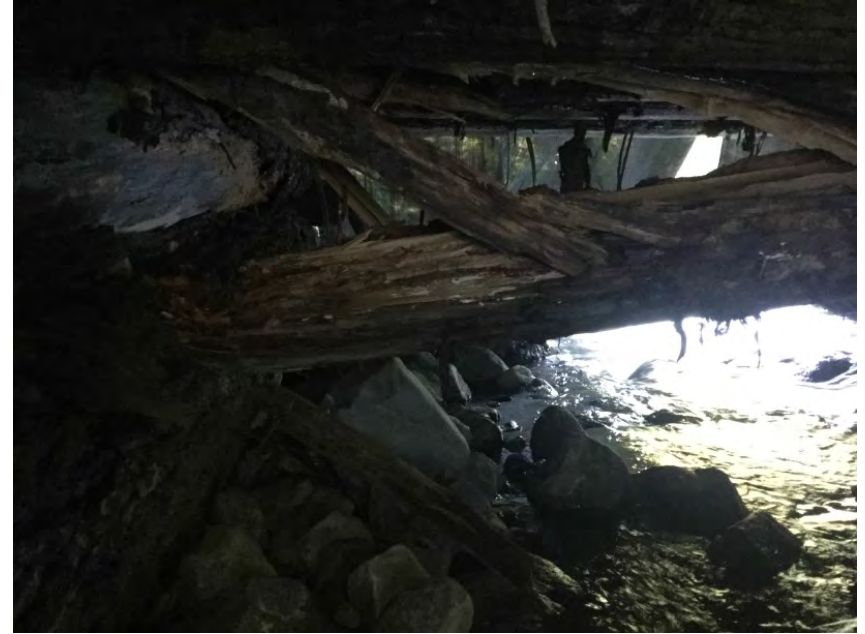
15 log stringers. Stringer 1 rotten. Stringers 2 &amp; 3 fungal growth. Stringer 8 failed. Stringer 14 fungal growth. Stringer 15 failed.

Stringer 8 Failed

| 1 | High | Replace bridge if use of road is required. |

| 2 | High | Remove remains of bridge. |

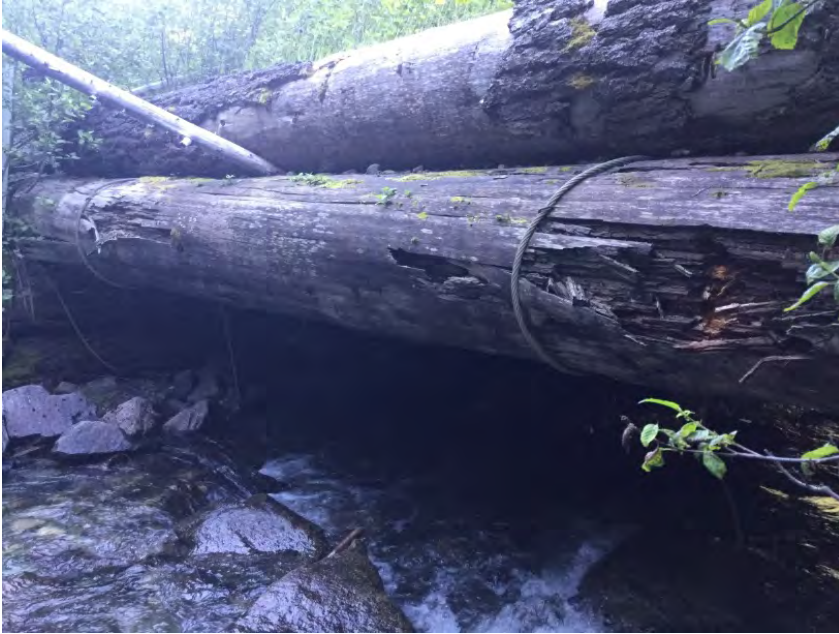
Stringer 1 Rotten

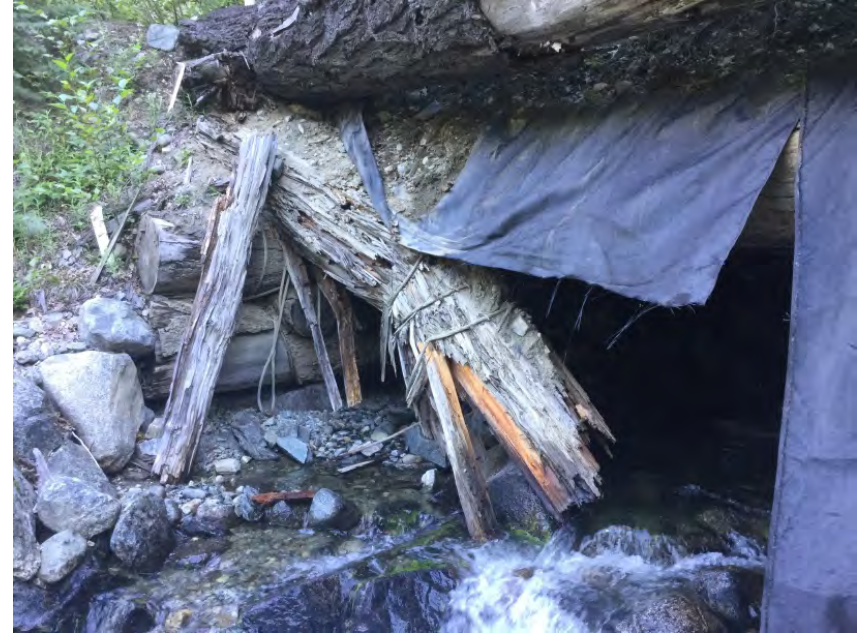
Stringer 15 Failed

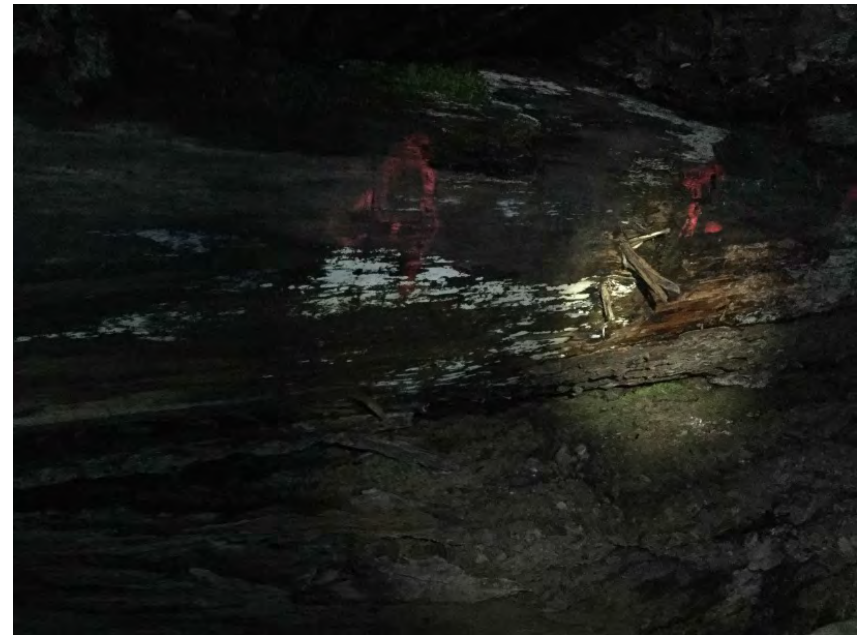
Fungal growth and significant sap rot noted on crib logs.

Left Abutment Fungal Growth

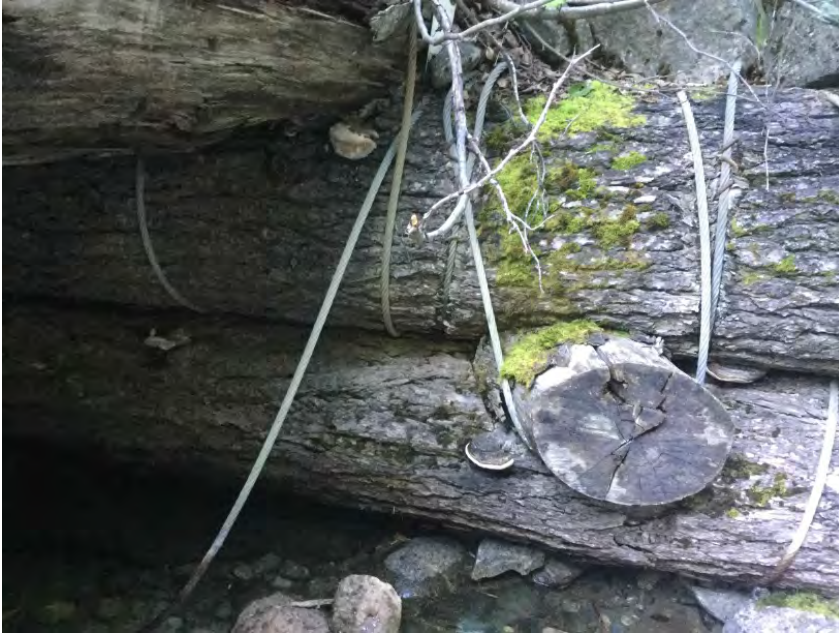
Right Abutment Fungal Growth

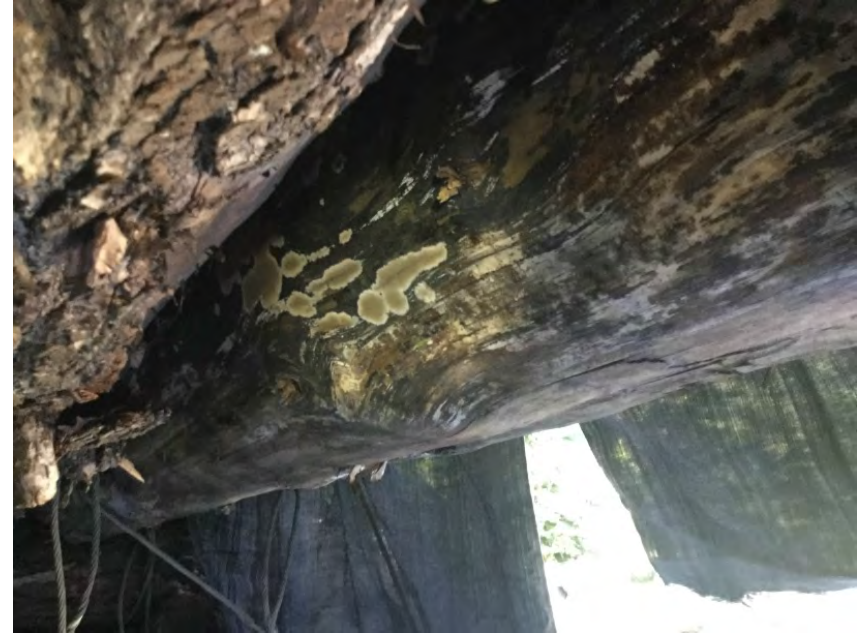
Stringer 14 Fungal Growth

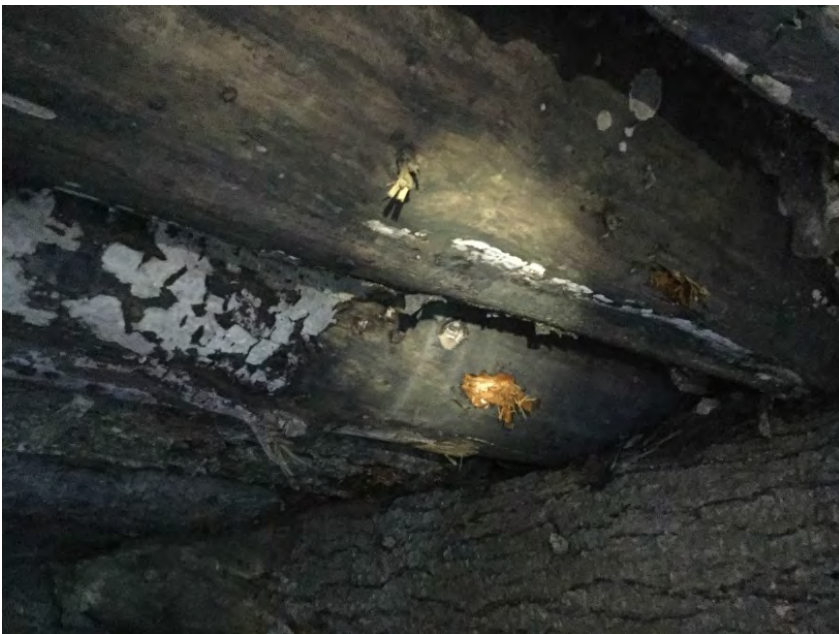
Stringer 2 & 3 Fungal Growth
