CK-2207

MOWHOKAM 15.7km

2016 Inspection

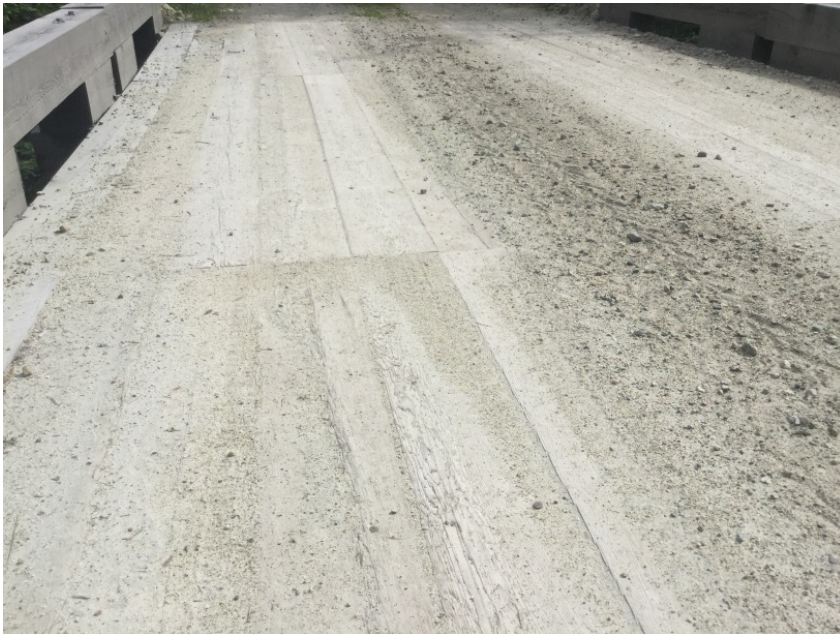
Wearing Planks

Running Planks Good Light wear in wheel tracks.

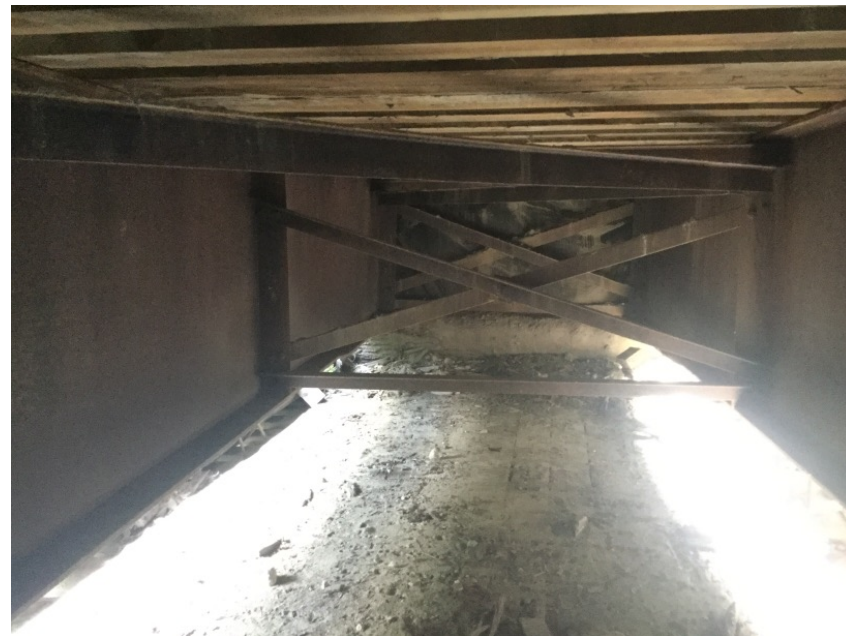
Girders Fair Recycled girders from longer span.

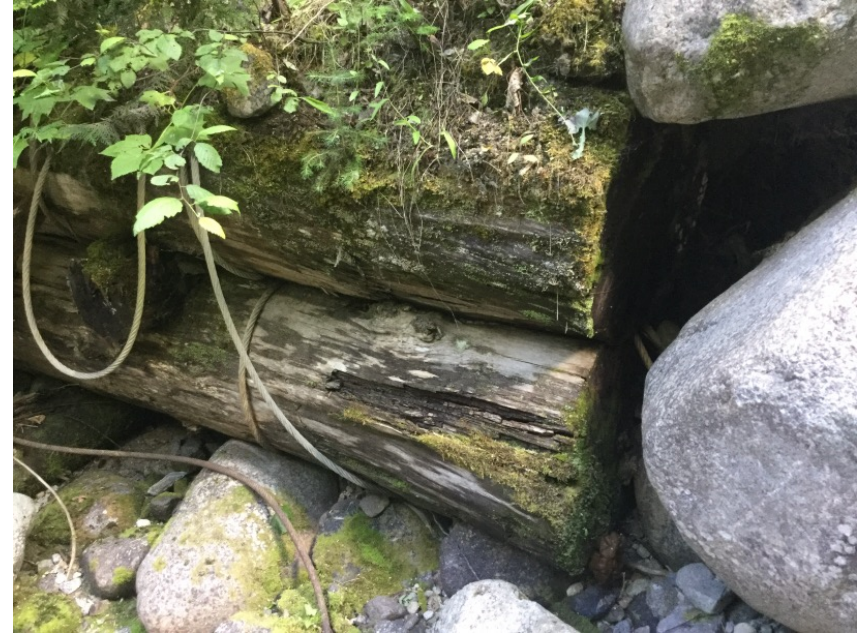
Recycled steel and timber structure bears on old log crib abutment. Fungal growth noted on log crib components with vegetation growing out of top log. Significant sap rot on bottom logs. No signs of crushing or distress noted. Previous inspection noted 30 tonne load rating, that should be re-evaluated based on log crib condition.

Left Abutment Downstream Corner Fungal Growth

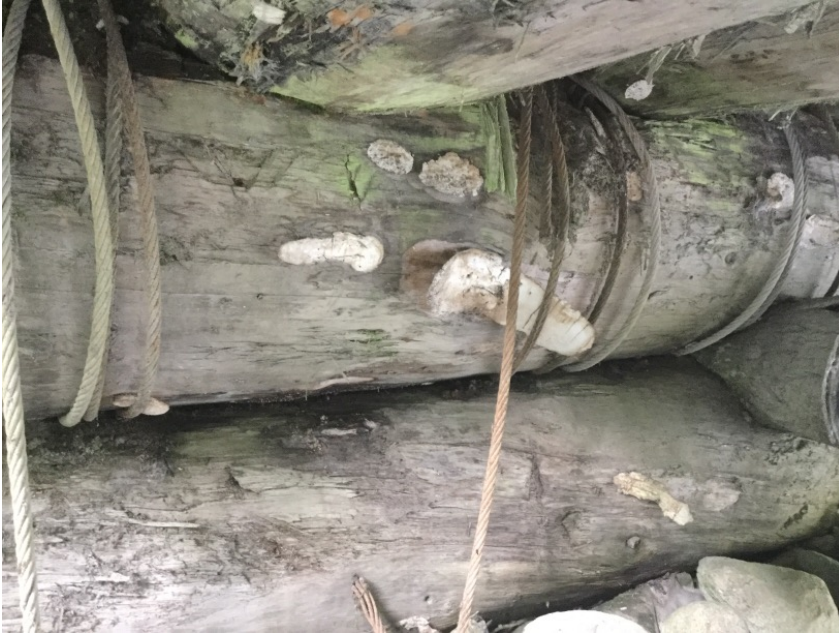
Right Abutment Crib Fungal Growth

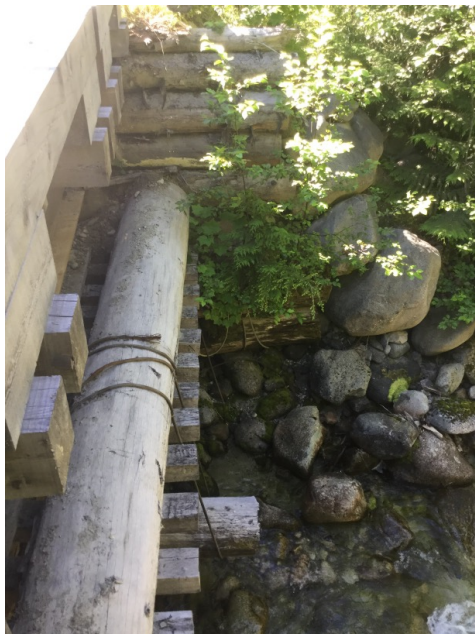
The steel girders bear on log sills which are directly overtop the old log stringer deck and log cribs; and both components (stringers and crib) continue to deteriorate. While the structure, as it stands now, can withstand light loads the condition of the old log structure puts the steel structure and users at risk. Based on that I recommend closing the bridge (bridge condemned), removing both structures and reinstalling a longer permanent style structure at this site.

Log cribs support new sill logs, which are placed on old log stringer bridge deck. Below girders 180 mm of sap wood rot noted in bottom logs, 50 mm sap wood rot noted in top logs.

Sill Log Bearing on Old Bridge Deck & Log Crib

| Repair Item | Priority | Repair Description |
|---|---|---|
| 1 | High | Replacement of bridge required. |
