CK-2214

PEERS CREEK 0.3km

2016 Inspection

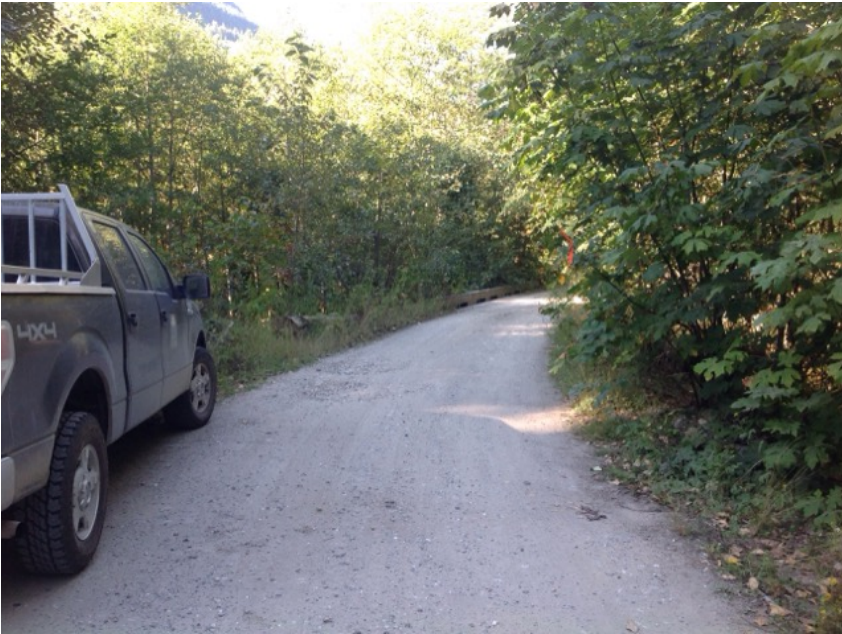
Approach from Right Bank when facing downstream

HC right approach

Road Surface Poor

potholes, requires grading prior to use

| Repair Item | Priority | Repair Description |
|---|---|---|
| 3 | Medium | brush approaches |

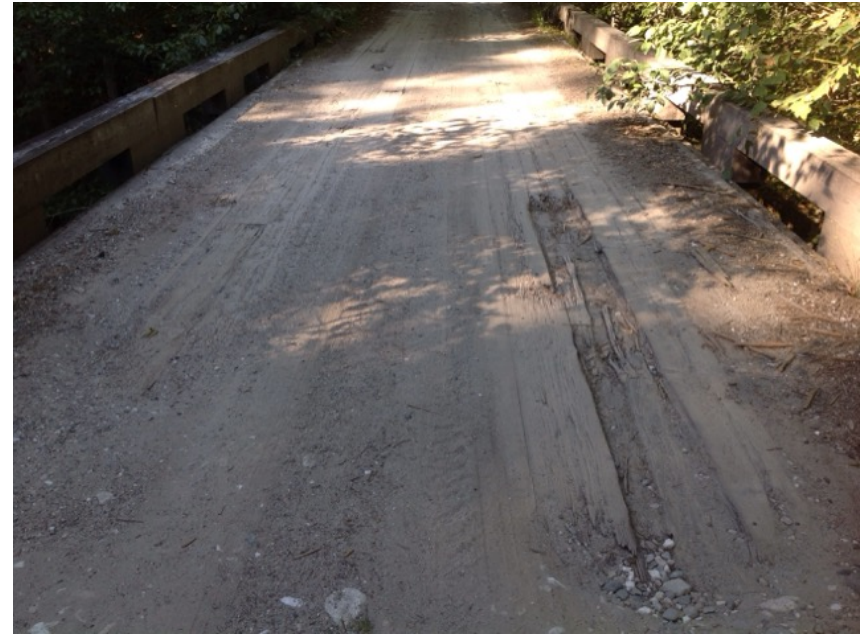
| Running Planks | Poor | holes showing |
| Nails | Poor | protruding through planks |
| Overall Deck Condition | Poor | due to planks |

| Repair Item | Priority | Repair Description |
|---|---|---|
| 1 | Medium | replace wear planks prior to use |

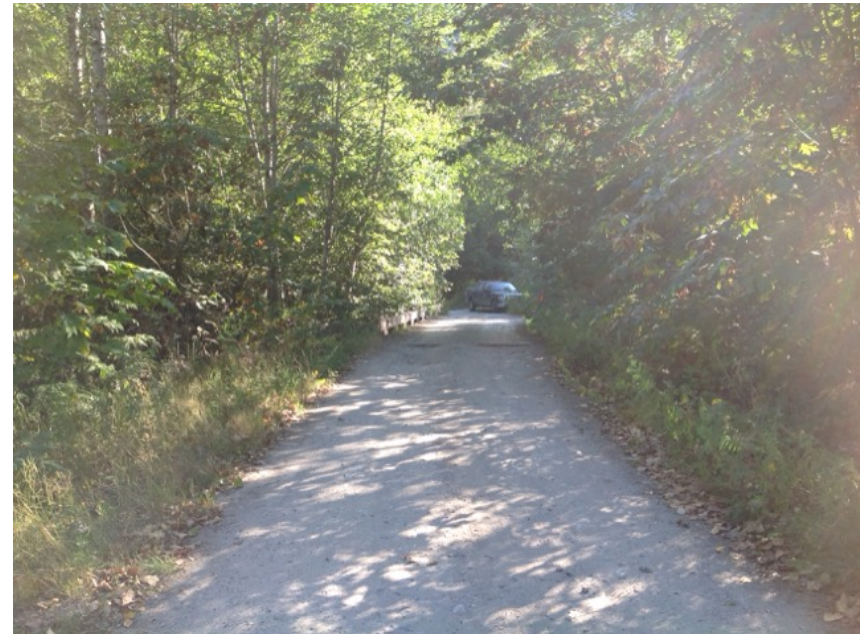
Approach from Left Bank when facing downstream

Delineator Missing  
Left ☐ 0 ☐ 1 ☒ 2

| Repair Item | Priority | Repair Description |
|---|---|---|
| 2 | Medium | replace missing delineators and bridge ahead signs |

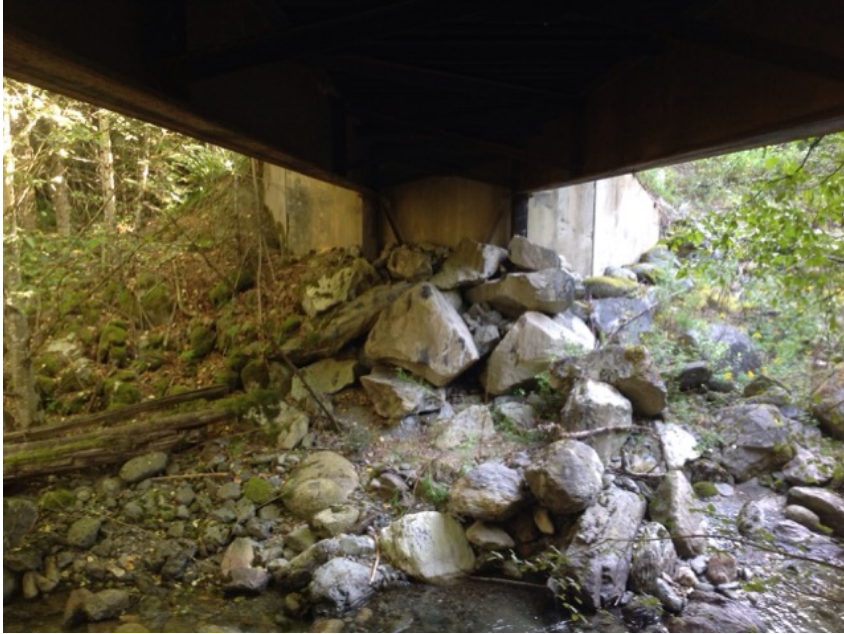
Right Bank Abutment when facing downstream

Ballast Wall Fair precast - not connected to girders

Bracing Fair only appears to be 1 set - steep angle

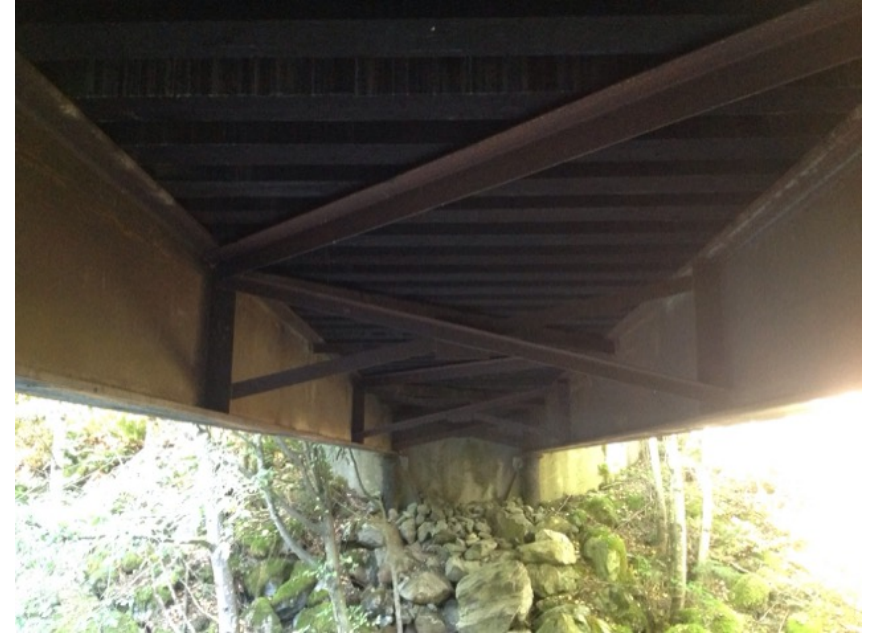
superstructure

Girders Good minor surface corrosion

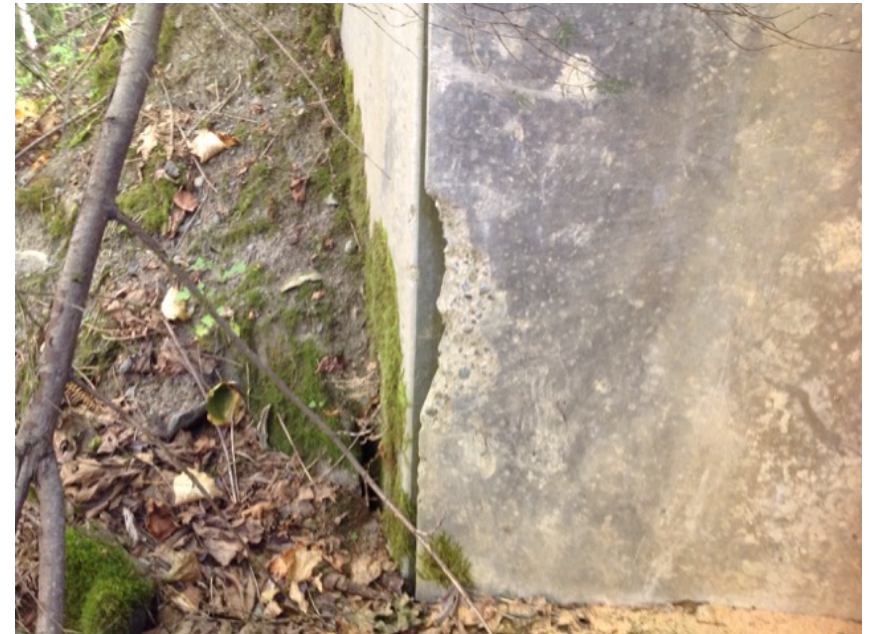
minor damage to concrete ballast wall

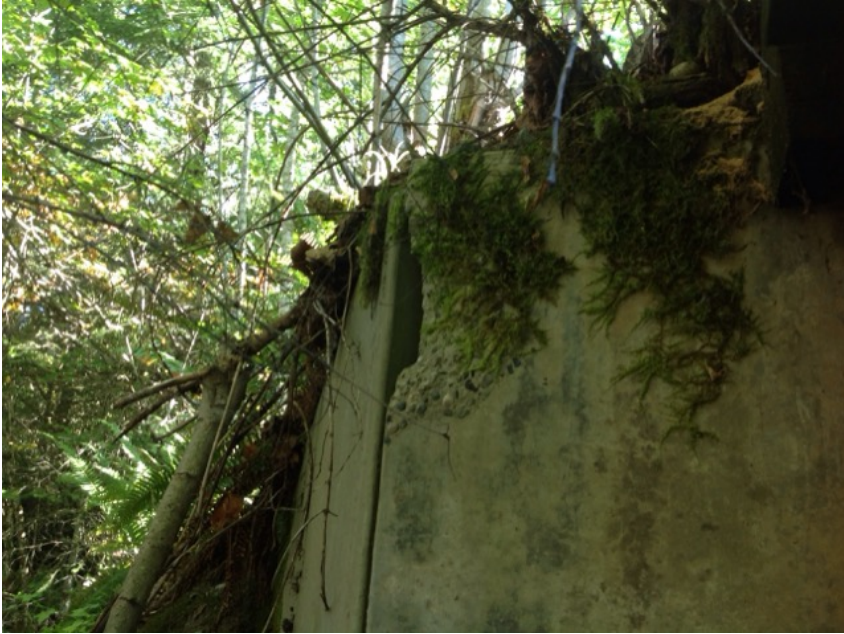
minor damage to ballast wall
