CK-2217

PITT RIVER 2.2km

2016 Inspection

| Structure Class | Temporary Bridge | | |

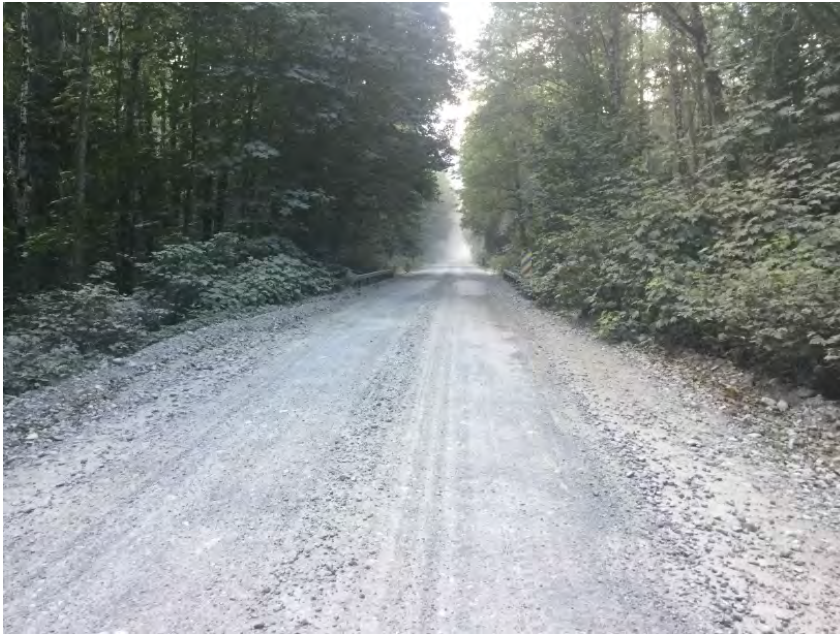
Right Approach Facing Bridge

Bridge Ahead Signs  
Missing ☐ 0 ☒ 1 ☐ 2 Right approach sign missing.

| Item | Priority | Repair Description |
|---|---|---|
| 1 | Medium | Replace guide logs, install bridge ahead sign and replace missing delineators. |

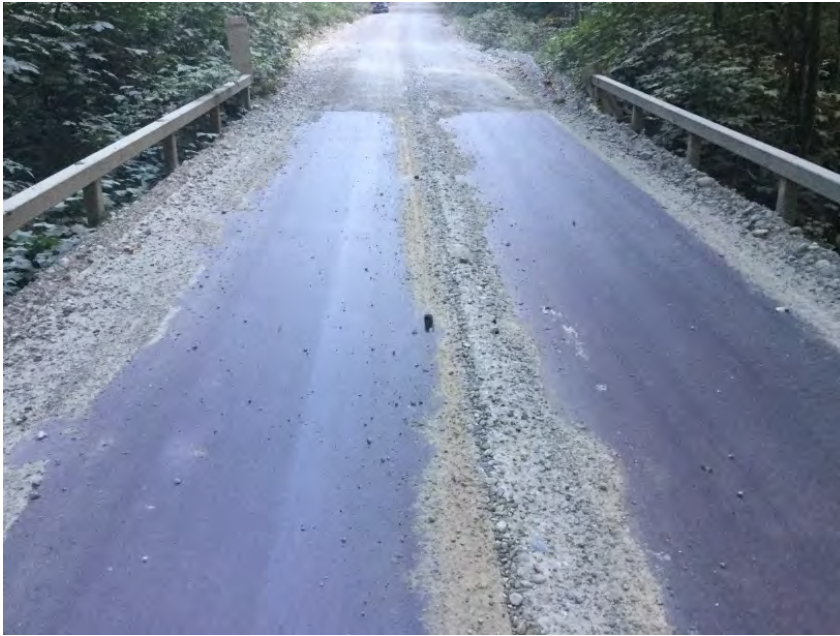
| Steel Deck Plate | Fair | Anti skid worn off. Some minor dents. |

| 2 | Low | Clear debris from deck and brush approaches. |

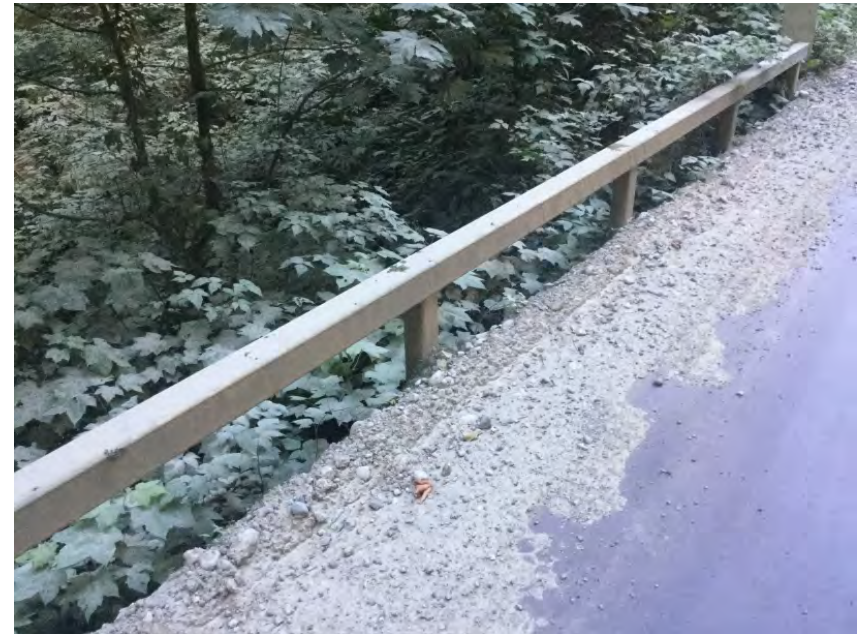
Guardrail

| Curb Rail/Blocks/Posts | Fair | Covered in road dirt, hard to assess coating. |

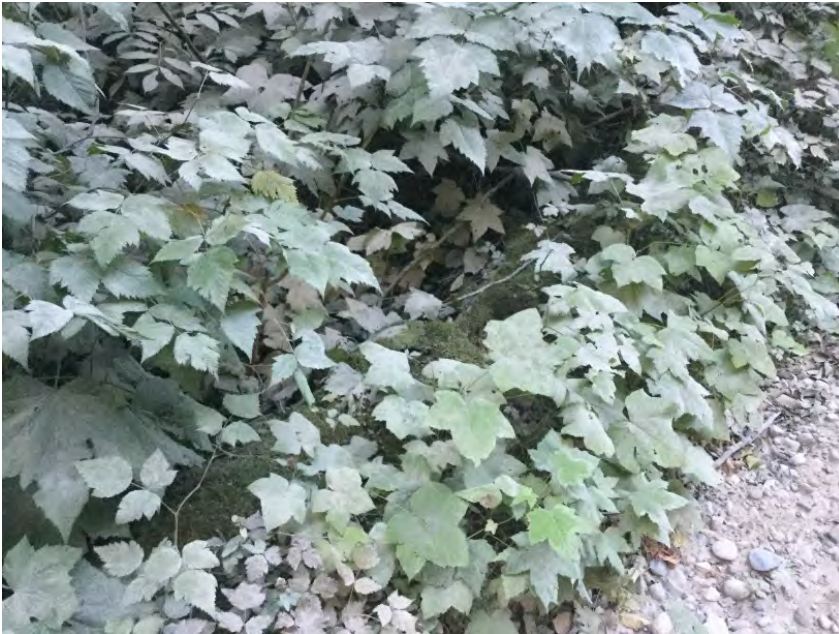
Fender Condition Poor Rotten and undersized guide logs.

Rotten & Undersized Guide Log

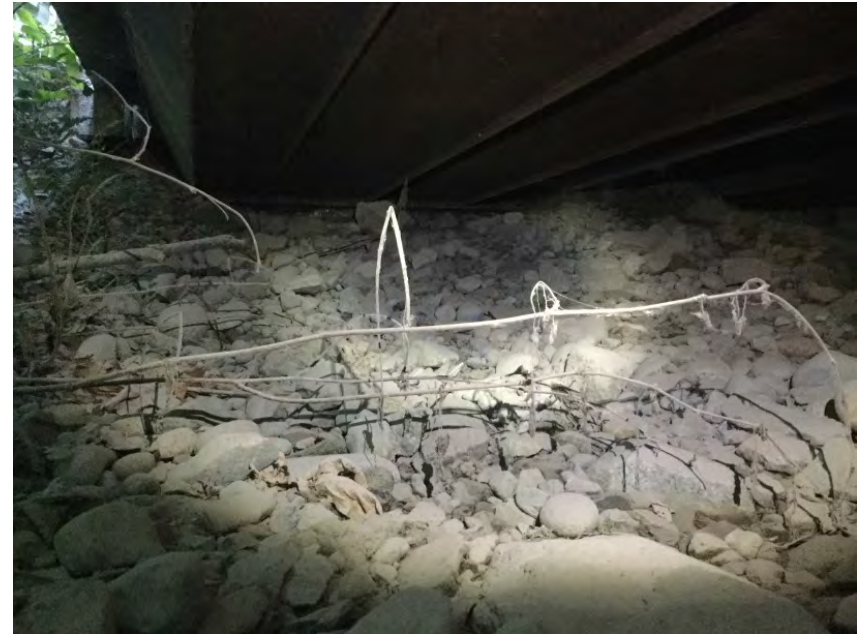
Right Bank Abutment

Caps or Sills Unrated Abutments buried in fill with low clearance under bridge.

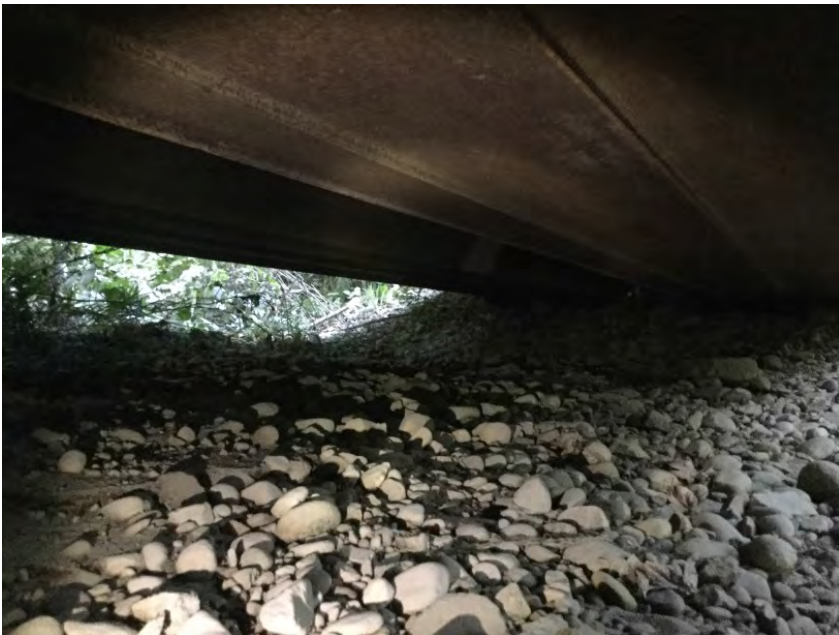
Girders Fair Two sections of All Steel Portable.
