CK-2218

PITT RIVER 8km

2016 Inspection

| Crossing Name | Fish Hatchery Creek |

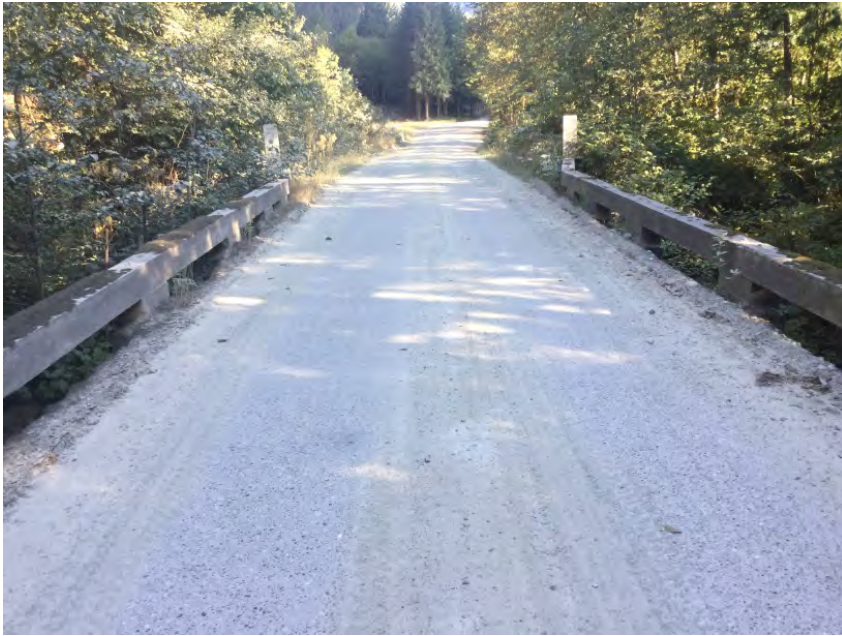
| Concrete Deck | Fair | Wear in wheel tracks. Flare in end deck panels. |
| Grout Pockets | Unrated | Covered in debris, not visible for inspection. |

| Item | Priority | Repair Description |
|---|---|---|
| 2 | Low | Clear debris from deck. |

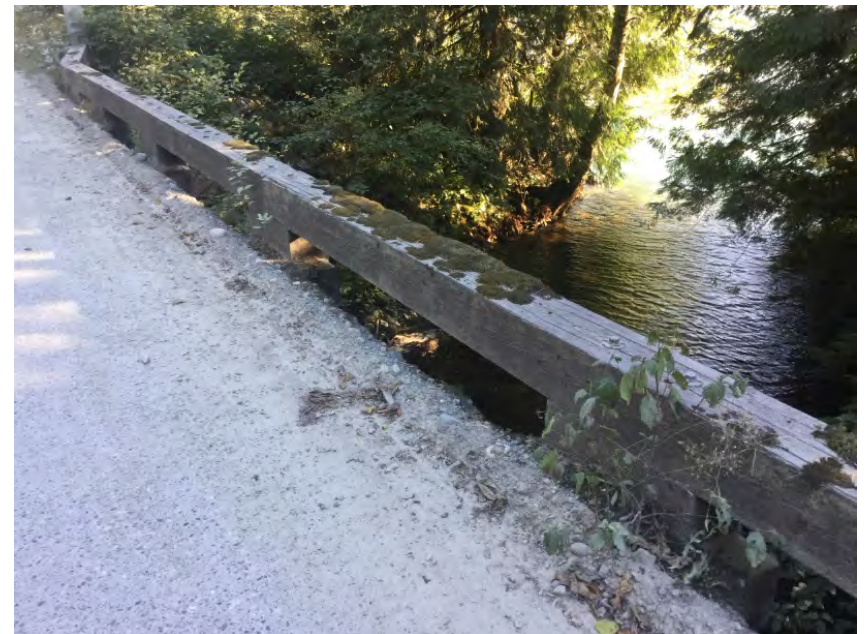
Guardrail is rotten and requires replacement, otherwise bridge is generally in good condition.

| Curb Rail/Blocks/Posts | Poor | Guardrail, risers and blocking rotten with moss growth. |

Replace guardrail, risers and blocks. Present load rating of L120 or 109 tonnes to continue.

| Item | Priority | Repair Description |
|---|---|---|
| 1 | High | Replace guardrail. Requires 50 m of 250x250 mm guardrail, 24 650x250x250 mm riser 24 900x250x250 mm blocking. |

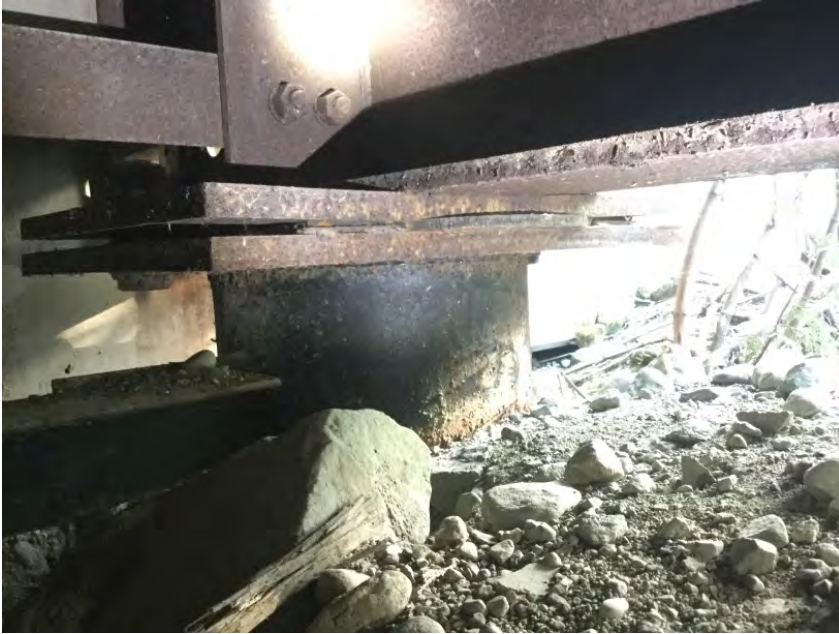
Bearings Fair 15 mm pads at left abutment are squeezing/bulging. 50 mm pads at right abutment are in good condition.

Typical Left Abutment Bearing - Bulging

| Item | Monitor Description | Frequency |
|---|---|---|
| 1 | Monitor bulging/squeezing bearings at left abutment. | Routine Inspection |
