CK-2219

PITT RIVER 9.8km

2016 Inspection

| Crossing Name | Corbold Creek |

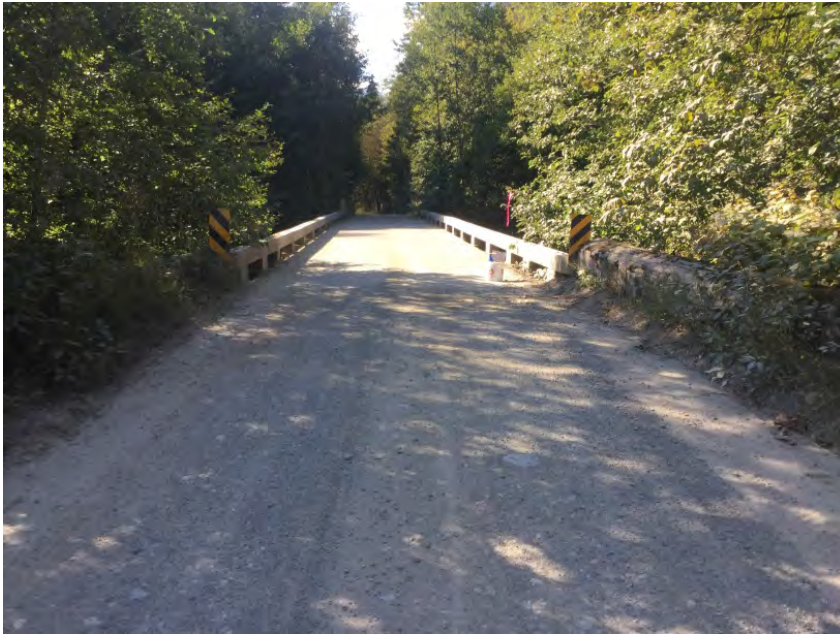
Left Approach Facing Bridge

Alignment Fair Horizontal and vertical curve.

Fender Condition Fair Old guide logs starting to rot.

Replace sealant at left abutment panel joint and seal all grouted panel joints. Brush approaches and clean debris from deck. Present load rating of L120 or 109 tonnes to continue.

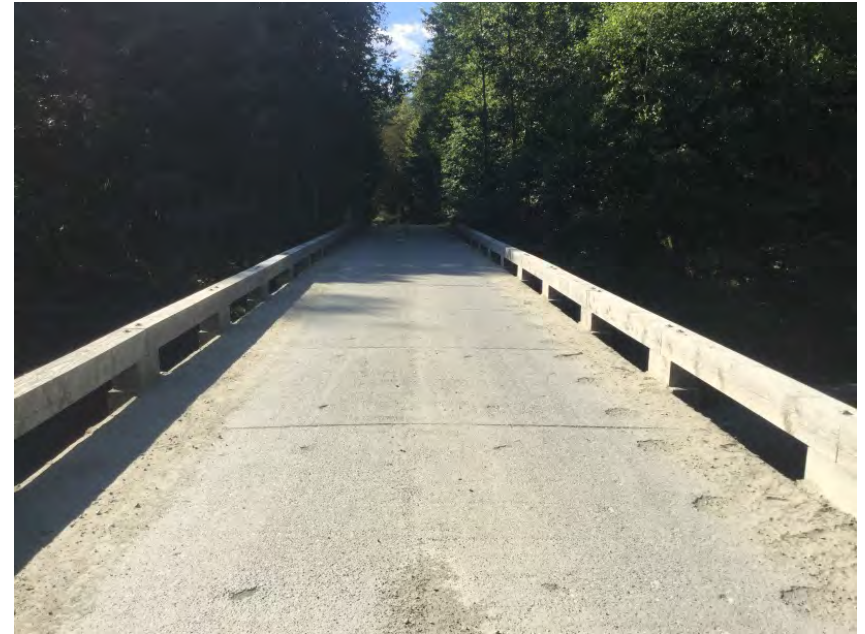
| Concrete Deck | Fair | Wear in wheel tracks. |

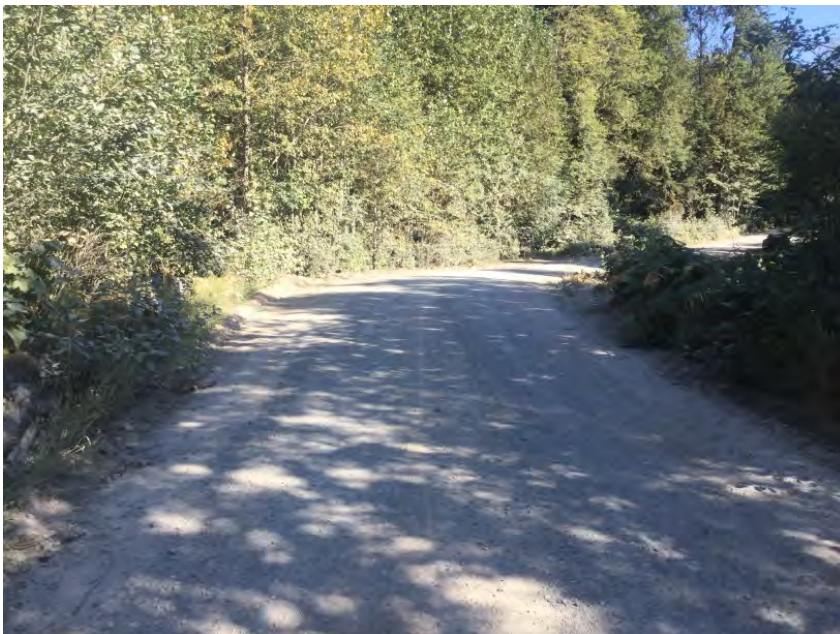
Left Approach Facing Away From Bridge

Brushing Required Y Minor brushing.

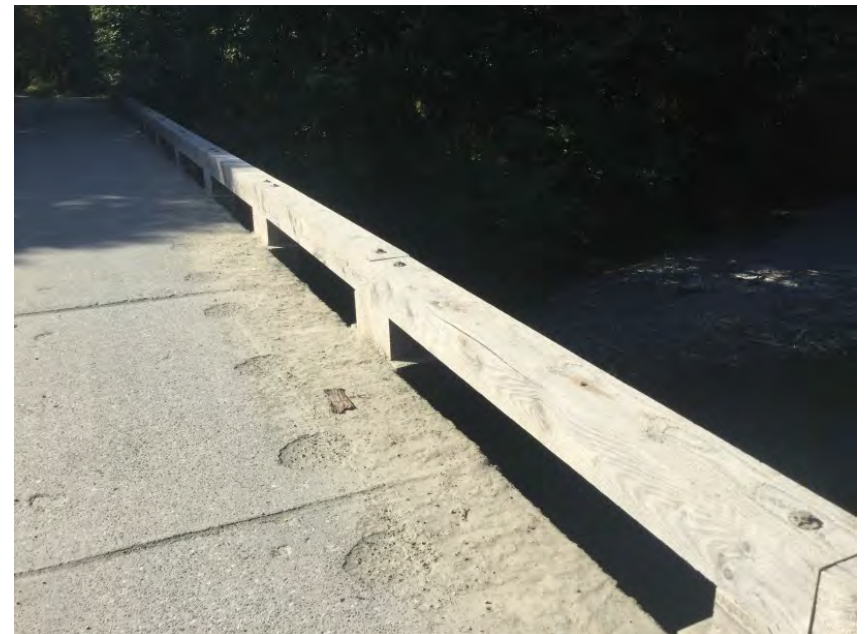
Guardrail

| Curb Rail/Blocks/Posts | Good | Replaced since last inspection. |

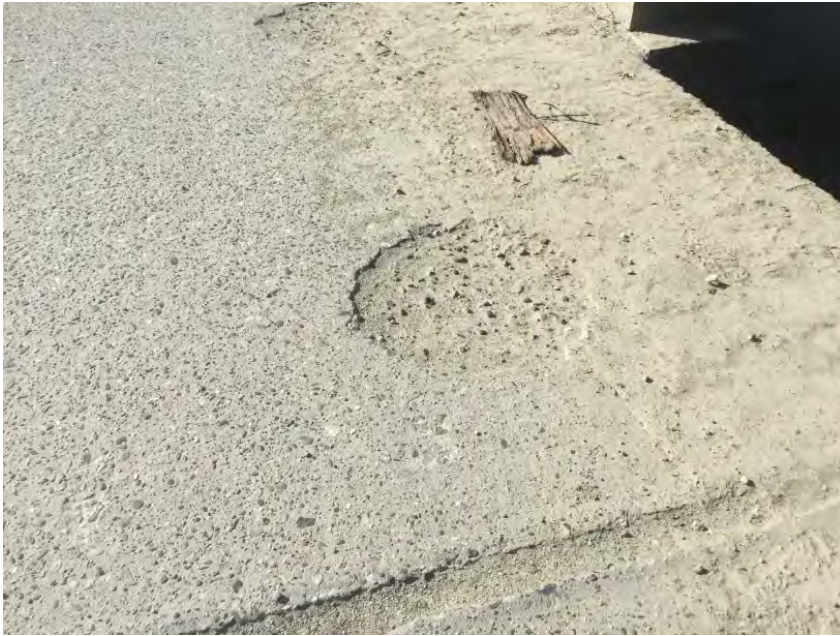
| Grout Pockets | Fair | Typically below level of deck due to wear. |

Typical Grout Pocket Condition

| Item | Monitor Description | Frequency |
|---|---|---|
| 1 | Monitor wear of grout pockets. | Routine Inspection |

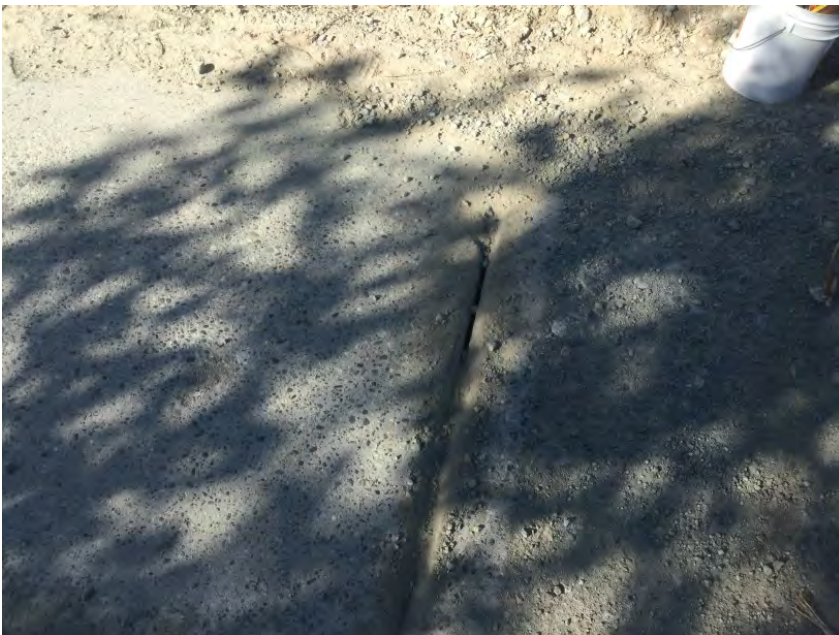
| Deck Joints | Fair | Section of failed joint in wheel tracks at left abutment. Corrosion noted on girder at some panel joint locations. |

Failed Deck Panel Sealant at Left Abutment

| Item | Priority | Repair Description |
|---|---|---|
| 1 | Low | Clear debris from deck. Brush approaches. Replace sealant at left abutment panel joint. Seal all grouted panel joints. |

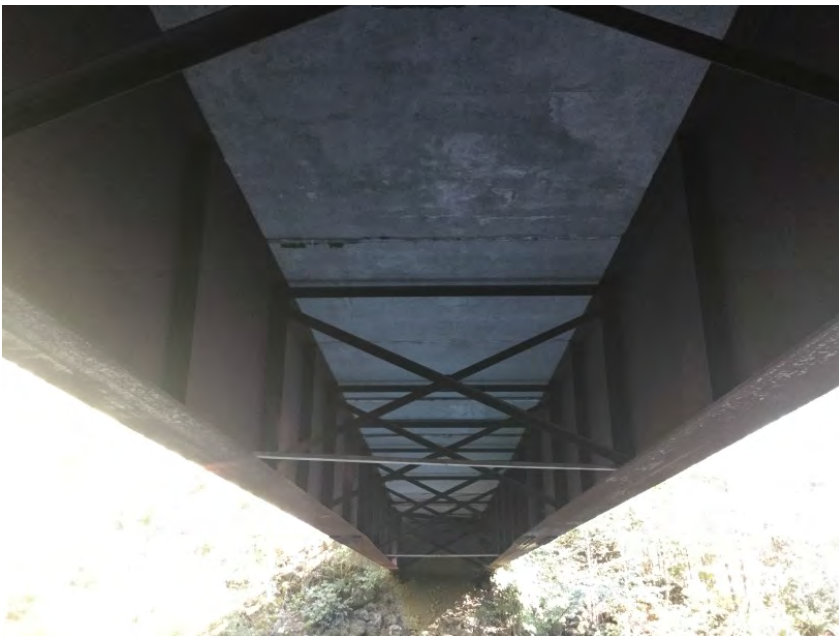
Girders Good

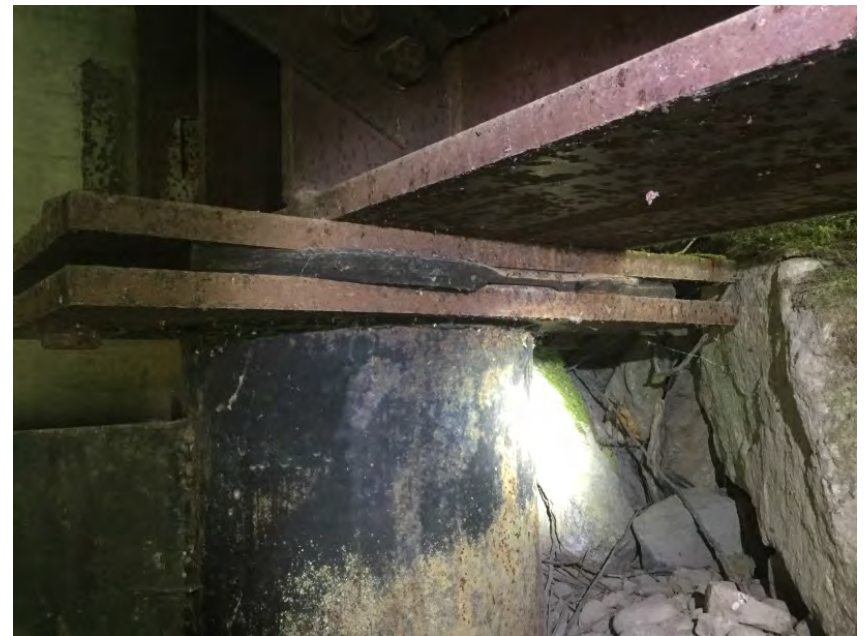
Bearings Fair All bearings are bulging.

Typical Bulging Bearings

| 2 | Monitor bulging of bearings. | Routine Inspection |

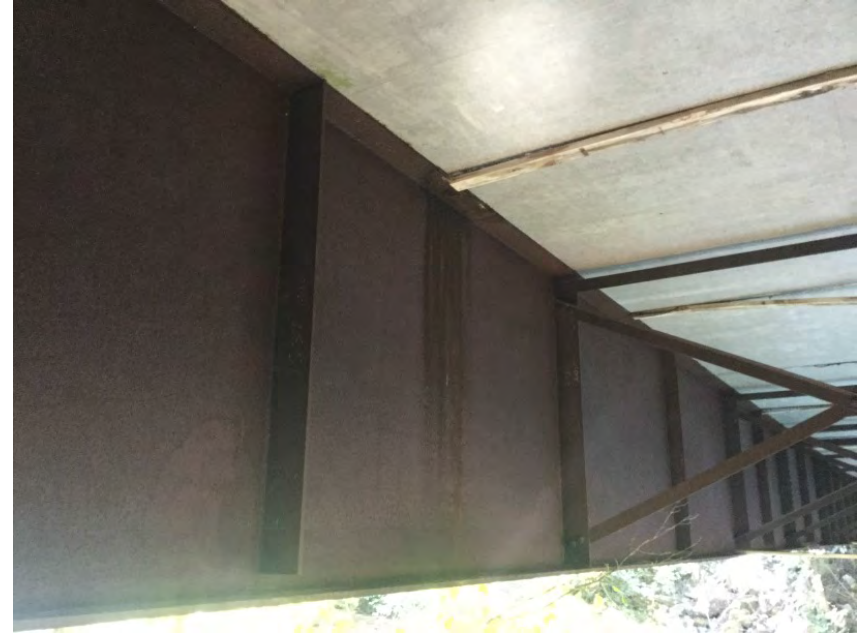
Corrosion of top flange and web at a few panel joint locations. Measurable section loss not anticipated based on extent of corrosion.

Corrosion of Girder at Panel Joint
