CK-2221

PITT RIVER 15.5km

2016 Inspection

| Structure Class | Major Culvert | | |

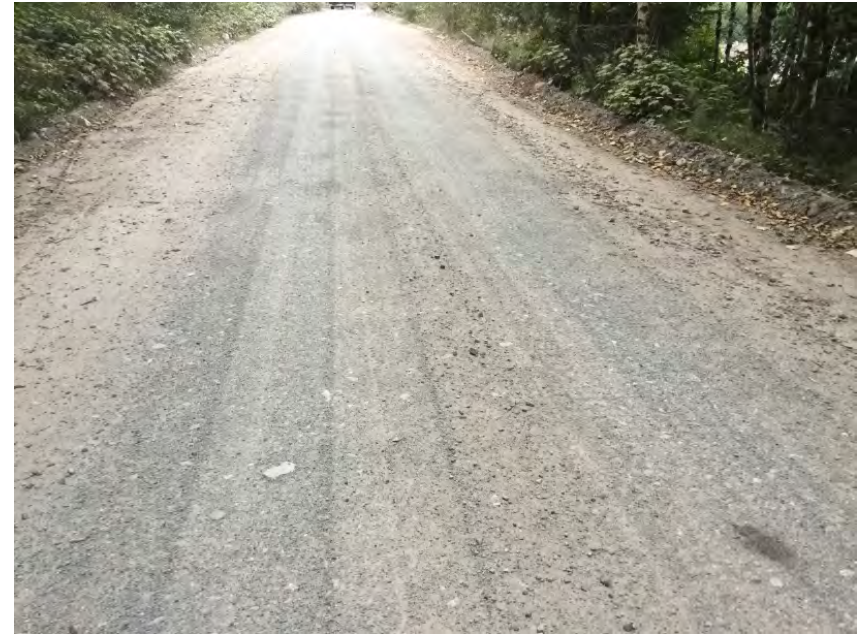
Roadway Over Culvert

Road Surface Good

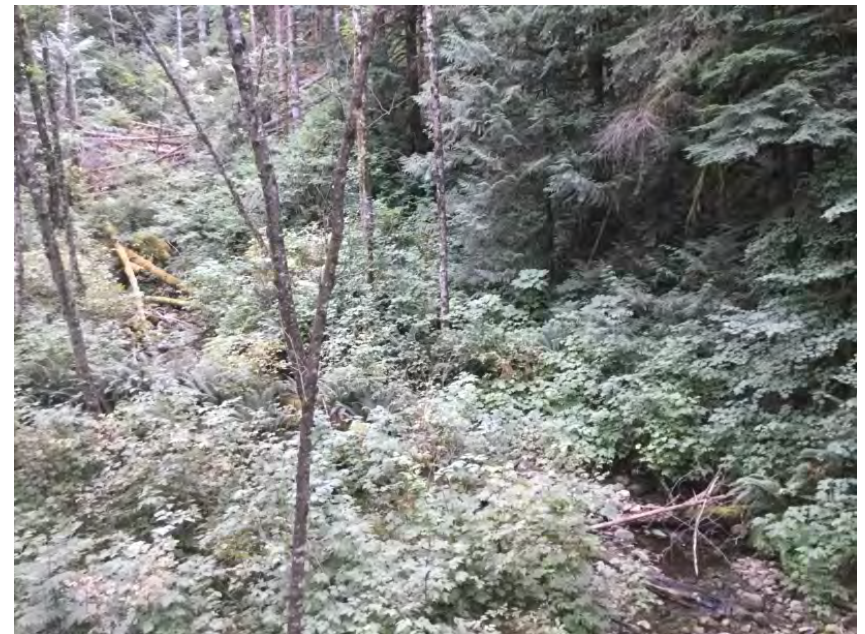
Looking Upstream

Comments Debris has been cleared from inlet since last inspection. Lots of dead fall upstream with some small woody debris.

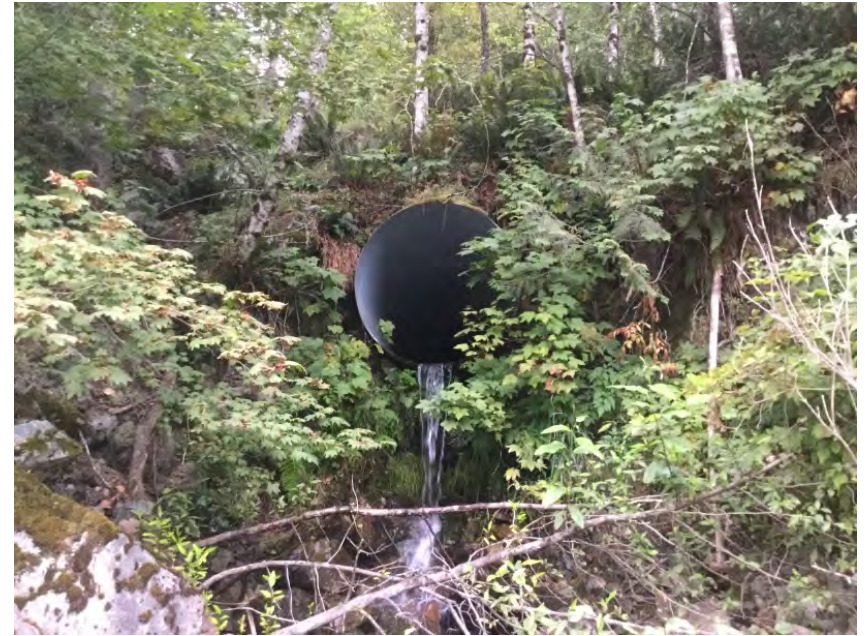
Downstream Elevation

| Fill | Fair | Oversteepened embankment slopes. |

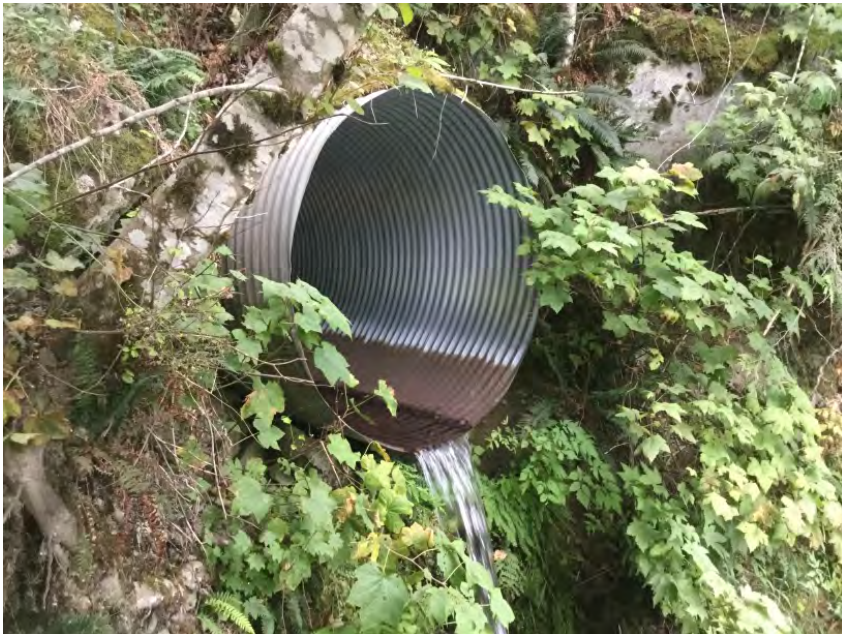
| Outlet | Fair | Culvert is overhanging with 2 m drop from outlet. Riprap splash pad working effectively. |

| Item | Monitor Description | Frequency |
|---|---|---|
| 1 | Monitor outlet for possible scour. | Routine Inspection |

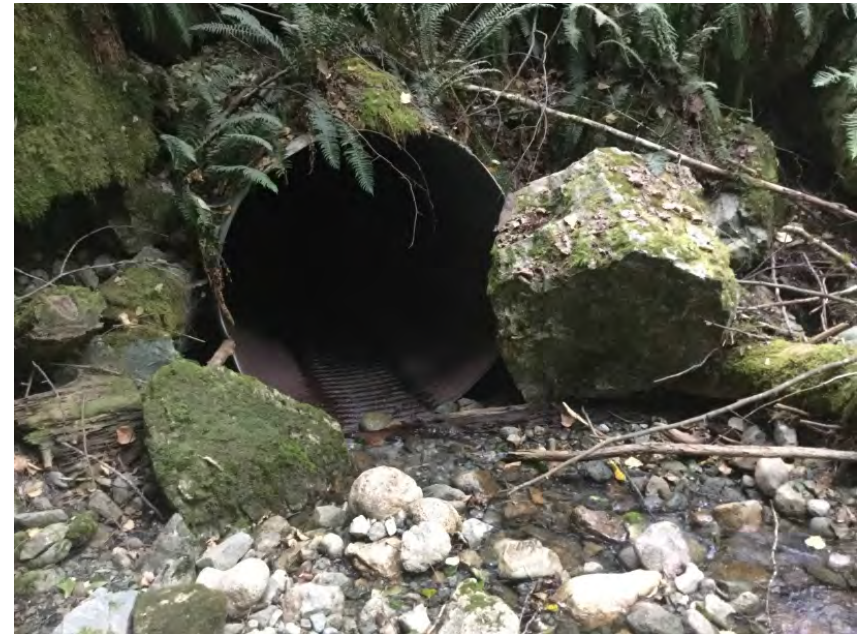
| Inlet | Fair | Debris cleared since previous inspection. |

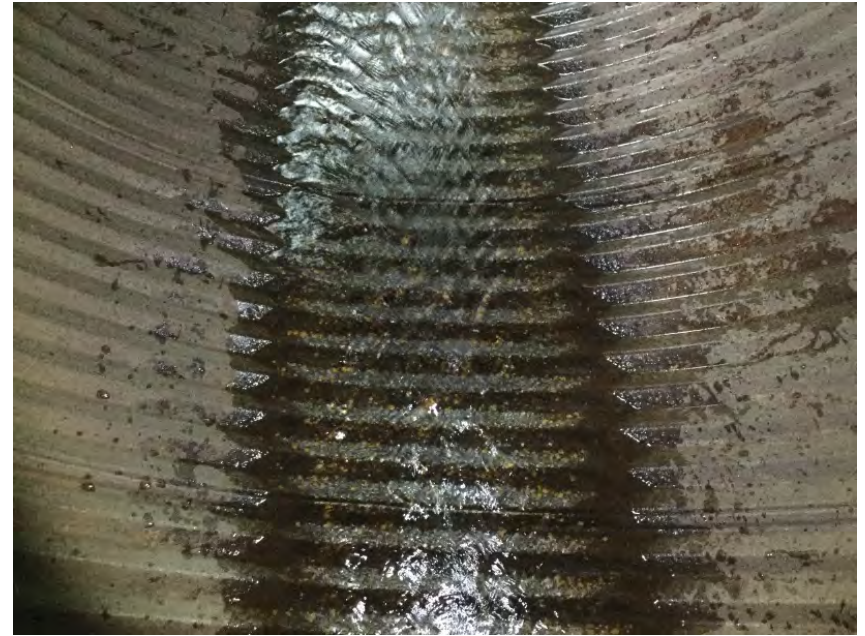
Culvert Floor

| Floor | Fair | Light corrosion on floor of culvert. |

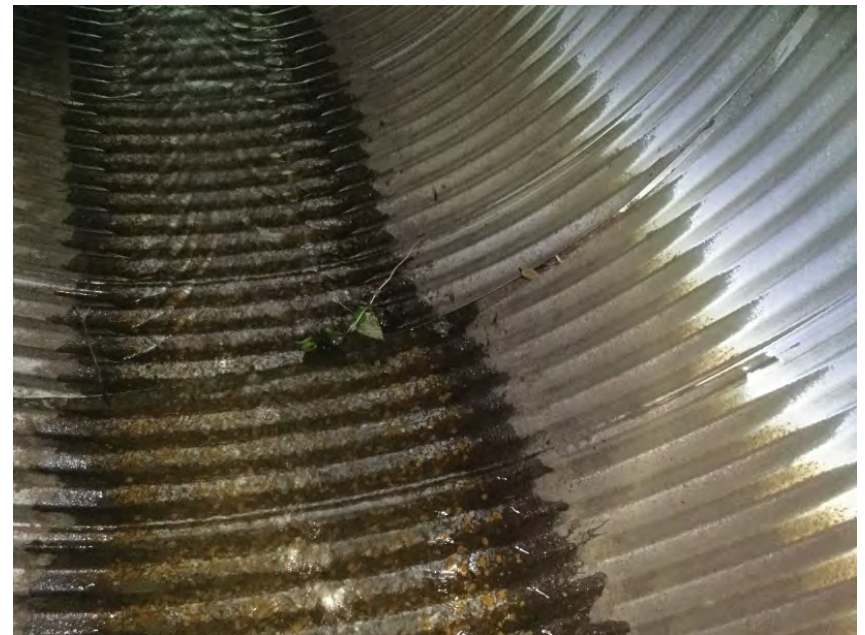
| Coupled Connections | Fair | Slight misalignment resulting in debris catching at coupler joint. |

Slight Misalignment at Coupler
