CK-2224

PITT RIVER 23km

2016 Inspection

| Crossing Name | Shale Creek | | |

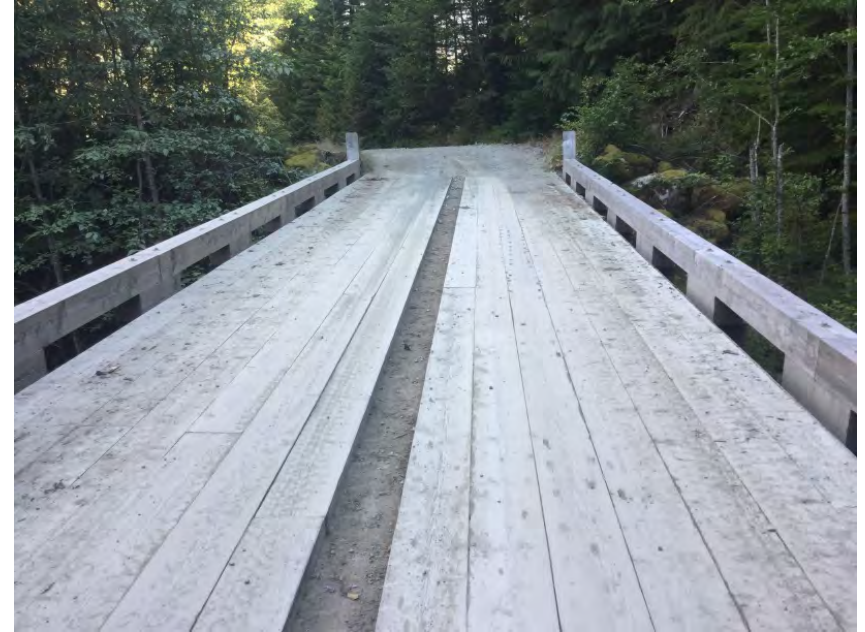
| Running Planks | Good | Some damage from vehicle tracks. Replaced in 2014. |

Deck Note Track Marks

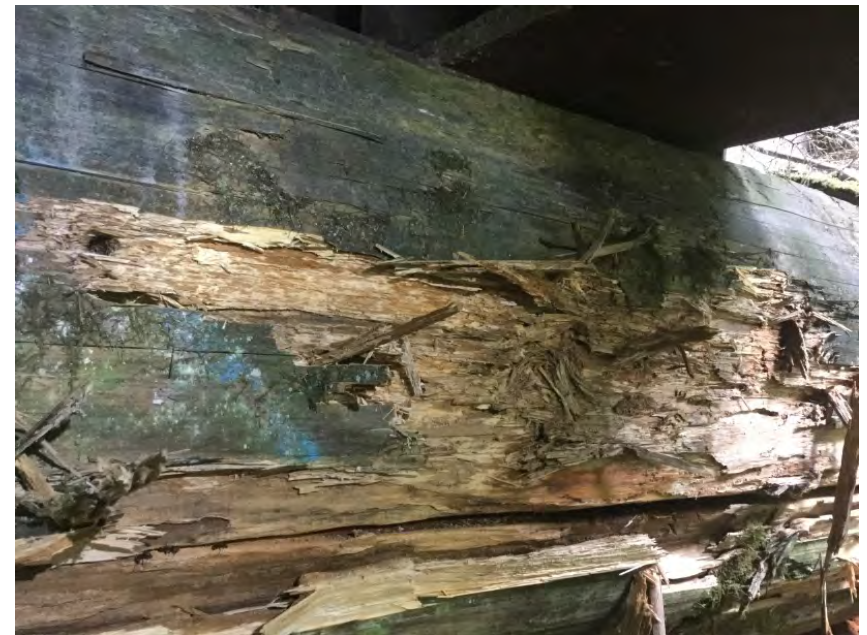
The running planks were replaced in November 2014 and bridge ahead signs have been installed since. The top crib log at the right abutment has a horizontal split and signs of bug infestation under the girder. No rot was identified and there are no signs of crushing or bulging. Signs of bug infestation were also noted at the downstream end of the log, outside the bearing area. The deterioration of the cribs should be monitored during future inspections.

Typical 25 mm sap rot under girders. R/B U/S corner under girder, horizontal split in top crib log with signs of bug infestation. No crushing or distress noted. No rot identified in cores.

R/B U/S Corner Split in Top Crib Log with Signs of Bug Infestation

Replace guide logs with appropriate sized ones. Monitor crib condition, especially top crib log on right bank. Present load rating of L100 or 91 tonnes to continue.

| Item | Monitor Description | Frequency |
|---|---|---|
| 1 | Monitor deterioration of right abutment log crib. | Routine Inspection |

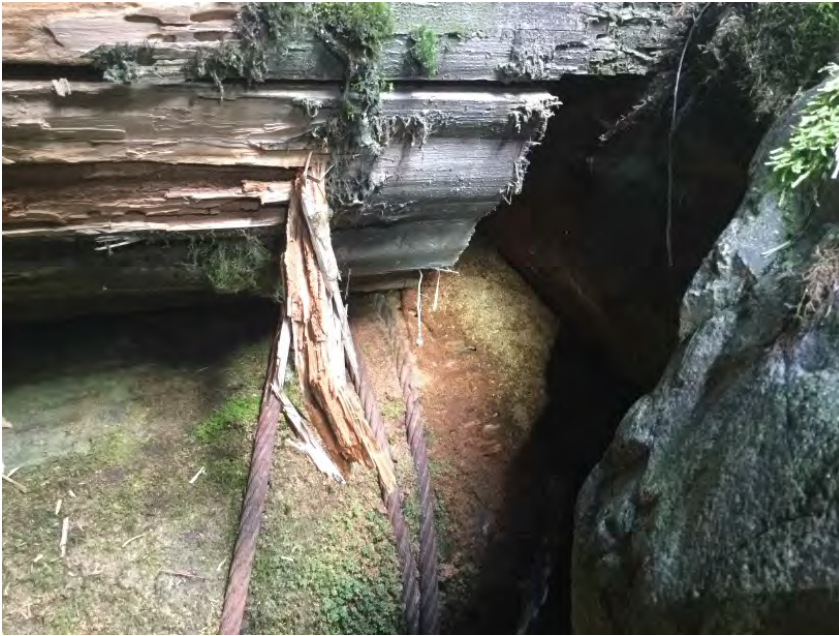
R/B U/S Corner Signs of Bug Infestation in Top Crib Log

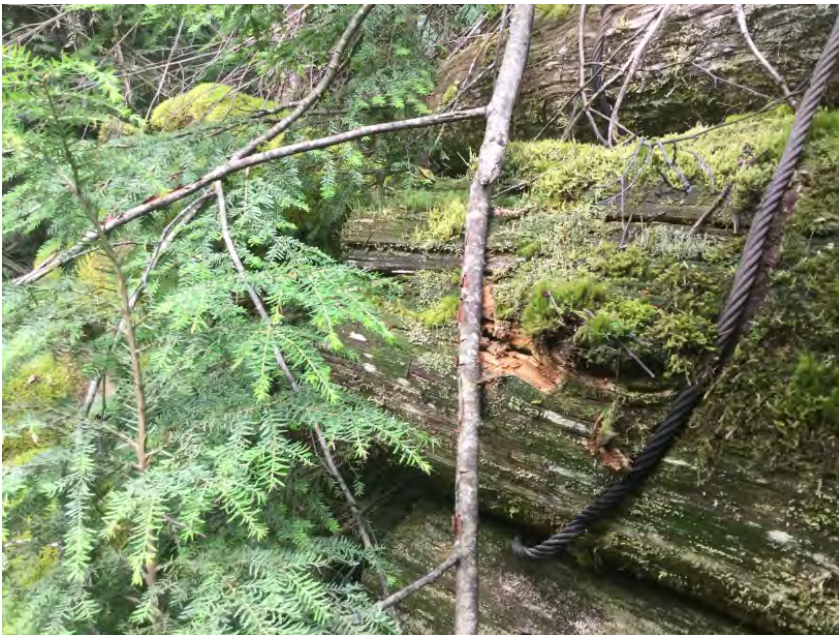
R/B D/S Corner Signs of Bug Infestation

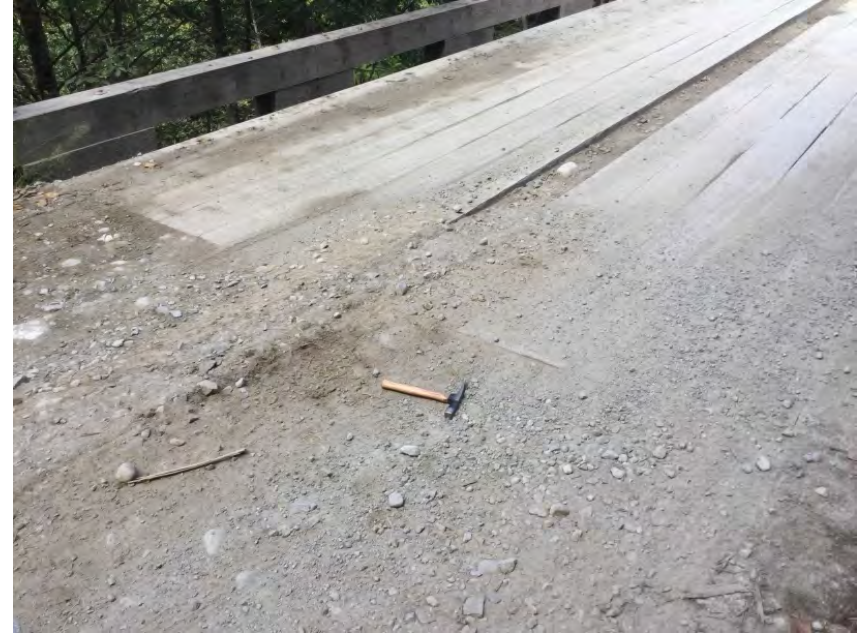
Potholes forming in left approach wheel tracks.

Left Approach Pothole Forming

| Item | Priority | Repair Description |
|---|---|---|
| 2 | Low | Fill pothole in left approach and clear debris from end of deck. |
