CK-2235

SCUZZY CREEK 6.6km

2016 Inspection

Inspection Company SNT Engineering

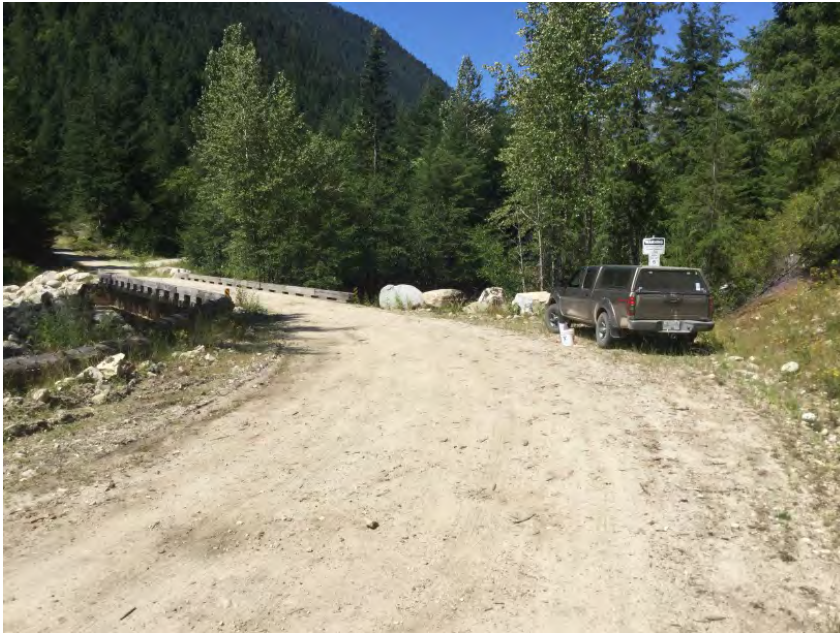
Left Approach Facing Bridge

Alignment Fair On S turn.

Bridge Ahead Signs Missing ☐ 0 ☐ 1 ☒ 2

| Repair | | Repair Description |
|---|---|---|
| 3 | Medium | Install bridge ahead signs and full size delineators. |

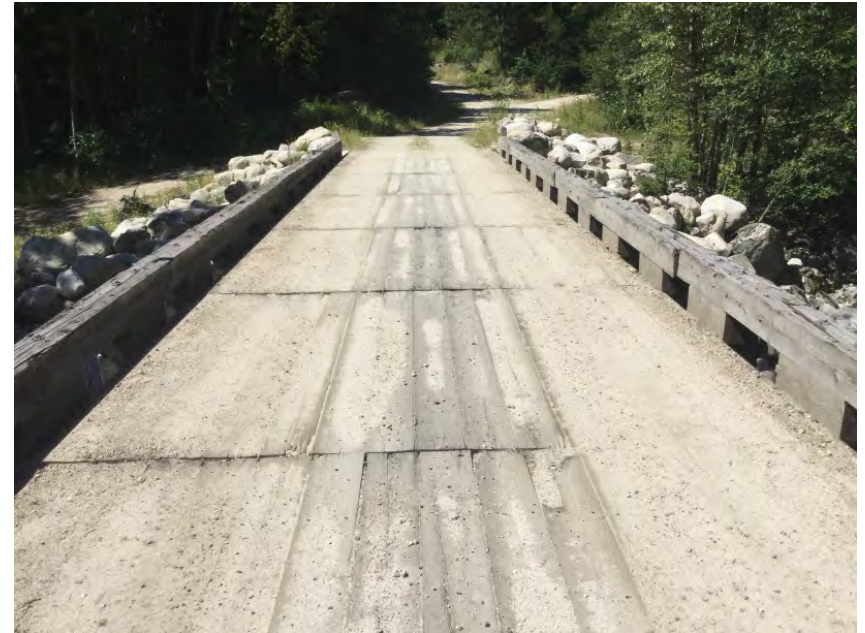
| Running Planks | Fair | 75 mm planks. Debris accumulation limited visible deck. 1 rotten plank on upstream side, light wear in wheel tracks and typical pockets of rot at ends of deck panels. |
| Sub Deck | Poor | Typically 25 mm of rot noted in sub deck at interface with ties. |
| Ties | Poor | 21 ties noted to have pockets of rot at ends, including 5 adjacent ties at right end. |
| Overall Deck Condition | Poor | Rot in ties and in guardrail. |

| Repair | | Repair Description |
|---|---|---|
| 1 | High | Replace ties, sub deck and wearing planks. 3 m long panels with 200x250 mm ties @ 400 c/c. Clear deck width of 4550 mm. 75 mm thick wearing planks and 100 mm thick sub deck. |

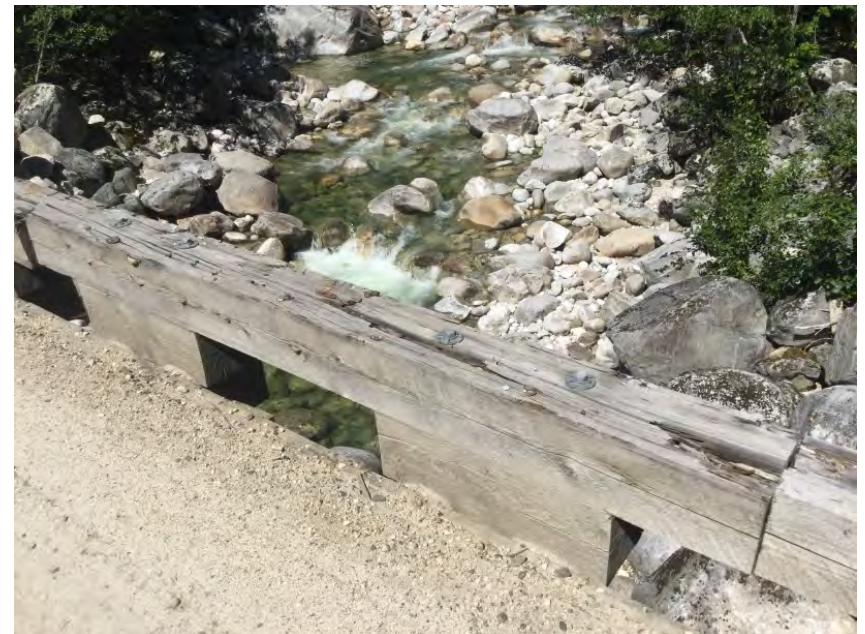
Guard Rail

| Curb Rail/Blocks/Posts | Poor | Rot and fungal growth noted in majority of guardrail. |

| Repair | | Repair Description |
|---|---|---|
| 2 | High | Replace guardrail. 3 m panels with 2 650x250x250 mm risers each side, and 250x250 mm guardrail. |

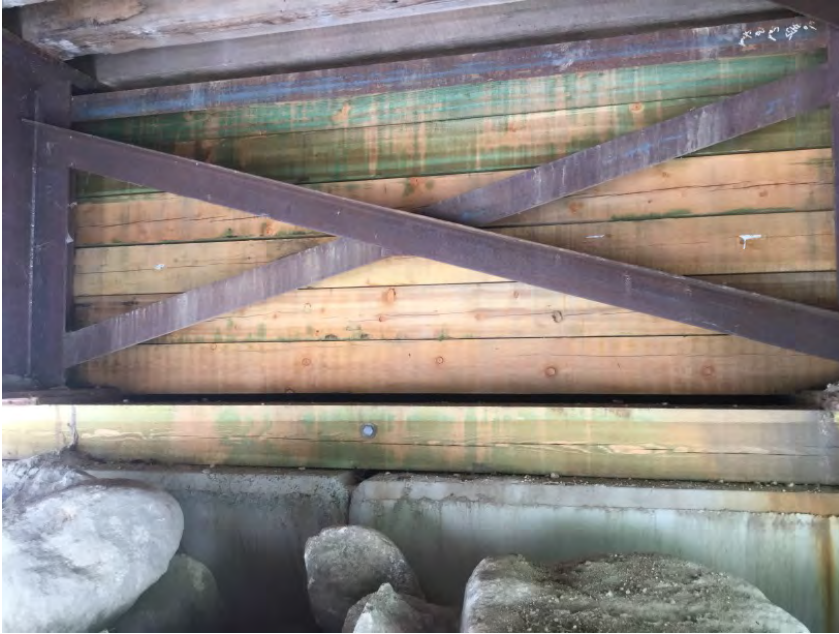
Concrete Good Lock blocks appear to have been replaced since previous inspection.

Caps or Sills Good Timber sill replaced since previous inspection. Girders bear evenly on sill.

Typical New Sill & Lock Blocks

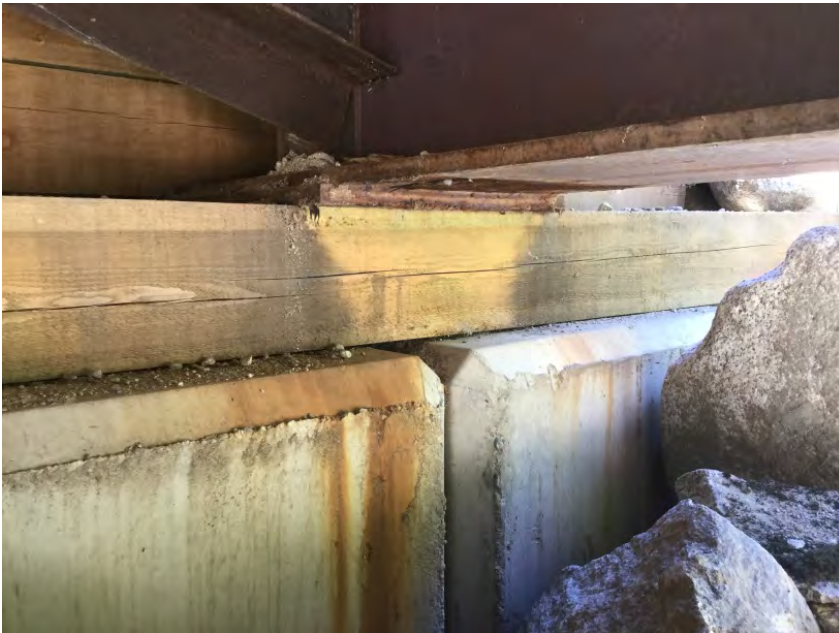
Typical Girder Bearing on Sill

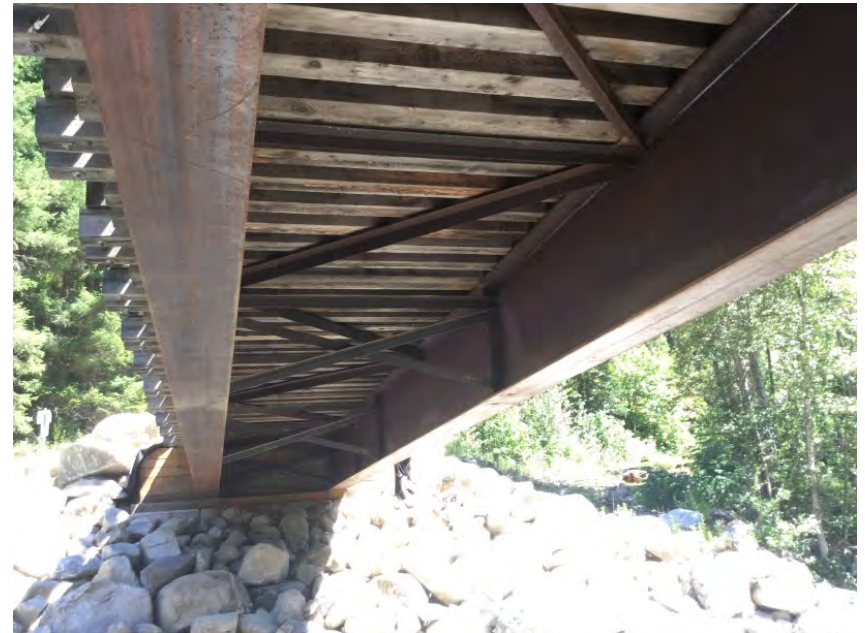
Girders Good

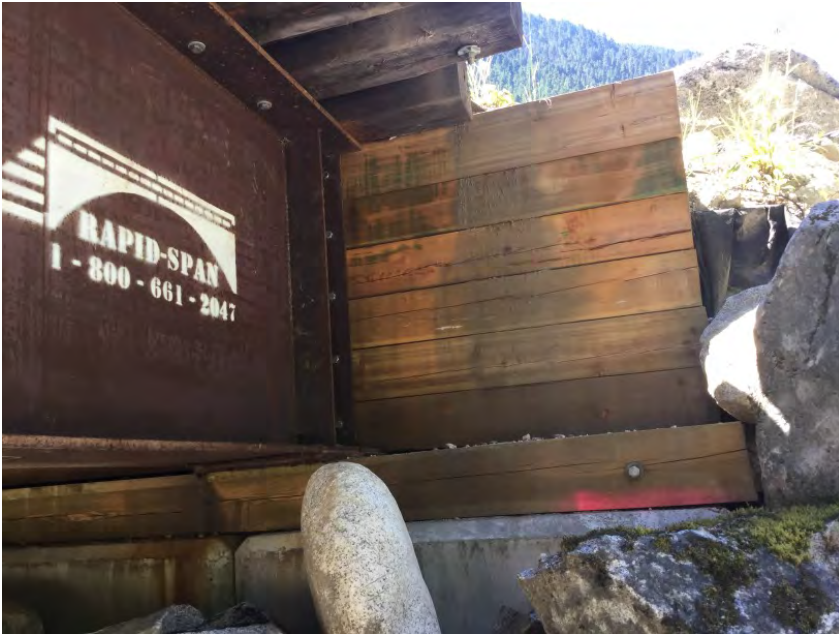
Ballast Wall & Fabricator

Ballast Wall Good Ballast walls replaced since previous inspection.

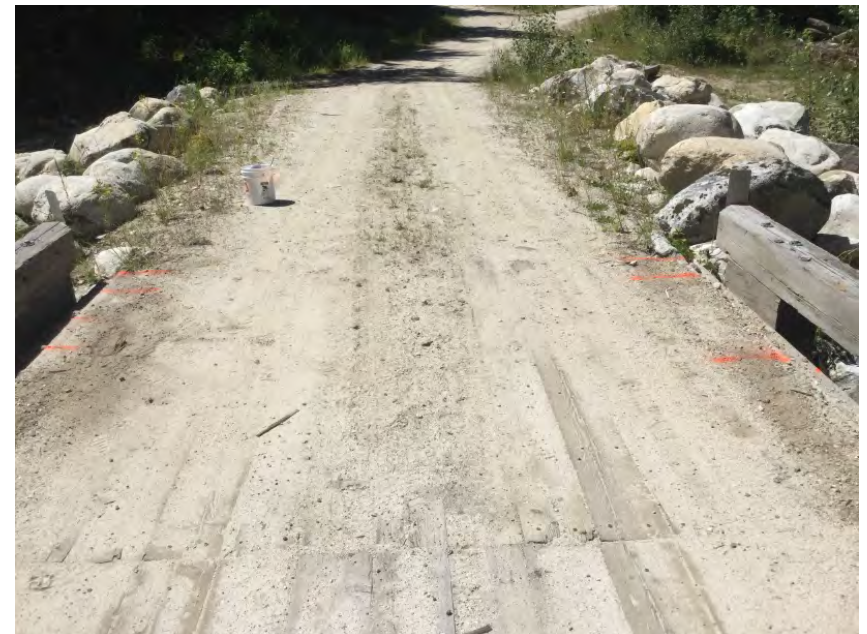
Rot Found in 5 Adjacent Ties at Right Abutment

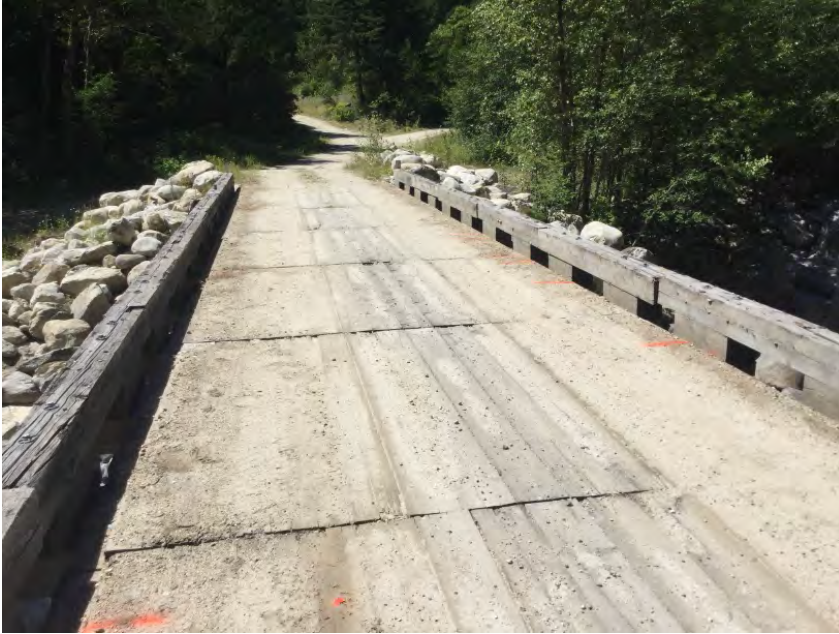
Substructure replaced since previous inspection. Deck and guardrail require replacement. Drilled deck at 11 locations where rot identified in ends of ties. Pockets of rot noted in 10 drilled locations. Pockets typically 100-150 mm deep at interface between sub deck and ties with one location of 300 mm deep pocket. Typically 75 -125 mm pockets of rot noted in top of ties. 5 adjacent ties at right abutment drilled, 4 found to have typical rot at interface with sub deck. Bridge currently posted for 5 tonnes.

Rot in Ends of Ties Shown in Orange

Replace entire deck system (ties, subdeck, wear planks, guardrail and risers). Limit loading to 30 tonnes until such time. Update load rating sign and post bridge ahead signs.

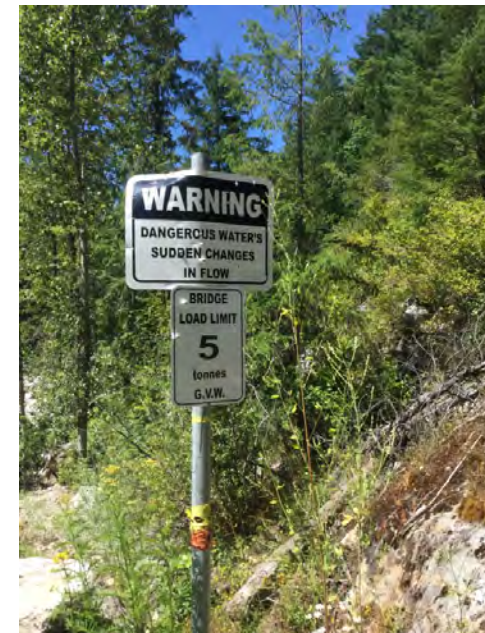
Load Posting

Posted Load Rating 5
