CK-2236

SOWAQUA CREEK 9.6km

2016 Inspection

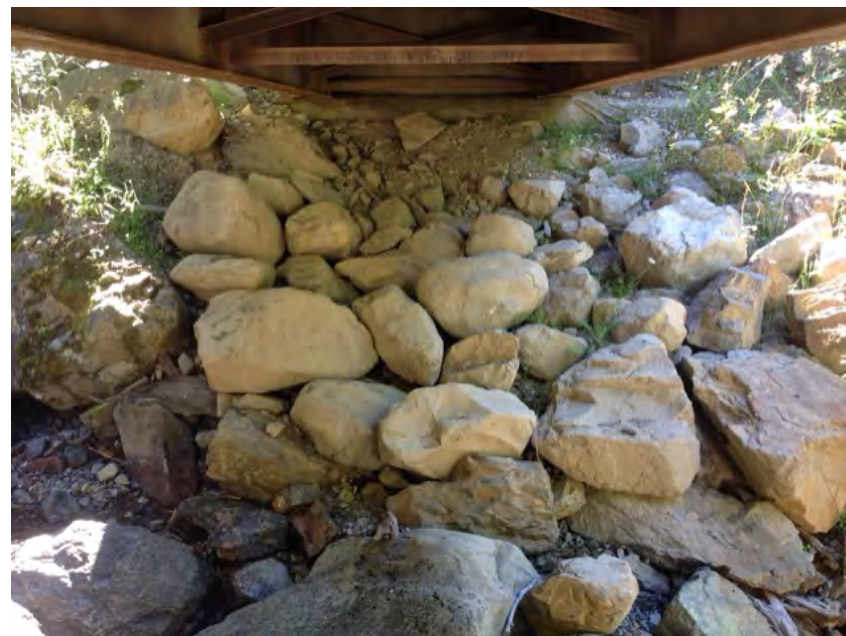
Left Bank Abutment when facing downstream

single log sill wrapped in fabric

limited and not well keyed in or tied together

| Item | Monitor Description | Frequency |
|---|---|---|
| 1 | due to limited riprap monitor abutment scour | following high flow events |

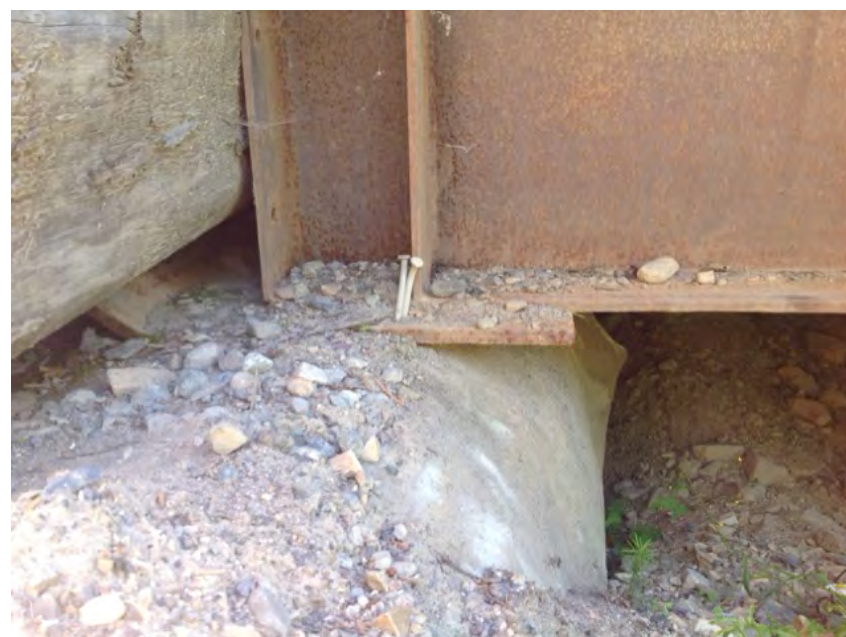
bear plates not completely on sills and loosely fasten

right bank downstream bearing - not fully on log sill - no signs of stress

| 2 | due to the poor bearing monitor the bearing plates for deformation | during industrial use |

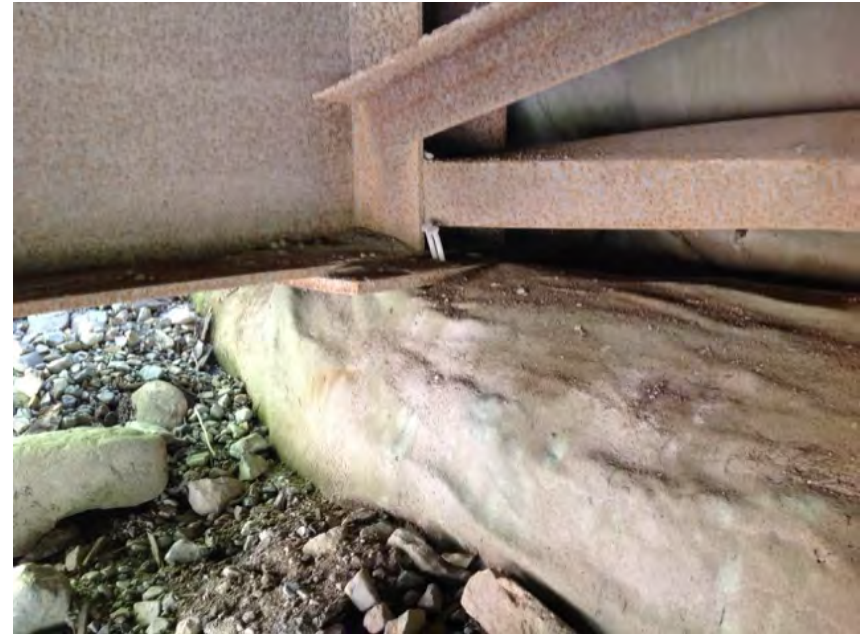
left bank upstream bearing not fully on log sill - no signs of stress

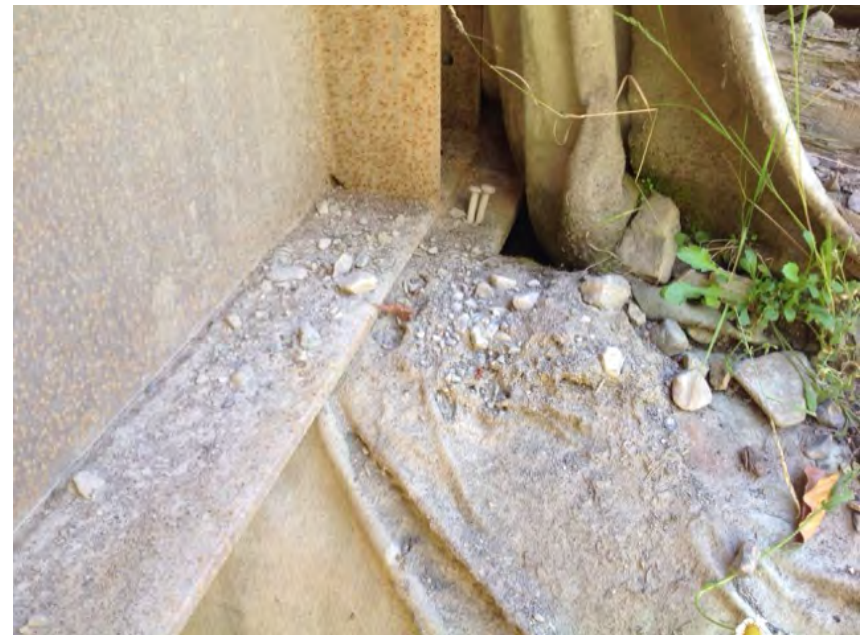
left bank downstream bearing plate barely on log sill - no signs of stress
