CK-2237

SOWAQUA CREEK 14.6km

2016 Inspection

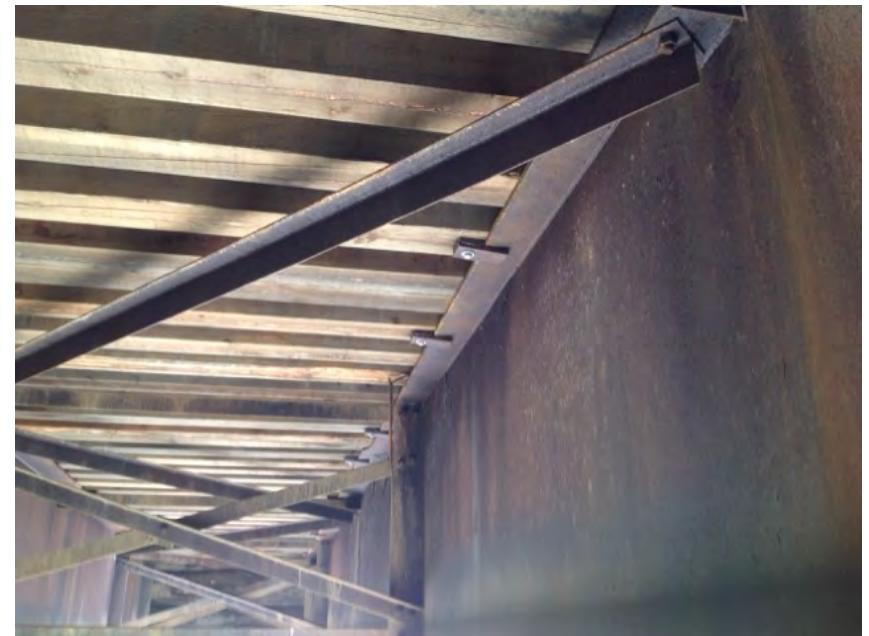
Deck to Girder Bolts Fair clips

deck clips

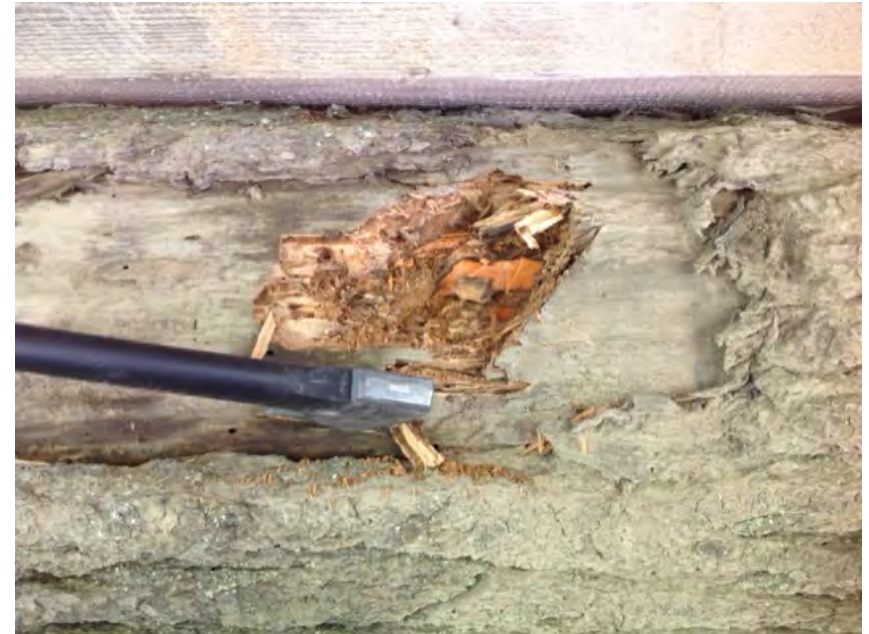
the crib logs were never peeled and have up 60mm sap rot - no signs of crushing  
 the cap not adequately fastened to the top crib logs  
 monitor crib condition

Log/Timber Crib Fair Fd logs not peeled and up to 60mm sap rot on top crib logs

up to 60mm sap rot on top crib logs - no signs of crushing

| 1 | crib condition | Anually |

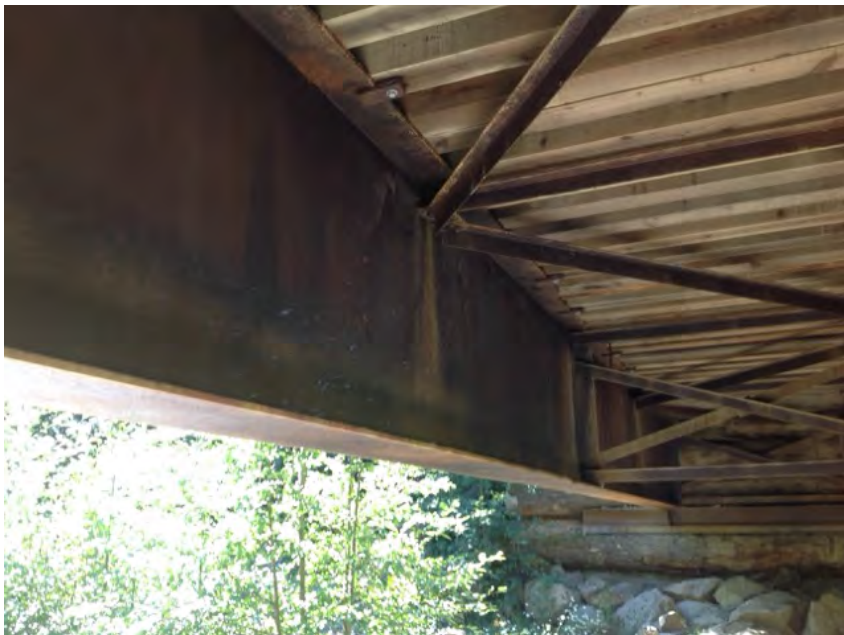
corrosion on upstream girder

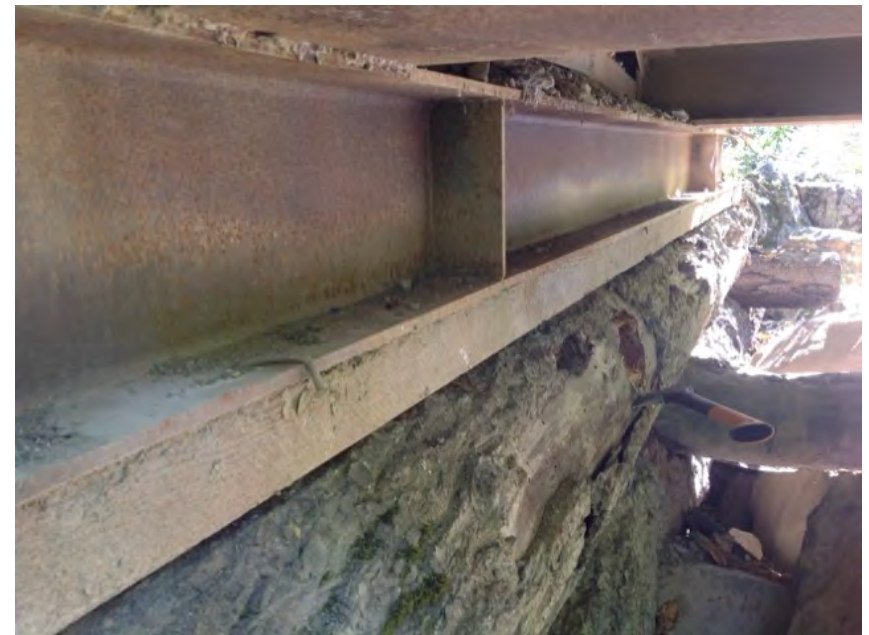
Caps or Sills Fair to poor steel cap on top of 100mm thick timber on crib - only appears to be fastened by 2 nails  
the stiffeners on the cap not directly under girders

Bearings Fair to Poor the steel cap not adequately braced and not centered under girders, girders not fastened to cap

H beam on timber on top of log crib

| 2 | steel cap condition and connection to timber | during industrial use |
