CK-2240

SPUZZUM CREEK 5km

2016 Inspection

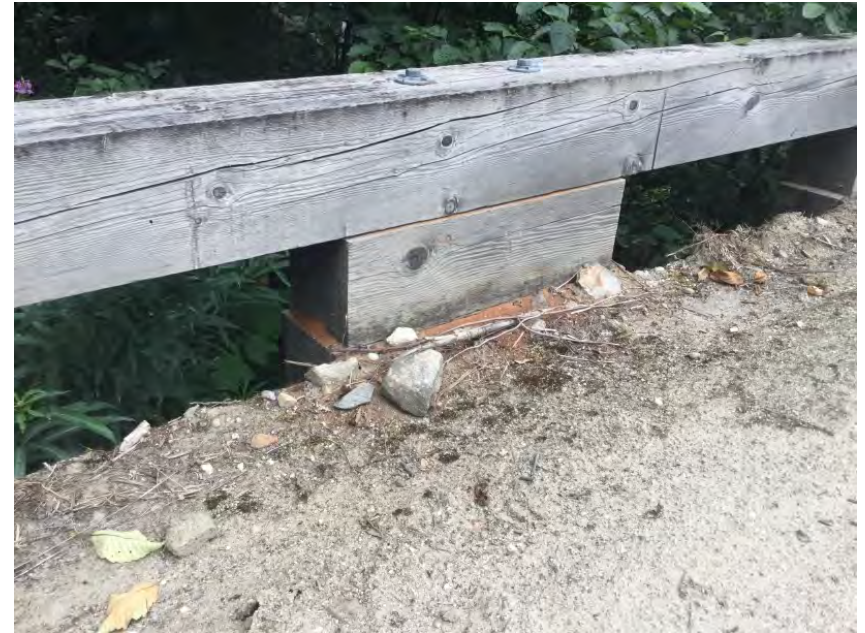
| Curb Rail/Blocks/Posts | Fair | Signs of bug infestation, no associated deterioration found. 1 pocket of rot found in blocking. Checks in guardrail with debris accumulation. |

Signs of Bug Infestation

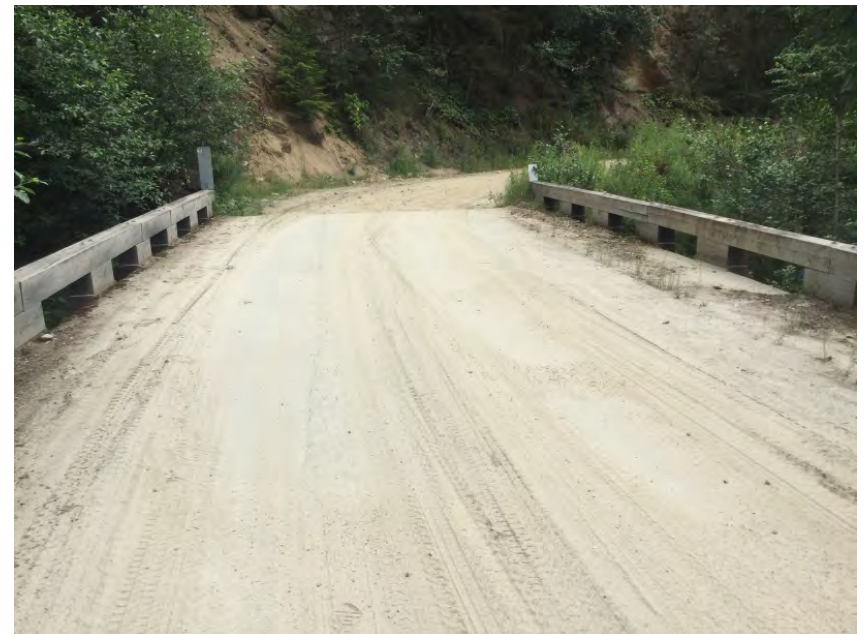
| Concrete Deck | Fair | Covered in debris limited amount inspectable. Some wear noted. |

| Item | Priority | Repair Description |
|---|---|---|
| 3 | Medium | Install bridge ahead signs and full size delineators. Brush approaches. Remove debris from deck. Regrade approaches for industrial use. |

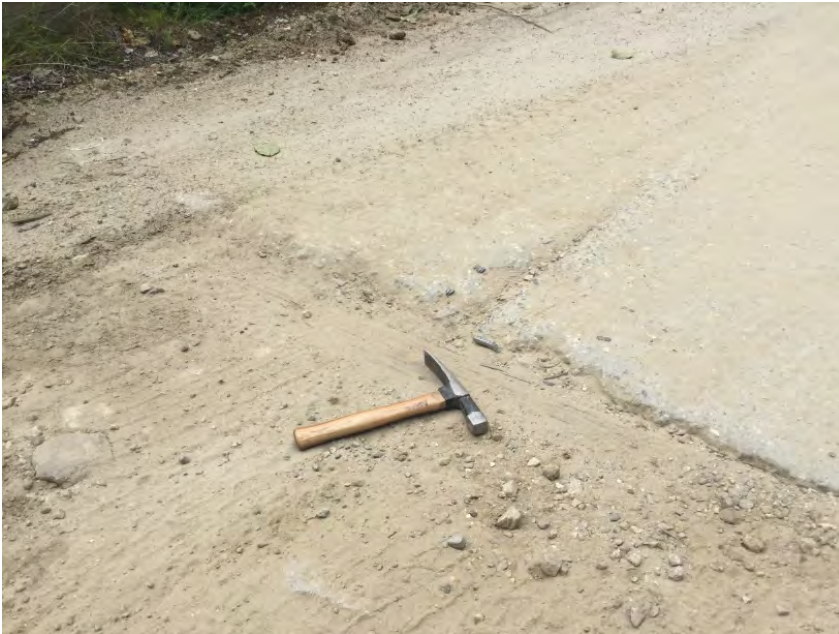
Left approach is below the level of the deck, resulting in damage to girder ends. 1500 mm long by 700 mm erosion at left abutment upstream corner.

Grouted slab girders. Previous inspection noted exterior girders not connected. Wear noted in wheel tracks. Damage at left abutment due to approach being below deck.

Wear of Girder in Wheel Track at Left Abutment

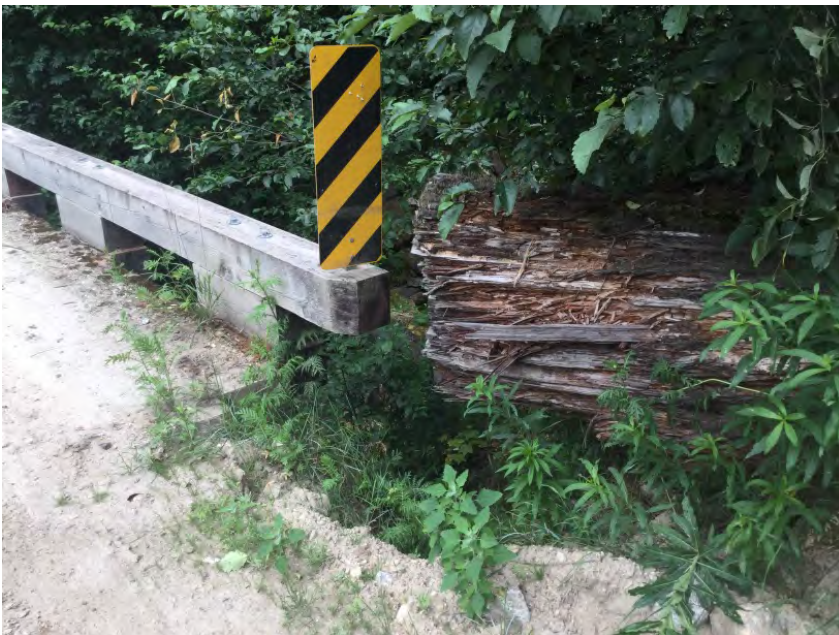
Erosion at left abutment upstream corner poses hazard to road users. Install new guide logs or CRB barriers at all corners - significant drop to creek.

Erosion at left abutment upstream corner has produced hole in road reducing road width and causing hazard.

Erosion of Bank Fill at Left Abutment Upstream Corner. Note Rotten Guide Log.

| Item | Priority | Repair Description |
|---|---|---|
| 1 | High | Repair bank erosion at left abutment upstream corner. |
| 2 | High | Install new guide logs at all corners. Significant drop to creek at downstream side. Also replace rotten log at right abutment downstream side that retains fill. Alternative options such as lock blocks to be considered. |

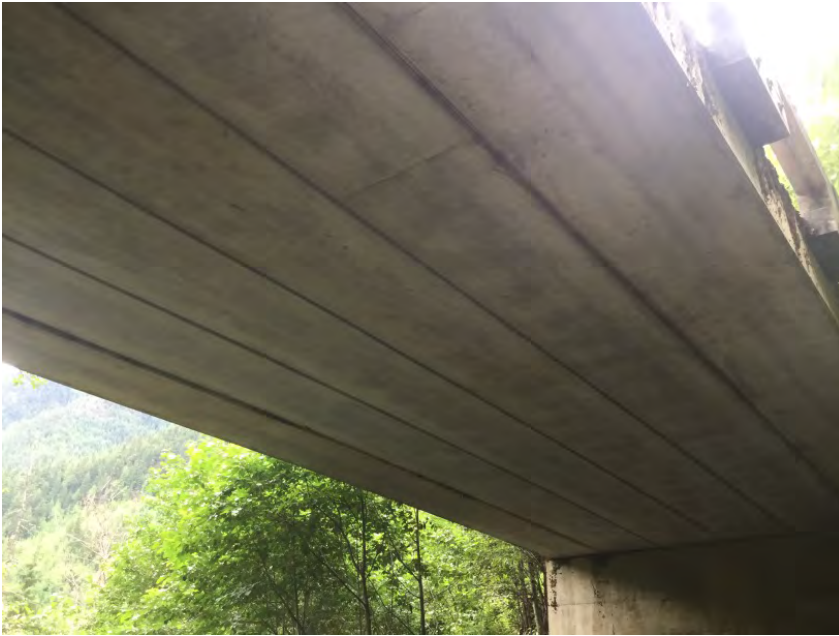
Girders

The 2 existing outside slab girders were added to the original 4 inside slab girders 2 years after the original install. Since the original outside slab girders do not have keys and not attached to the existing outside slab girders there is differential movement between them, causing the joint to disintegrate. Clean the the joint between the outside slab girders, insert oakum or styrofoam and apply a flexible bitumous sealer. Replace the fill retaining log at the right downstream approach;; repair the left upstream bank erosion; replace all fender logs; post bridge ahead signs; brush and grade approaches. This should be done prior to industrial traffic. Monitor the outside girder differential movement. Present load rating of L60 or 54 tonnes to continue.

| Item | Monitor Description | Frequency |
|---|---|---|
| 1 | Previous inspection noted exterior girders not connected, if these are not doweled into abutment they should be monitored. | Routine Inspection |

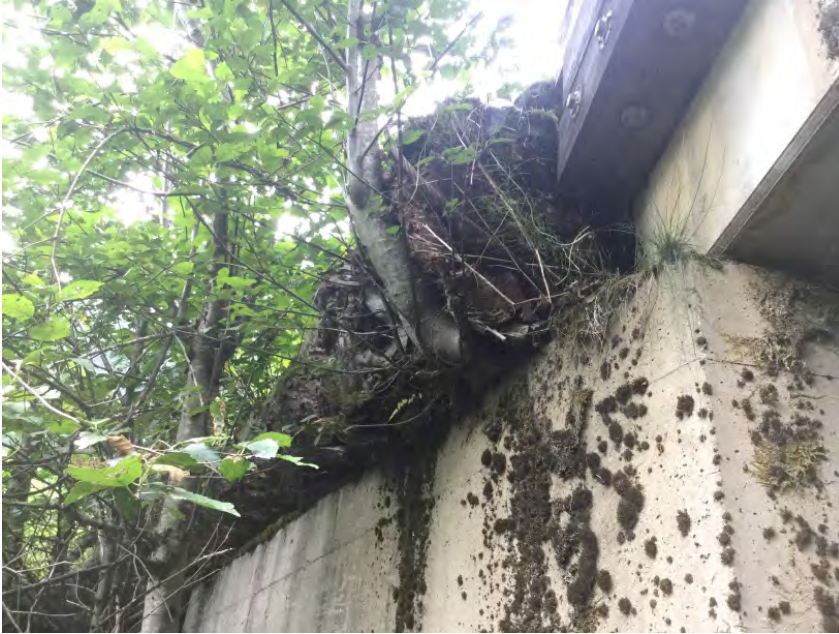
3 guide logs all rotten. No guide log at left abutment downstream side. Right abutment downstream guide log lashed to rotten log that retains roadway fill.

Downstream corners only. Right abutment wing wall not cast high enough, requiring log and lashing to retain fill at deck elevation. Log is rotten and in poor condition.

Right Bank Downstream Corner - Rotten Log & Lashing Supporting Fill
