CK-2241

SPUZZUM CREEK 25.4km

2016 Inspection

Inspection Company SNT Engineering

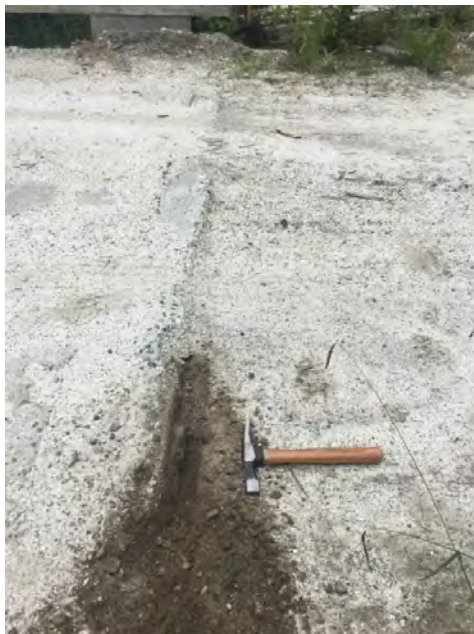
Left Abutment: spall in wheel track with exposed rebar and spall in upstream tapered section of ballast wall.

Left Abutment Damaged Ballast Wall

| Item | Priority | Repair Description |
|---|---|---|
| 3 | Medium | Repair left abutment ballast wall, regrade and brush approaches for industrial use. |

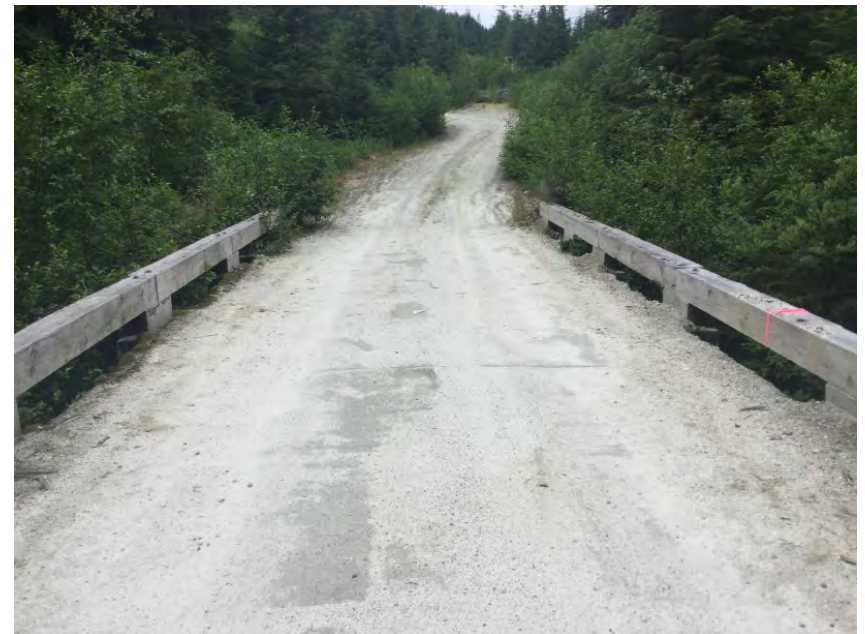
| Concrete Deck | Fair | Covered in debris, limited inspection. |

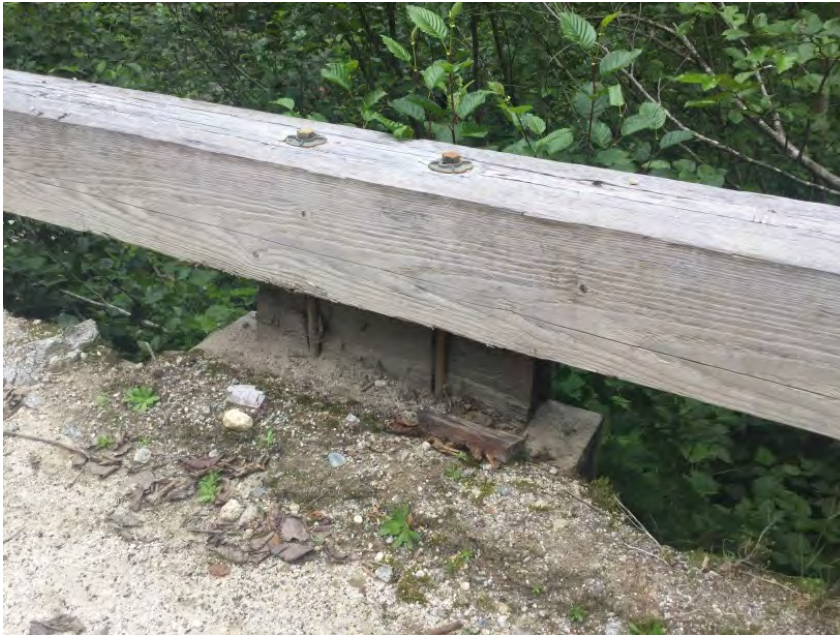
| Curb Rail/Blocks/Posts | Poor | Two risers rotted out, and rot noted in approximately half of blocking. Pockets of rot noted in a few guardrail sections, large checks also noted. |

Rotten Guardrail Blocking

| Item | Priority | Repair Description |
|---|---|---|
| 1 | High | Replace guardrail, risers and blocking. 16 900x250x250 mm blocking, 16 700x250x250 mm riser, 4 4800x250x250 mm guardrail and 3500x250x250 mm guardrail. Remove debris from deck. |

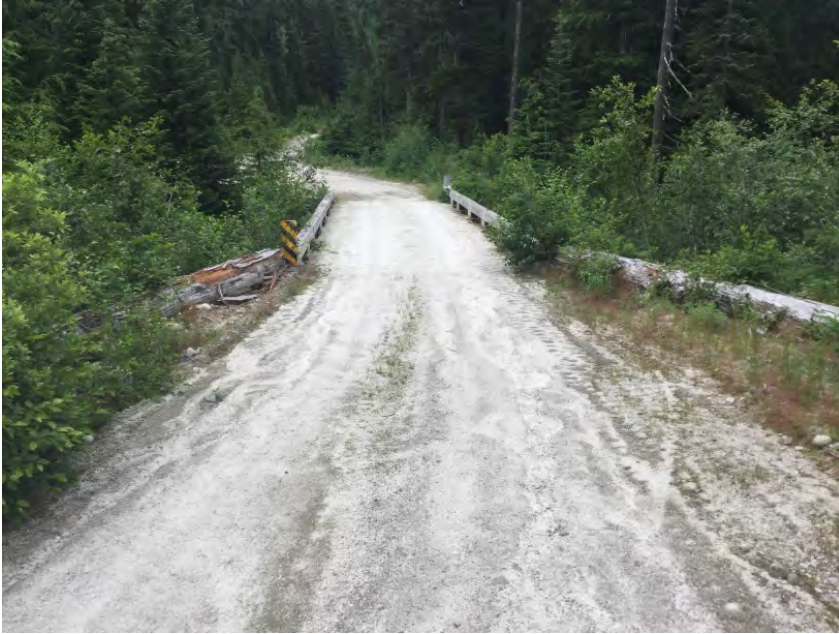
Right Approach Facing Bridge

Right approach below level of deck resulting in damage to ballast wall. Potholes and signs of ponding.

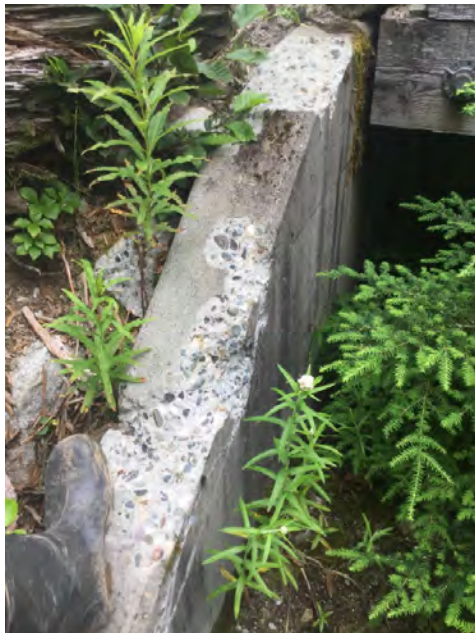
Spall in Left Abutment Upstream Section of Ballast Wall

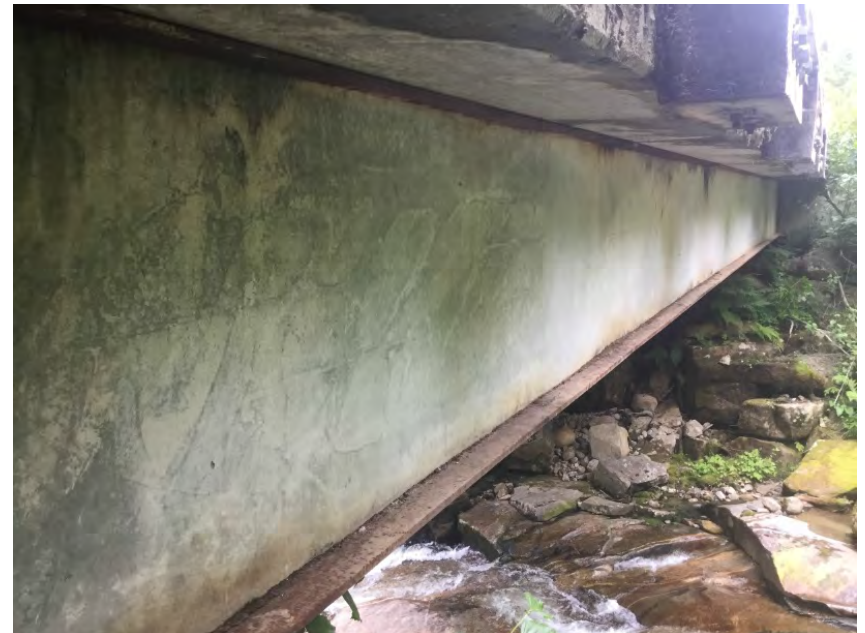
Girders Good Compo girders.

Typical Girder Condition
