CK-2254

SQUEAH 6.6km

2016 Inspection

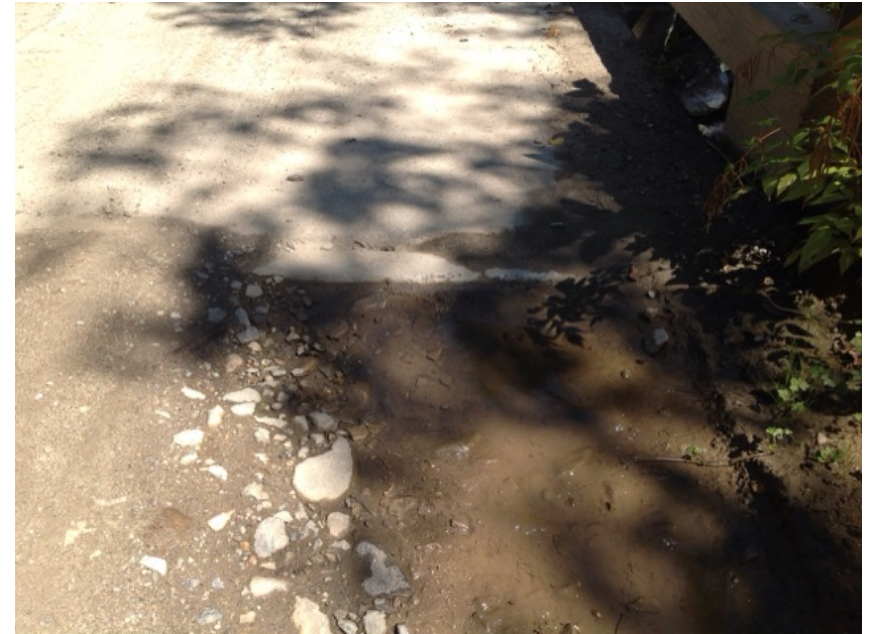
Road Surface Fair

potholes at approaches

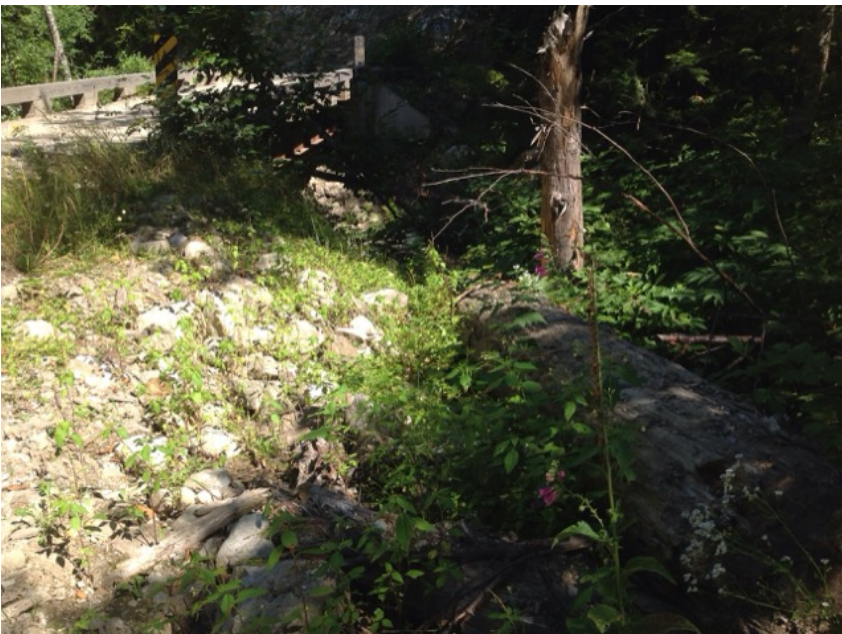
Fender Condition Fair

left bank upstream log fender rolled off hill

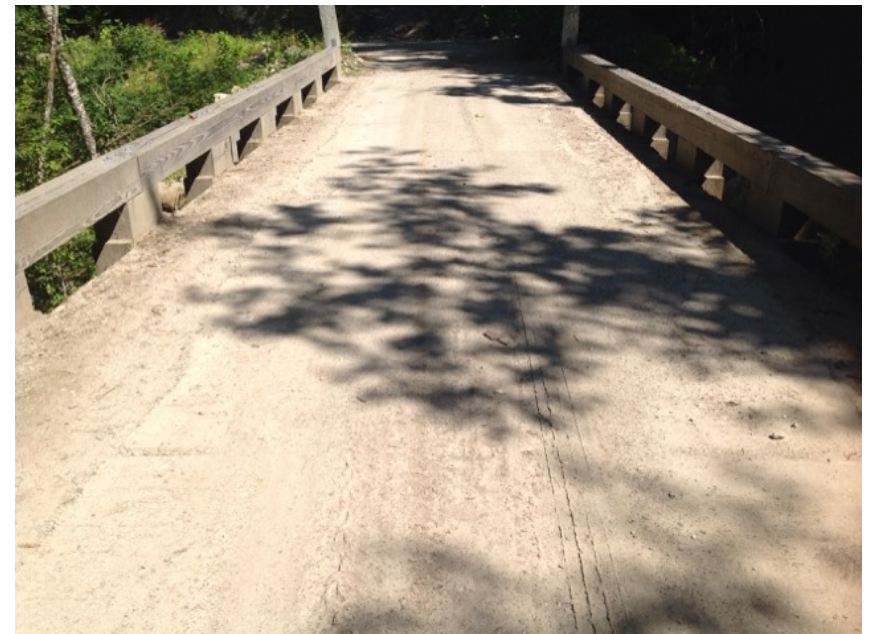
Overall Deck Condition      Good

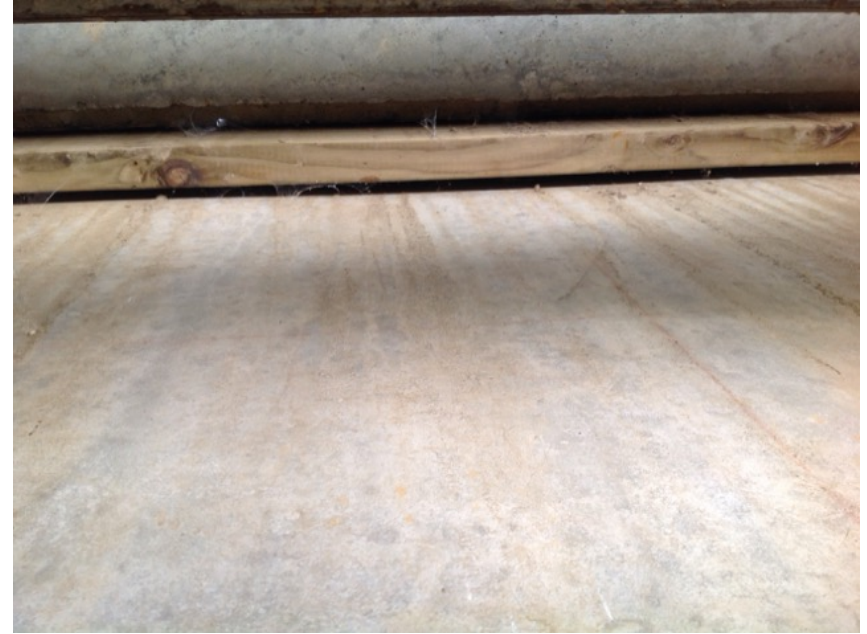
treated 2x4 to help hold fill in place on right bank

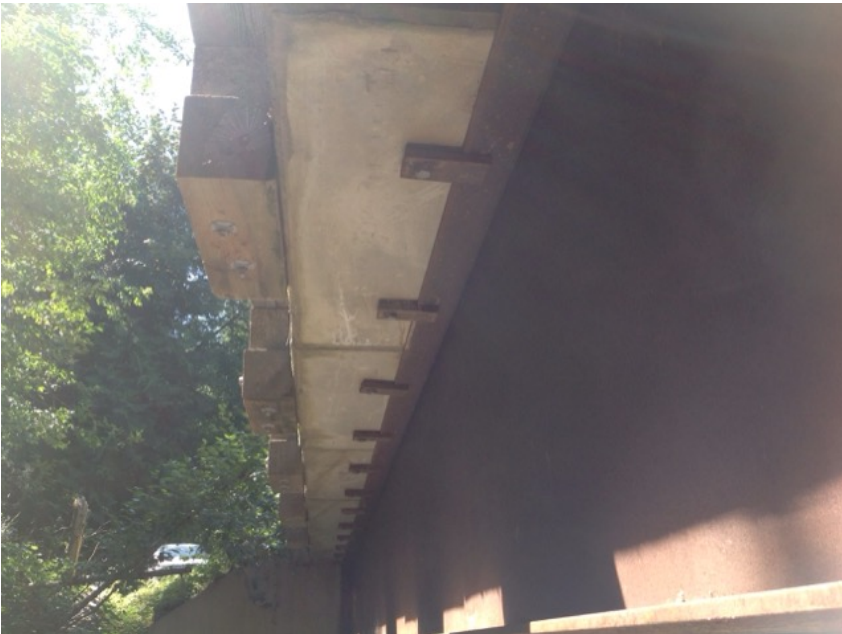
Deck to Girder Bolts      Good      clips

deck clips

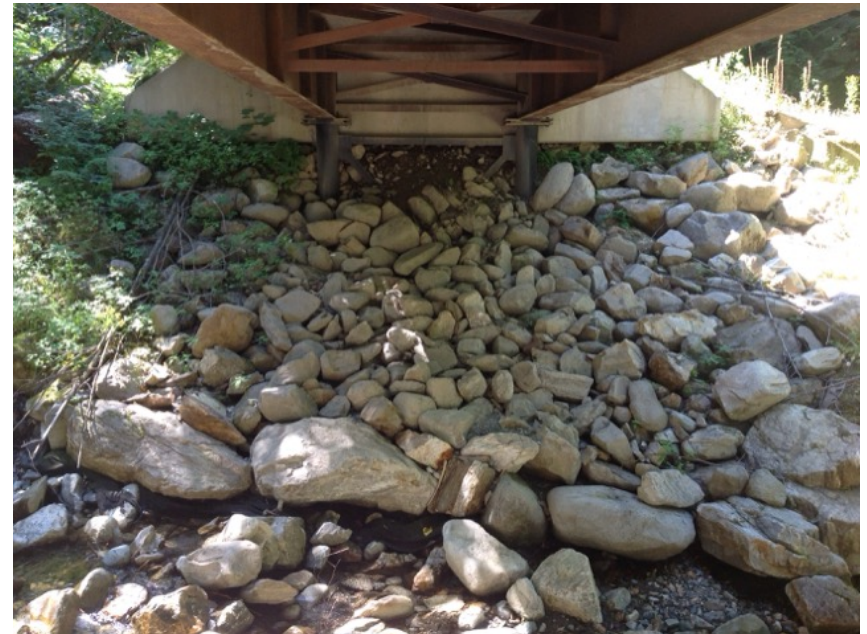
Left Bank Abutment when facing downstream

Bearings Fair slight buldging

| Item | Monitor Description | Frequency |
|---|---|---|
| 1 | bearings | routine inspections |
