CK-2261

STAVE RIVER 8.5km

2016 Inspection

| Crossing Name | Winslow Creek | | |

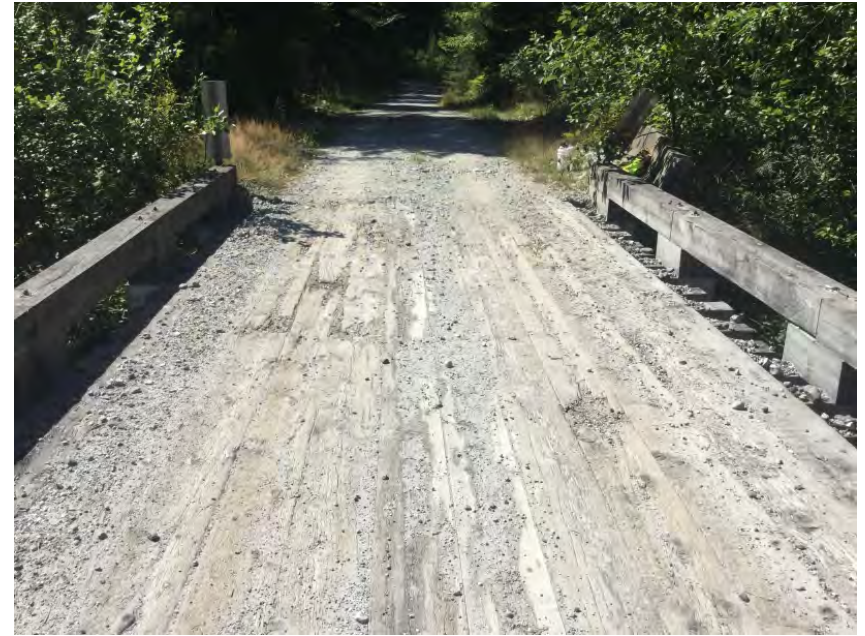
| Running Planks | Poor | Heavily worn in wheel tracks of span 2. Some wear in span 1. |
| Nails | Fair | Starting to protrude in span 2. |

Span 2 Deck

| Item | Priority | Repair Description |
|---|---|---|
| 2 | High | Replace wearing planks in span 2 and guardrail in span 1. Requires: 100 mm thick planks for 4.3 m wide, 14.6 m long section of deck. 44 m of 250x250 mm guardrail, 14 700x250x250 mm risers. |

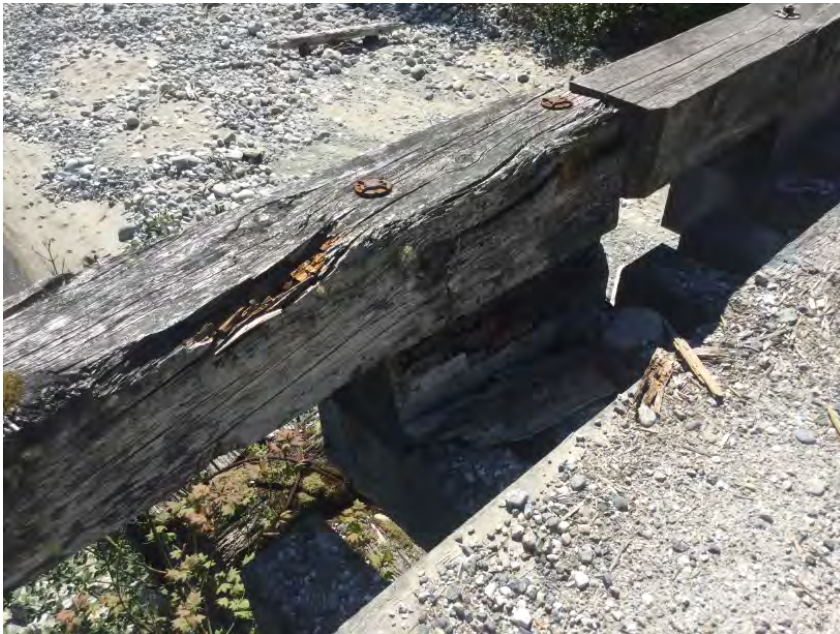
| Curb Rail/Blocks/Posts | Poor | Span 1: rot in 8 of 14 risers, with rotten sections of guardrail. Span 2: guardrail and risers typically sound. |

Rotten Guardrail and Riser

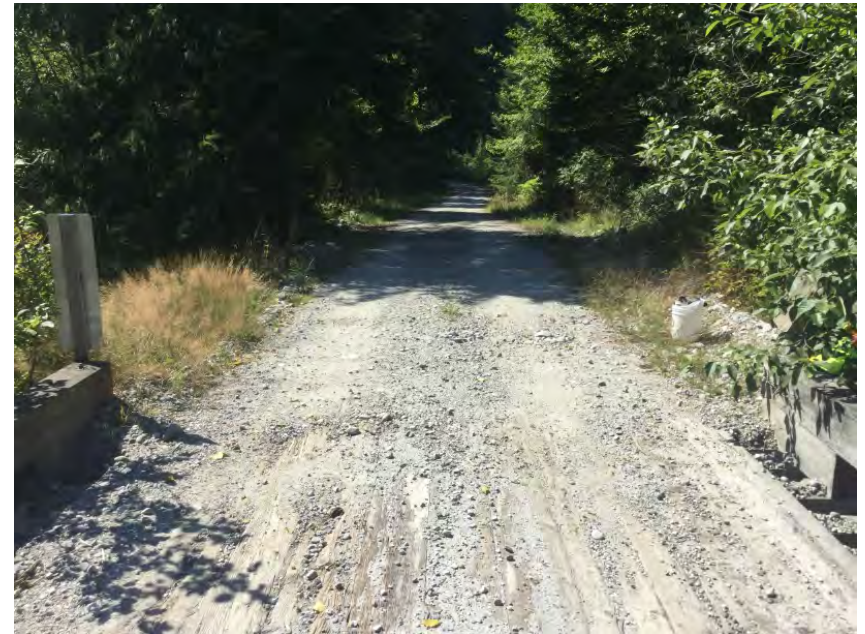
Right Approach Facing Away From Bridge

Fender Condition Fair Missing at downstream corner of right approach.

| Item | Priority | Repair Description |
|---|---|---|
| 3 | Medium | Install fender at right approach downstream corner. Install bridge ahead signs. |

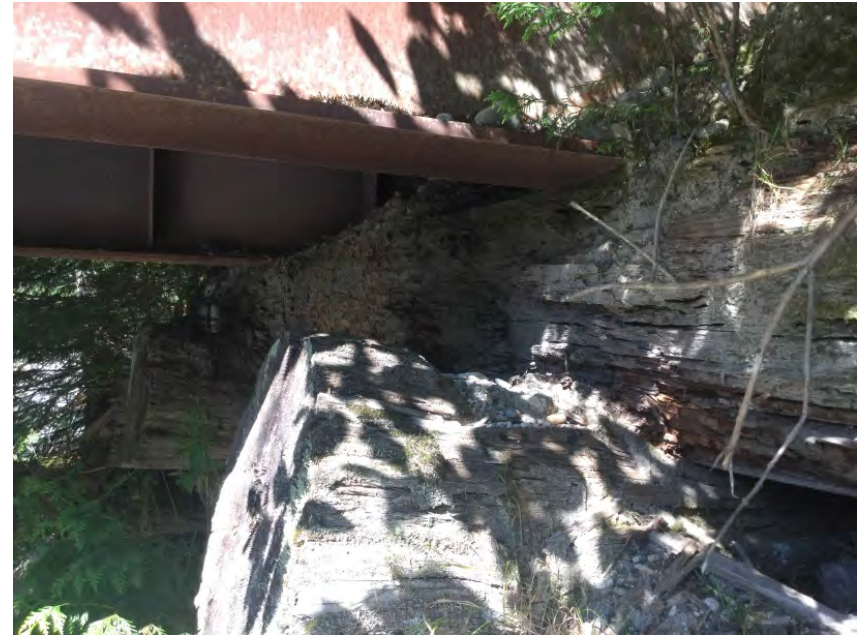
Log/Timber Cribs Poor Significant sap rot (&gt;100mm ) and end rot in logs. Could not identify reported crushing at L/B. Too much sap rot to see crushing at R/B.

Left Abutment Top Crib Log

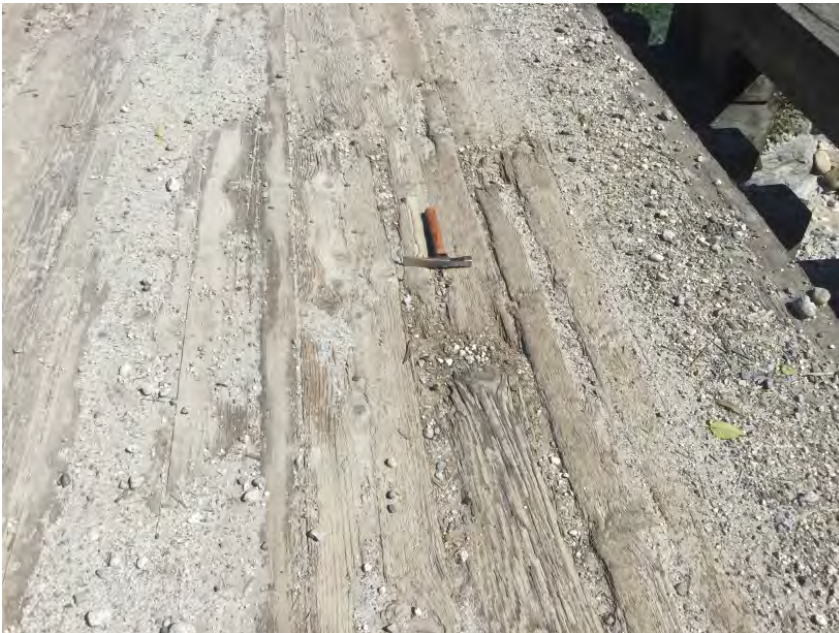
Span 2 Heavily Worn Deck

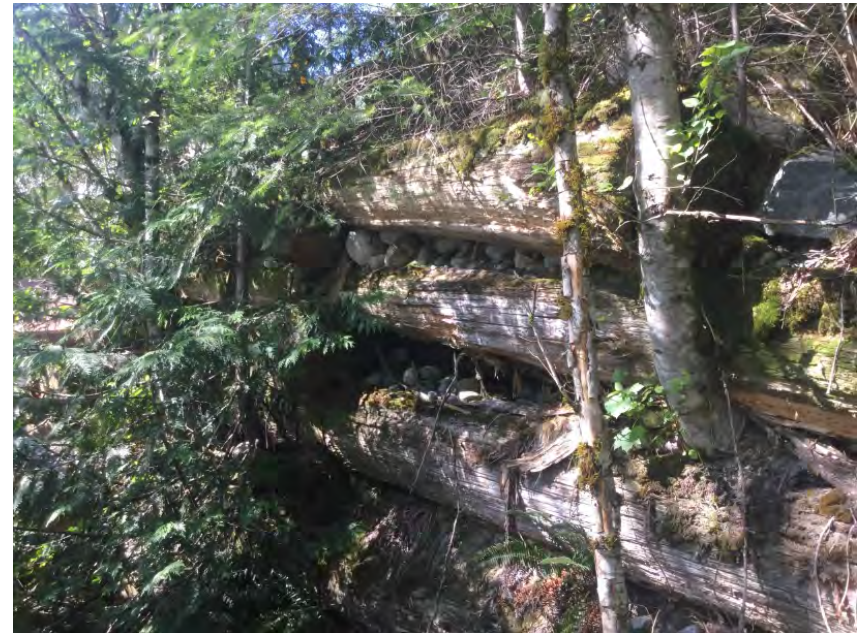
Wing Wall Poor Significant heart rot with some sap rot. Trees growing out of wing wall. Possible slumping.

Left Abutment Downstream Wing Wall

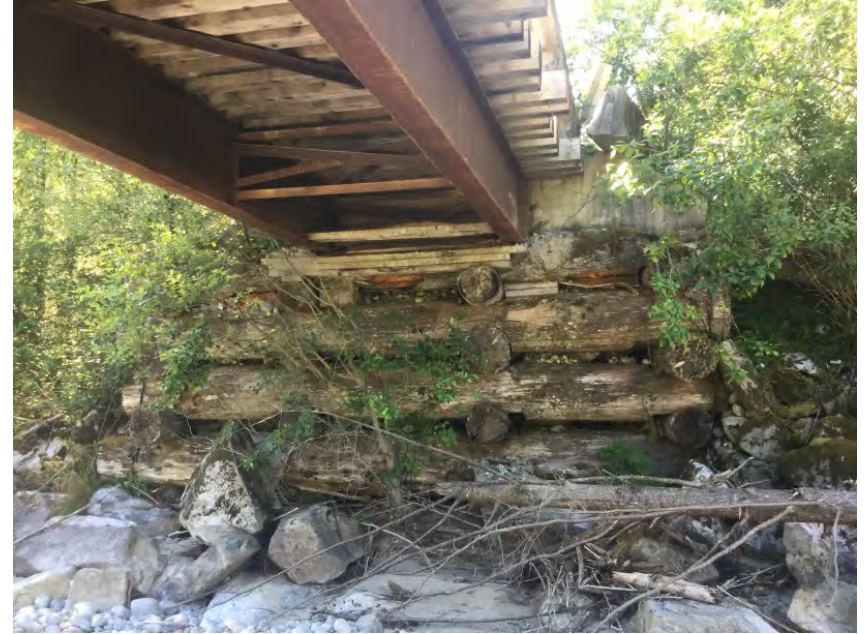
Right Bank Abutment

Ballast Wall Fair Concrete ballast wall at right abutment. Ballast wall logs at left abutment.

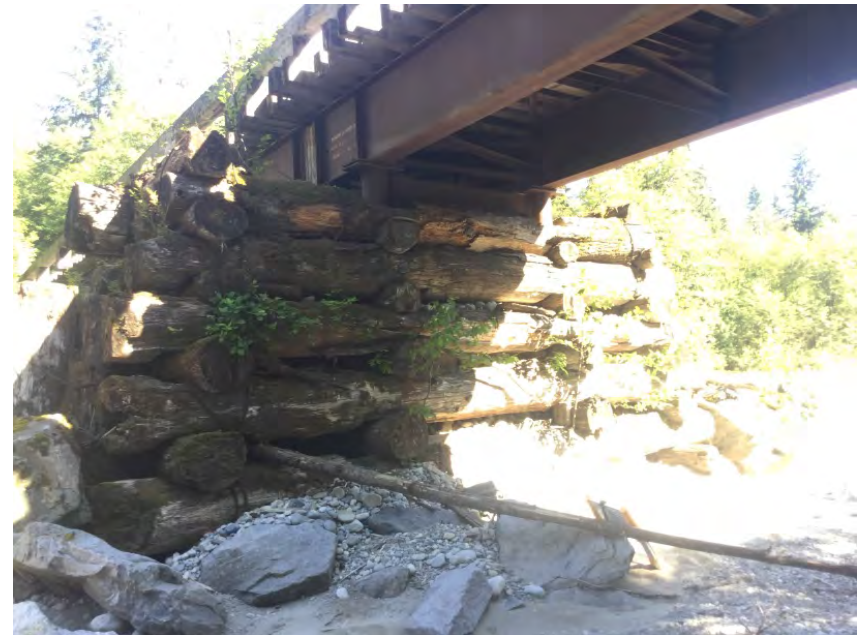
Pier Right Face

Bridge is in poor condition and currently rated for 30 tonnes, but no load posting sign in place. Limited access to all substructure components. Previous inspection noted crushing of top logs, this was not identified, likely due to amount of sap rot. Pier is in poor condition. Bug infestation of top pier log for span 2. 50 mm sap rot with some end rot noted. Trees growing out of pier. Previously noted upstream to downstream slope of deck could not be identified. Steel plate between posts at pier almost level. Deck is in poor condition due to deterioration of span 1 guardrail and span 2 wearing planks. Ties are also starting to rot. Structure requires replacement. Undated user km to 7.5 based on road km markings.

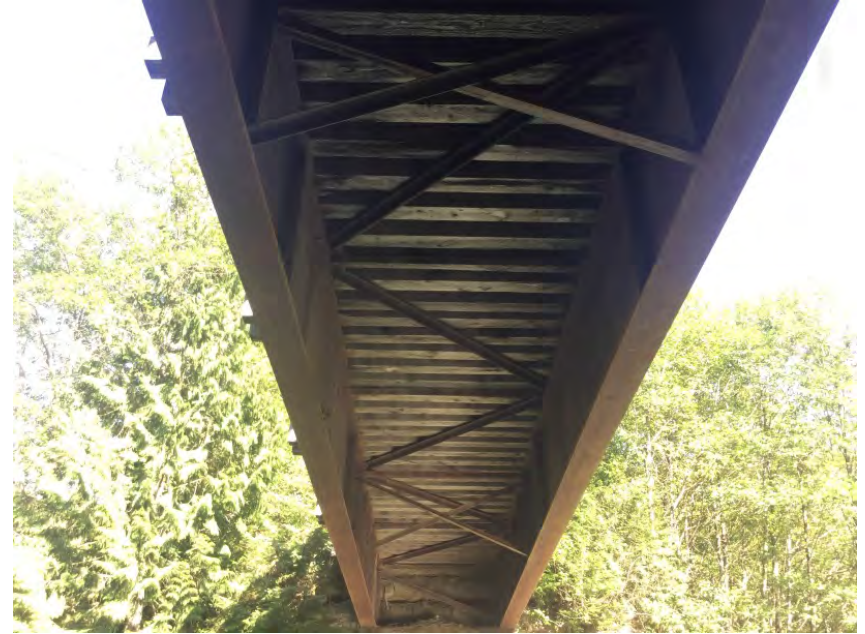
Girders Fair
