CK-2262

STAVE RIVER 10.5km

2016 Inspection

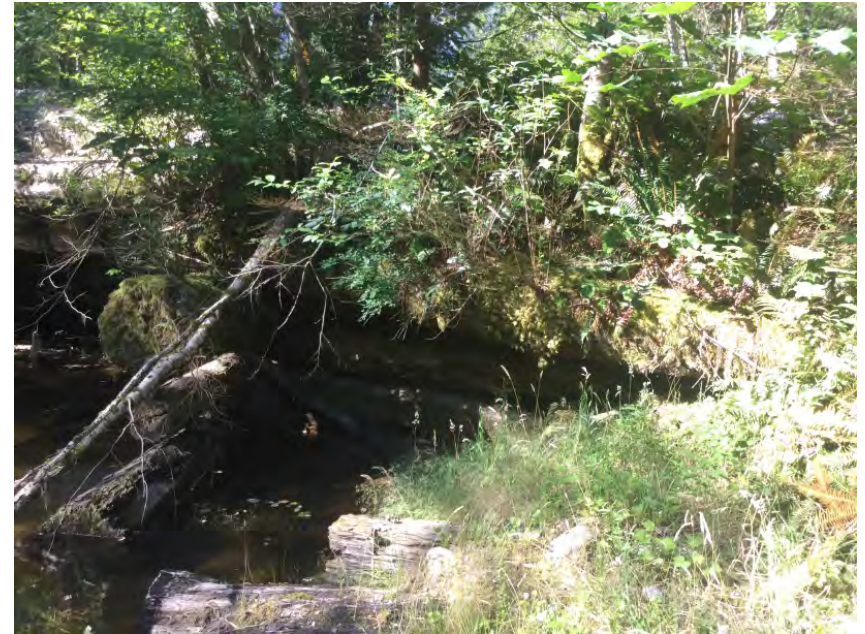
Comments Beaver dam built on gravel bar below bridge. Possible scour at left abutment upstream corner.

Possible Scour at Left Abutment Upstream Corner.

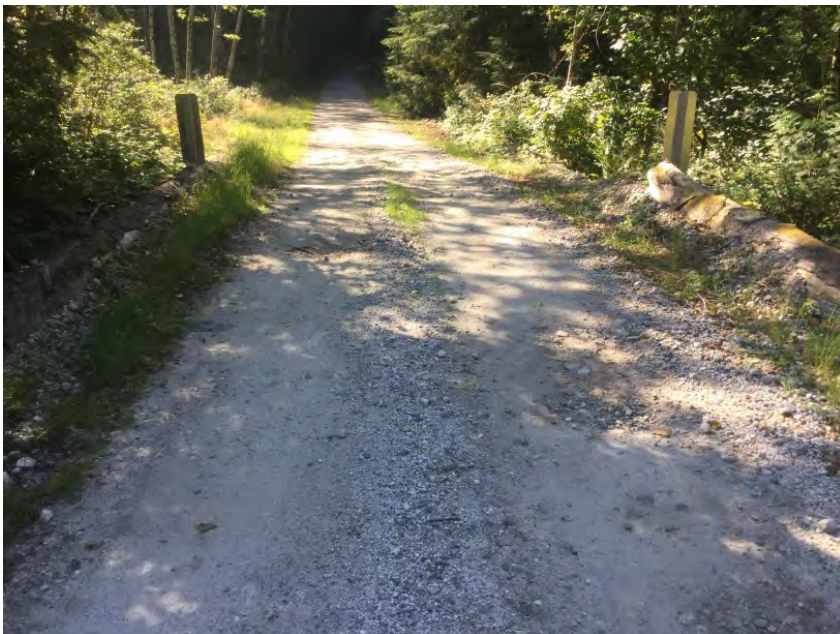
Deck

| Gravel Surface | Fair | Some potholes. |

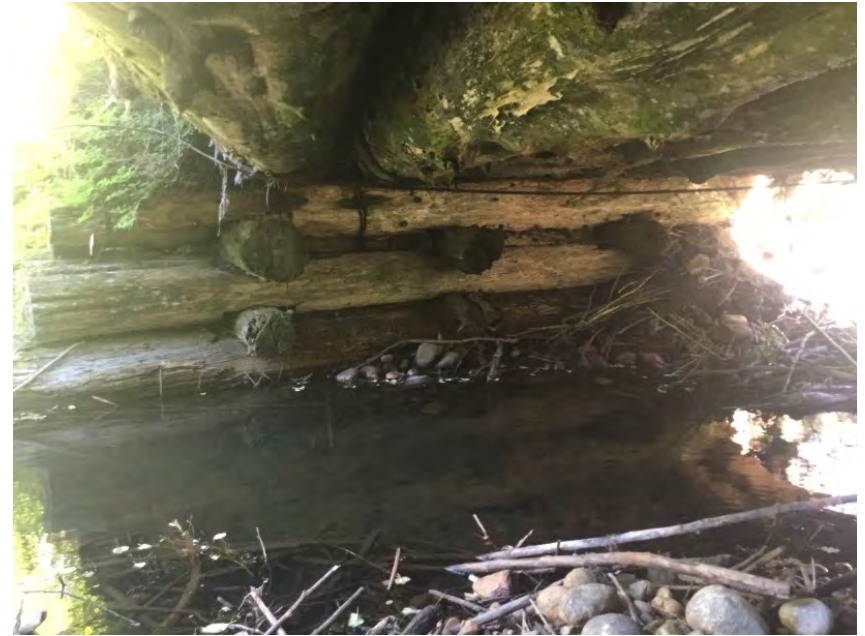
Right Bank Abutment

Fair to poor. Limited access due to water level. 30 mm sap rot. Vegetation growth at ends. No signs of crushing or distress.

50 mm sap rot. Large end splits. 2 tie backs with rotten ends. No signs of crushing or distress.

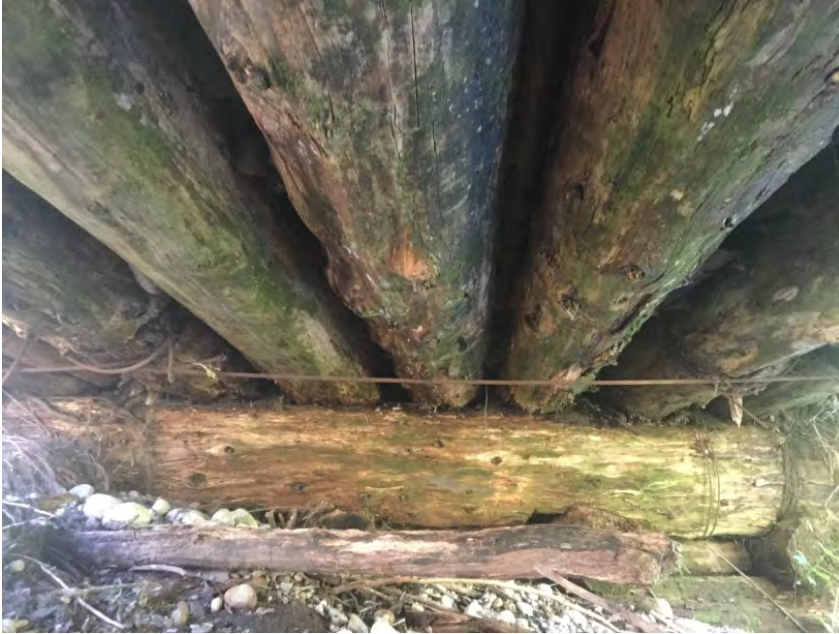
Stringers

Bridge has 2 layers of stringers. Bottom layer of stringers only accessible. The bridge is currently rated for 30 tonnes but no load posting sign is in place. Removal of gravel deck required to inspect top layer of stringers. A beaver dam has been build below the bridge. Limited access to abutments due to water depths. Error in App, subtract 1 for the actual stringer numbers. Updated user km to 9.4 based on road km markings.

| Item | Monitor Description | Frequency |
|---|---|---|
| 1 | Monitor deterioration of stringers and abutments. | Routine Inspection |

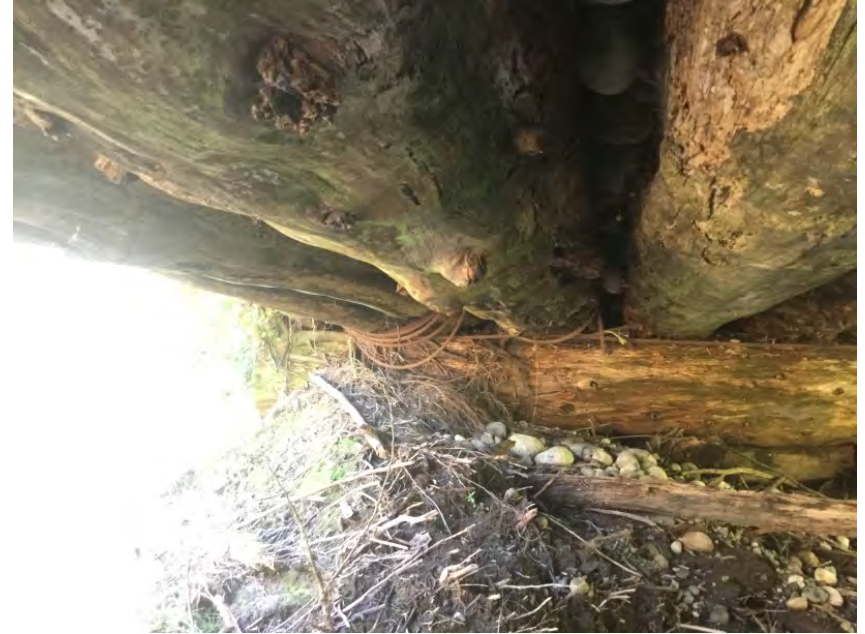
| 2 | Cw | Y | 640 | 0 | Fair | 20 sap rot. 2015 insp: 100 rot. |

Stringer 2 Knots

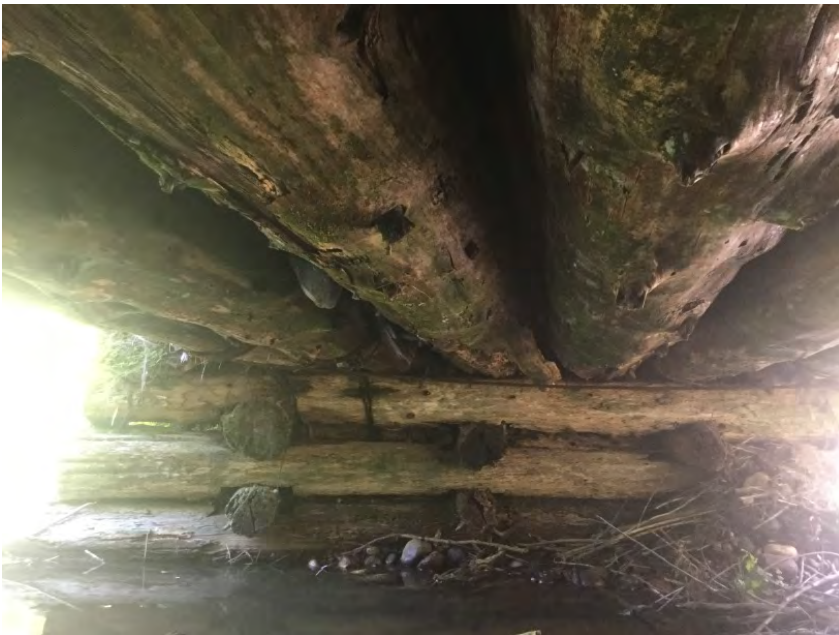
| 4 | Cw | Y | 650 | 0 | Fair | 35 sap rot. 2015 insp: 40 rot depth. |
| 5 | Cw | Y | 620 | 80 | Poor | Heart rot. Large knots. 2015: 250 heart rot. |
| 6 | Cw | Y | 520 | 0 | Fair | 25 sap rot. Lots knots. |

Stringers 6, 5 & 4 Knots
