CK-2263

STAVE RIVER 11.4km

2016 Inspection

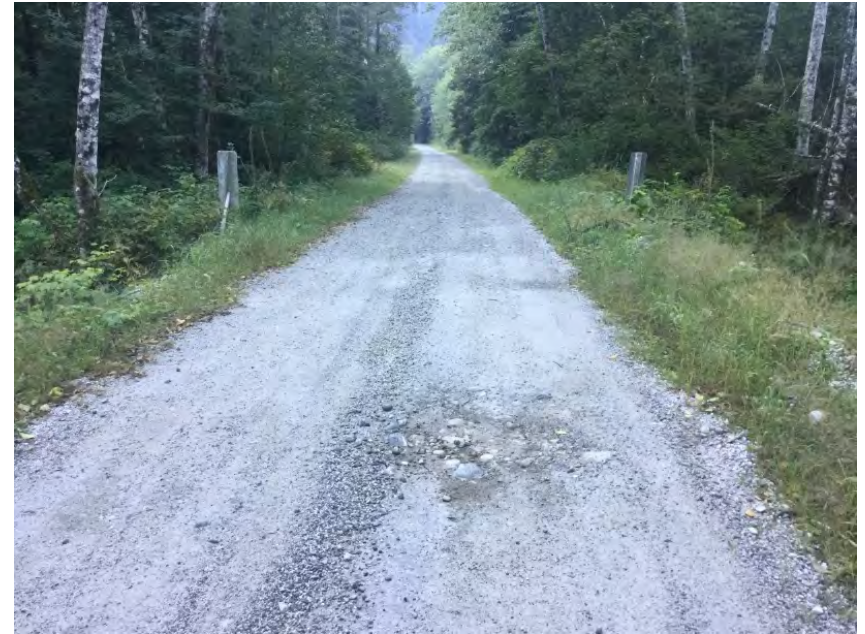
| Gravel Surface | Fair | Pothole in deck. |
| Overall Deck Condition | Poor | No curb logs. |

| Repair Item | Priority | Repair Description |
|---|---|---|
| 1 | High | Install curb logs, fenders, and load posting sign. |

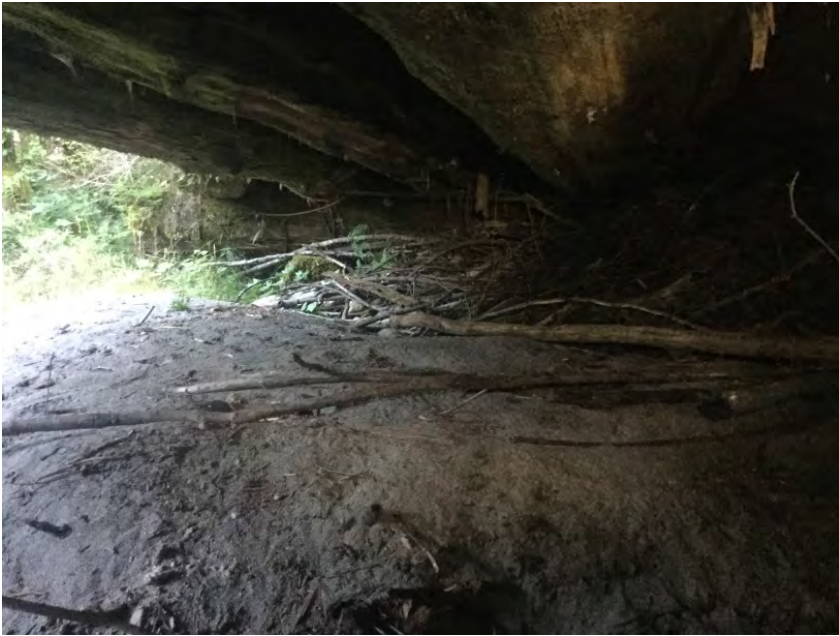
Right Bank Abutment

Comments Gravel bar formed under bridge with beaver dam built on top. Some scour at the right abutment upstream corner. Debris upstream.

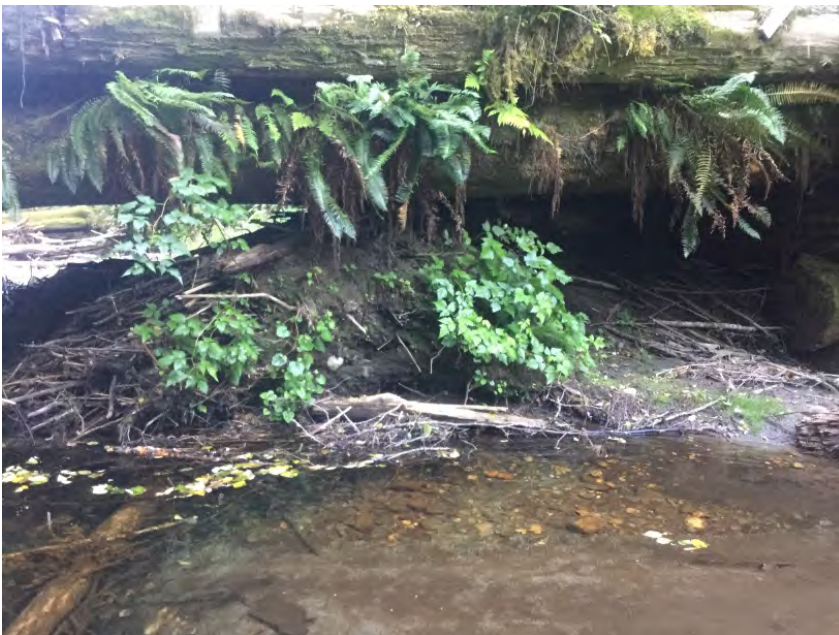
Beaver Dam

| Repair Item | Priority | Repair Description |
|---|---|---|
| 3 | Medium | Install bridge ahead signs. Remove beaver dam. |

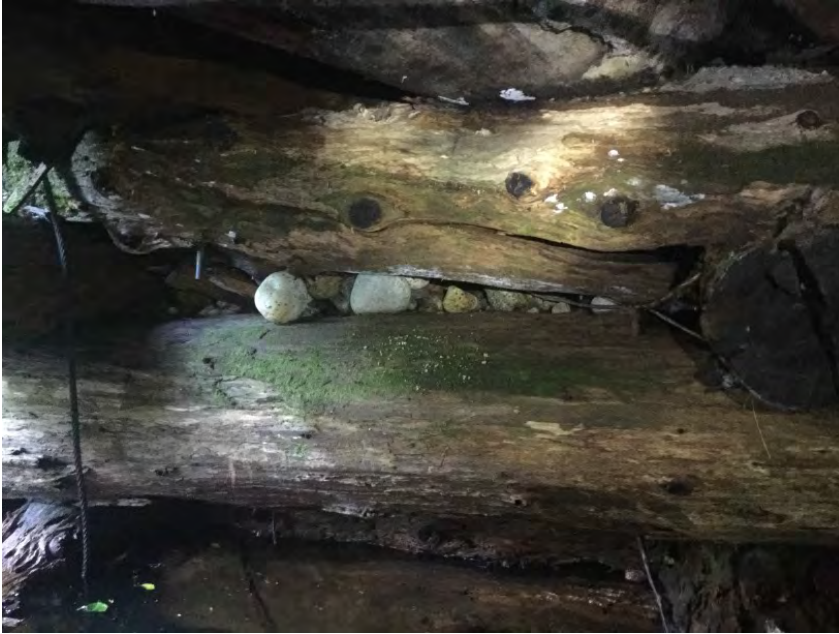
Log/Timber Cribs Poor Top log at left abutment upstream corner has split. 40 mm sap rot, some end rot outside of bearing area. Left abutment settled 600 mm to upstream side.

Left Abutment Split Crib Log

The entire structure is in poor condition. Limit loading to 10 tonnes, post load rating signs. Replace missing curb and fender logs immediately. Replace structure soon.

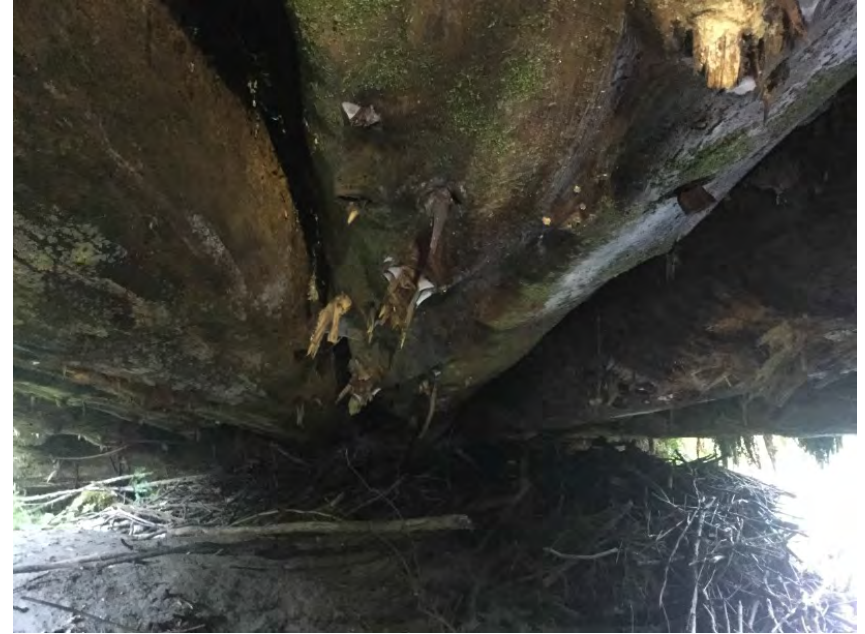
| Stringer<br>Number | Species | Peeled | Diameter<br>(mm) | Rot Depth<br>(mm) | Condition | Comment |
|---|---|---|---|---|---|---|
| 3 | Fd | Y | 920 | 0 | Fair | No sap rot. Fungus. 2015 insp: 30 rot. |

Stringer 3 Lots Knots

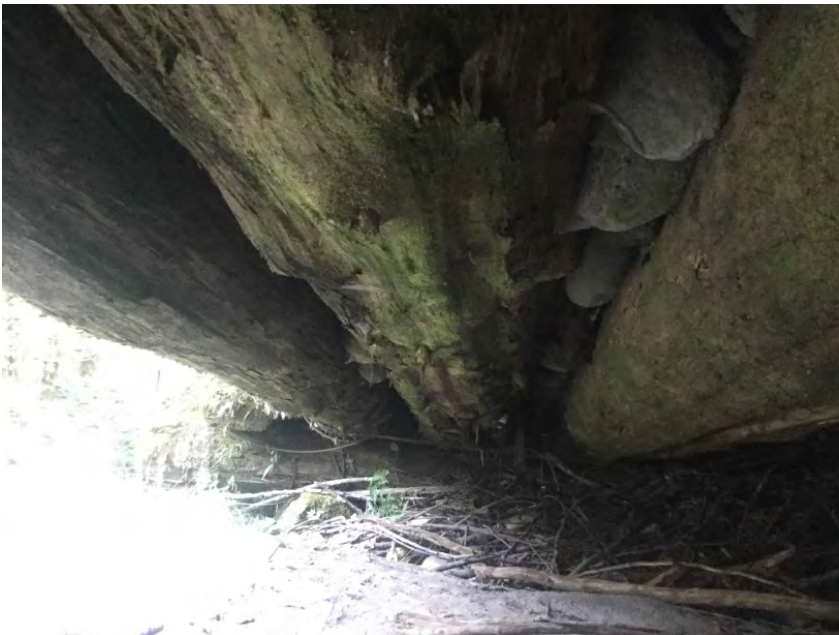
| Stringer<br>Number | Species | Peeled | Diameter<br>(mm) | Rot Depth<br>(mm) | Condition | Comment |
|---|---|---|---|---|---|---|
| 5 | Cw | Y | 930 | 0 | Fair | 30 sap rot. Limited access. 2015 insp: 50 rot. |

Stringer 5 Lots of Knots

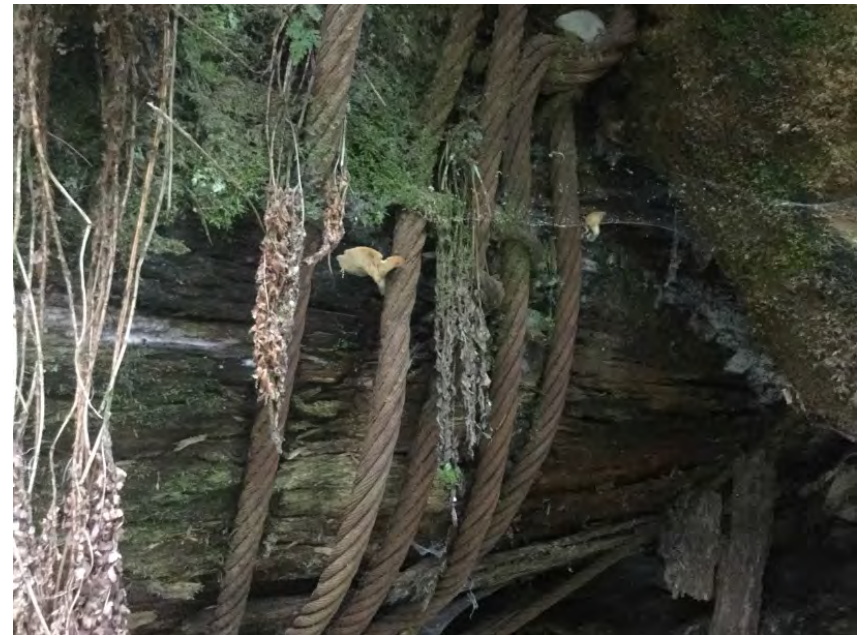
Stringer 1 Small Fungal Growth

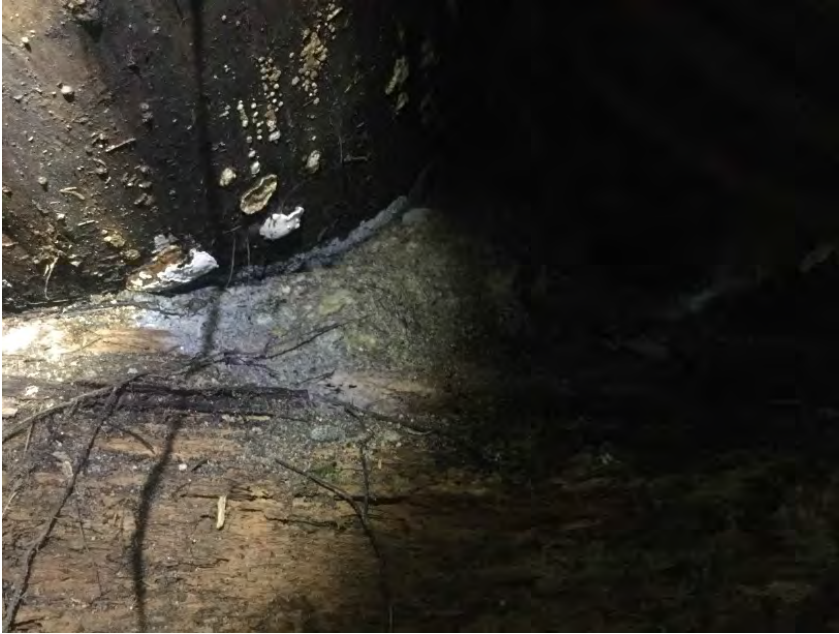
| Stringer<br>Number | Species | Peeled | Diameter<br>(mm) | Rot Depth<br>(mm) | Condition | Comment |
|---|---|---|---|---|---|---|
| 2 | Cw | Y | 760 | 0 | Fair | 20 sap rot. Knots. Fungus. 2015 insp: 40 rot. |

Stringer 2 Fungal Growth

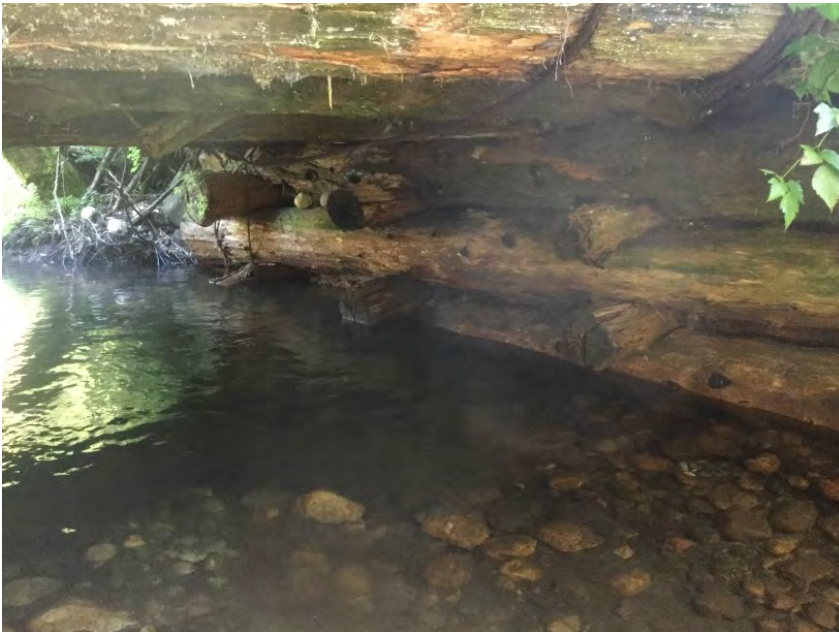
Left Abutment Note Slope of Logs

| Item | Monitor Description | Frequency |
|---|---|---|
| 1 | Monitor abutments until replacement. | Anually |
