CK-2264

STAVE RIVER 13km

2016 Inspection

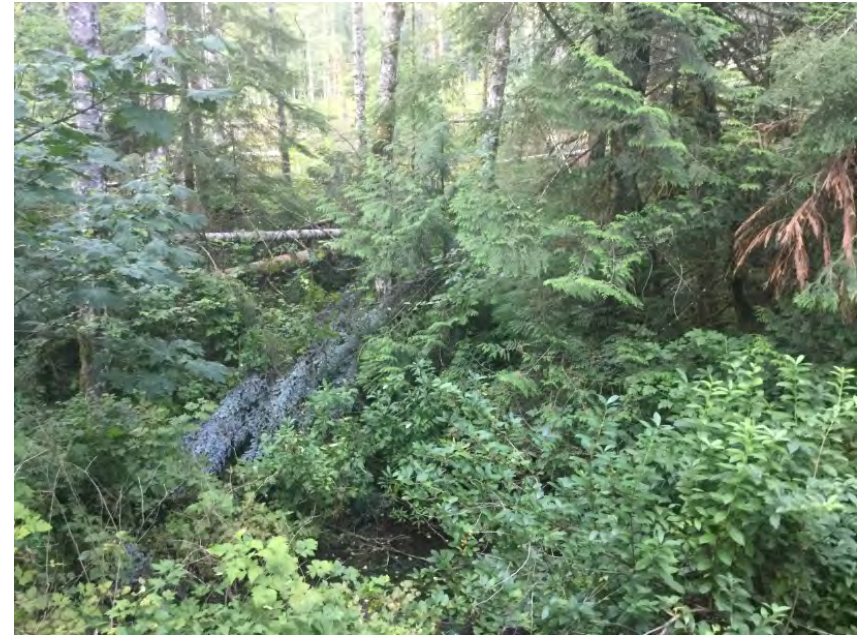
Looking Upstream

Comments    Lots of blow down upstream, fallen trees in creek.

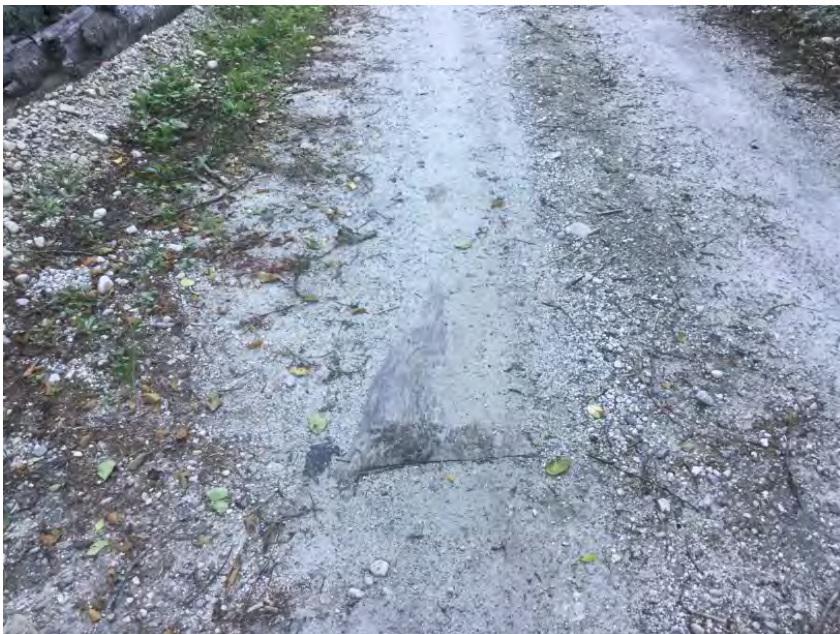
| Gravel Surface | Good | 200 mm deep gravel at left abutment, limited gravel at right abutment, stringer exposed. |

Right Abutment Top of Stringer Exposed

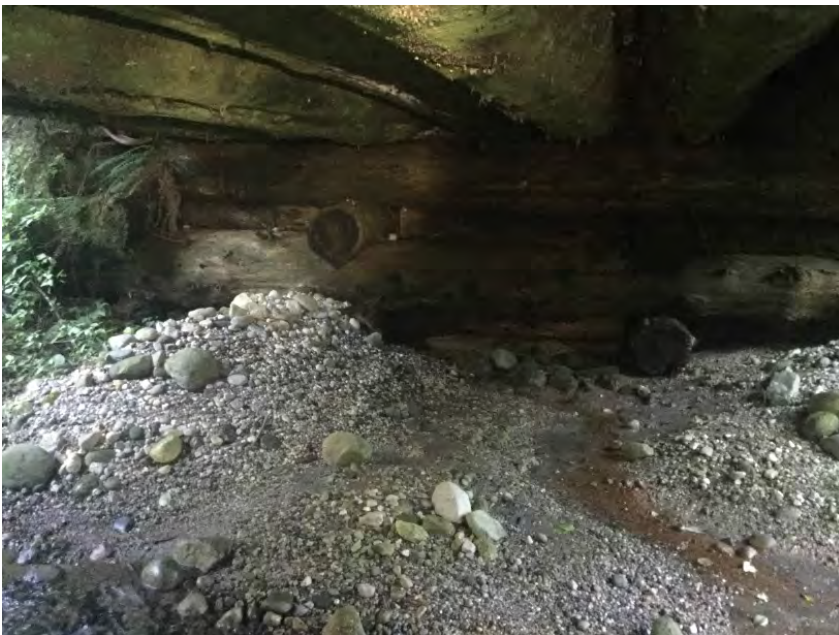
Left Bank Abutment

Tie Backs Fair Moss growth typical. 40 mm sap rot. End of left abutment upstream tie back rotten. No crushing or distress noted.

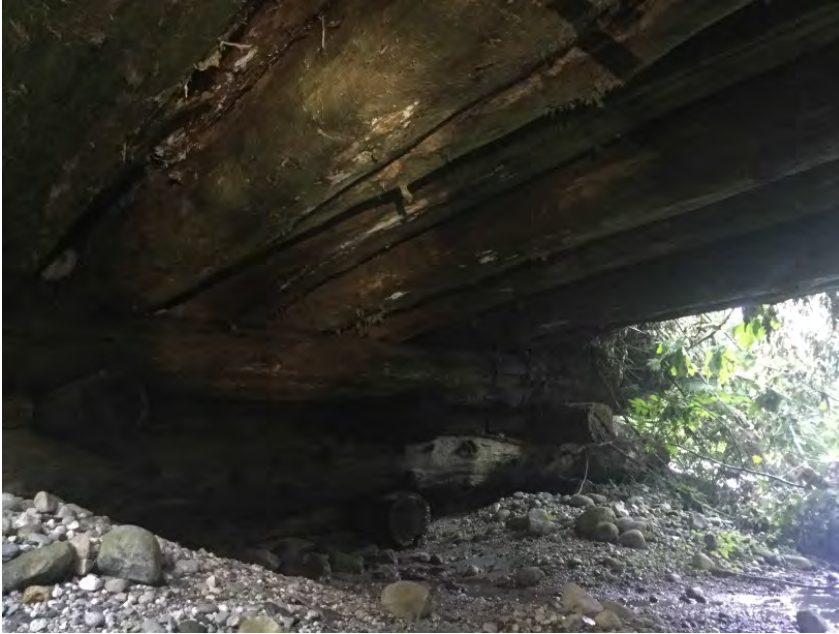
Stringers

Bridge has 2 layers of stringers. Only bottom layer accessible, which consists of 8 stringers. Previous inspection only recorded 7 stringers. Bridge location was verified by gps and looking at previous inspection photos. Bridge currently load rated for 30 tonnes, but no posting sign in place. Inspection of top layer of stringers required. Error in App subtract 1 for actual stringer numbers. Updated user km to 11.9 based on road km markings.

| 2 | Cw | Y | 460 | 90 | Poor | Heart rot. 15 sap rot. 2015 insp: 50 rot depth. |
| 8 | Cw | Y | 570 | 0 | Poor | 35 sap rot. Lots knots. 2015 insp: 120 rot |

| Item | Priority | Repair Description |
|---|---|---|
| 1 | High | Remove gravel deck to inspect top layer of stringers. |

| Item | Monitor Description | Frequency |
|---|---|---|
| 1 | Monitor deterioration of stringers and cribs. | Routine Inspection |
