CK-2265

STAVE RIVER 13.2km

2016 Inspection

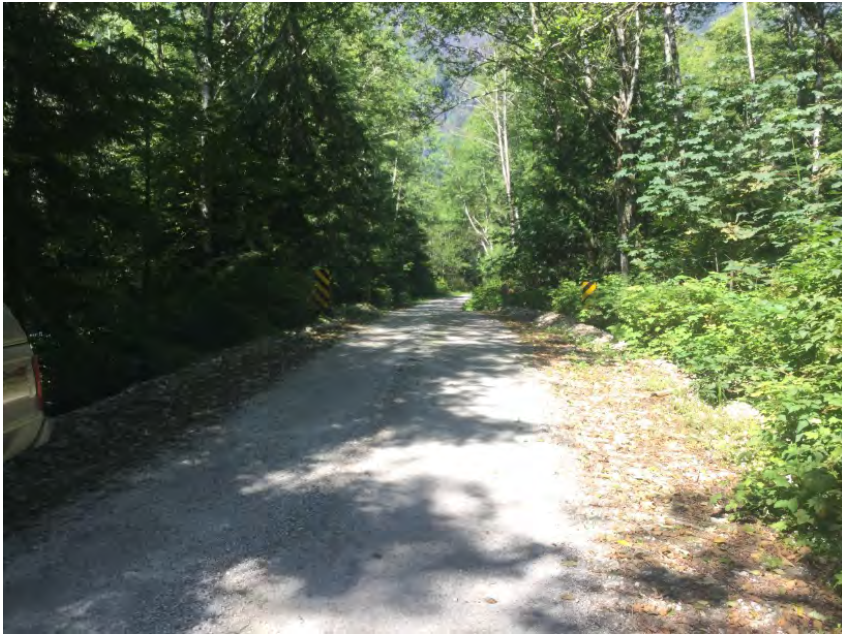
Left Approach Facing Bridge

Bridge Ahead Signs  
Missing ☐ 0 ☐ 1 ☒ 2

Brushing Required Y Vegetation starting to obscure delineators.

Posted Load Rating No posting sign.

| Item | Priority | Repair Description |
|---|---|---|
| 2 | High | Post load posting sign. |
| 3 | Medium | Clear debris from log curbs. Install bridge ahead signs. |

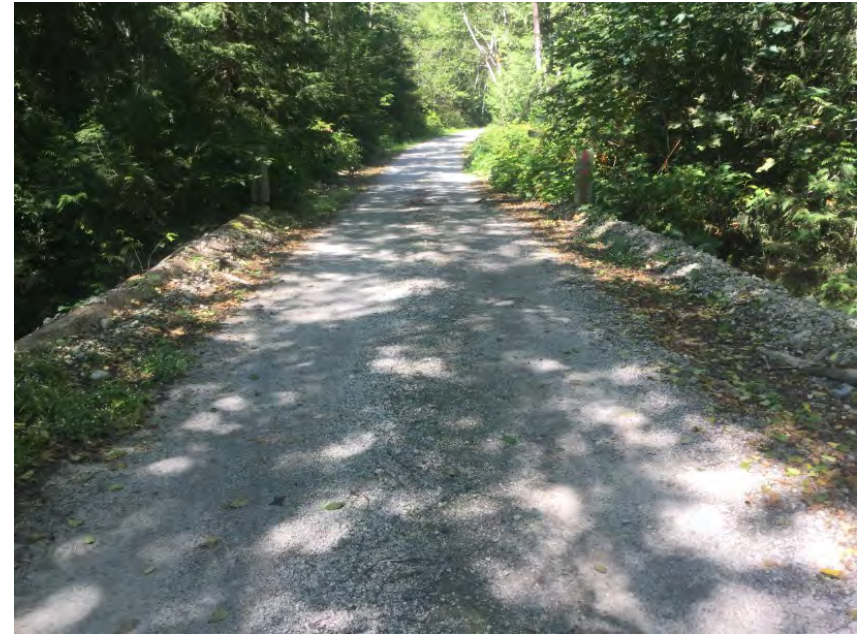
Deck

| Gravel Surface | Good | Top of stinger exposed at left abutment in centre of road. |

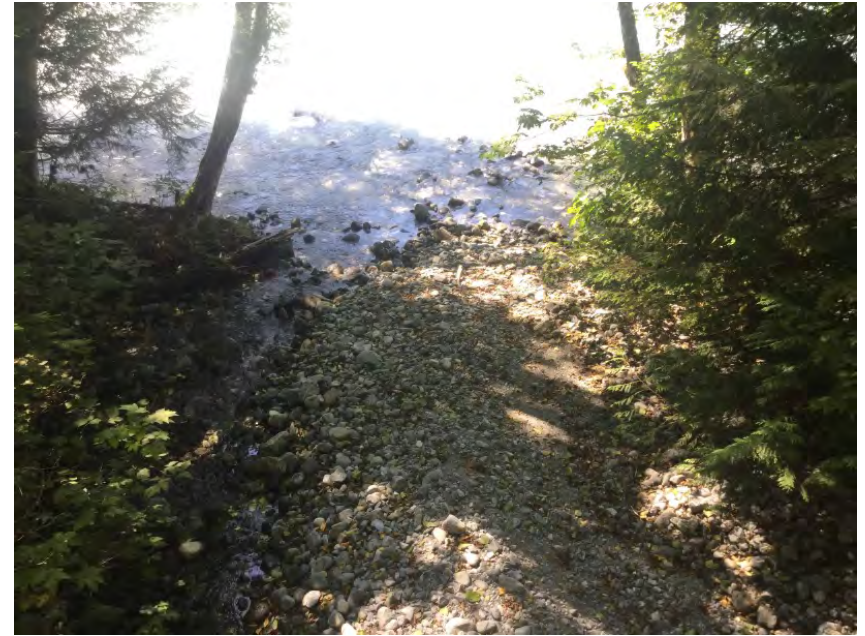
Looking Downstream

Comments Build up of gravel bar upstream and under bridge. Opening reduced to 1.1 m at right abutment.

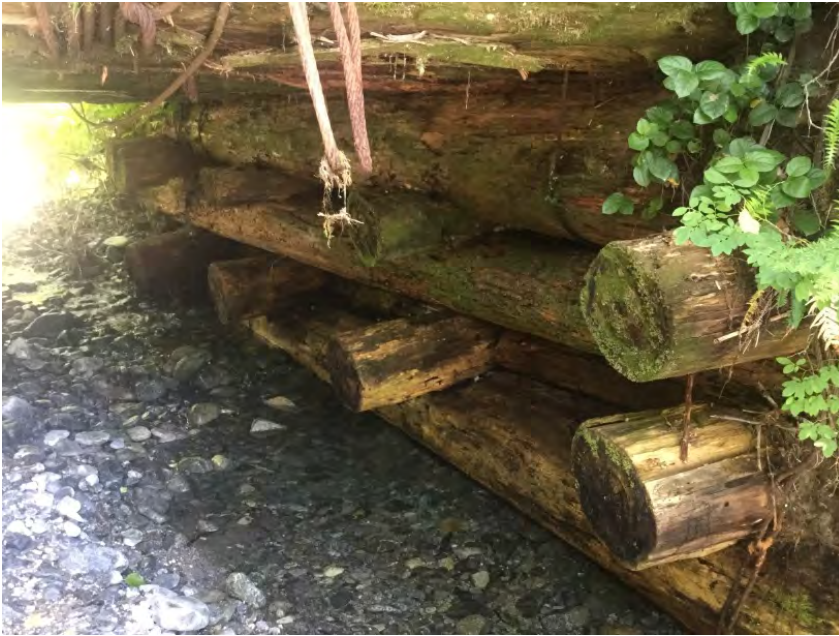
Left Bank Abutment

Log/Timber Cribs Fair Typically 20 mm sap rot. Some end rot outside of bearing area. No crushing or distress noted.

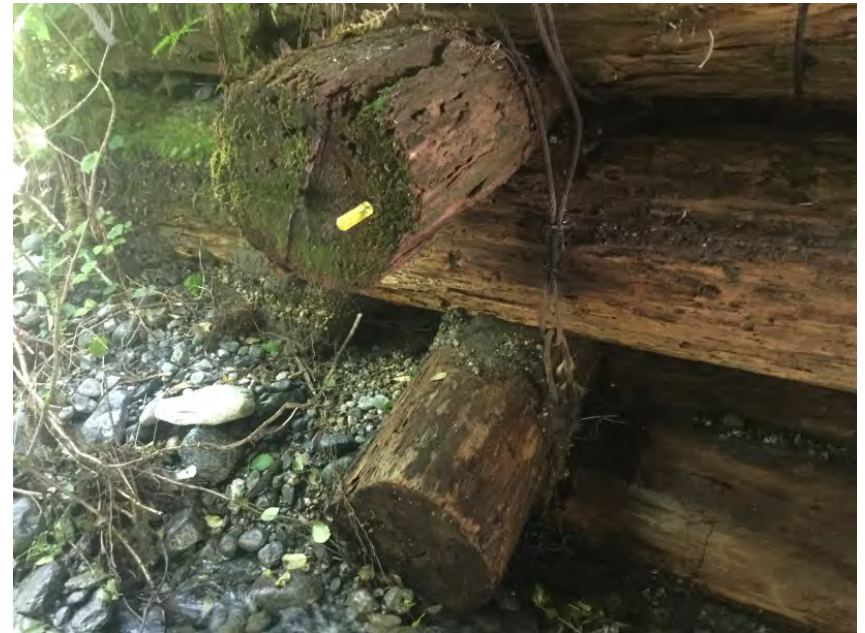
Tie Backs Fair Fair to poor condition. 40 mm sap rot with notable end rot. Tie backs typically saturated. No crushing or distress noted.

Tie Backs

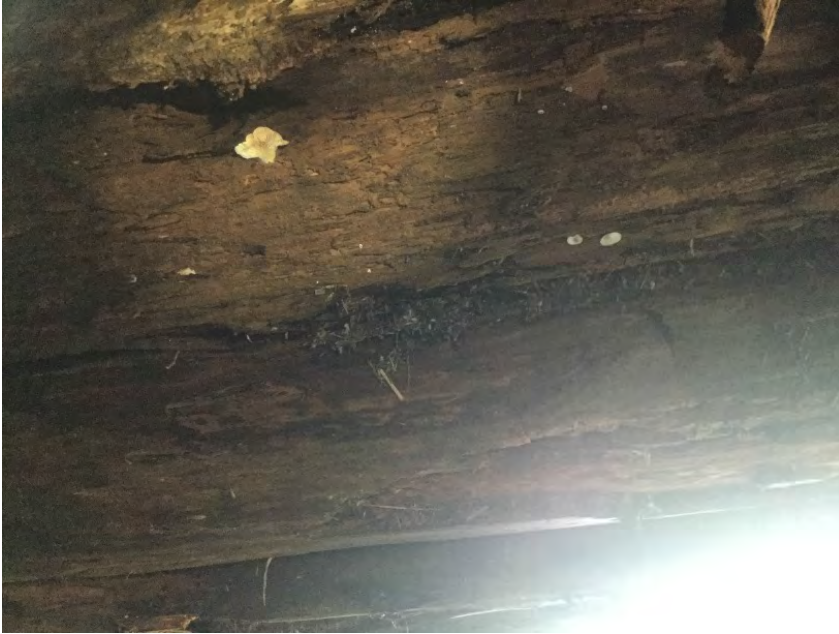
| 7 | Cw | Y | 700 | 0 | Poor | 25 sap rot. Large knots. Small conk. |

Stringer 6 Small Conks

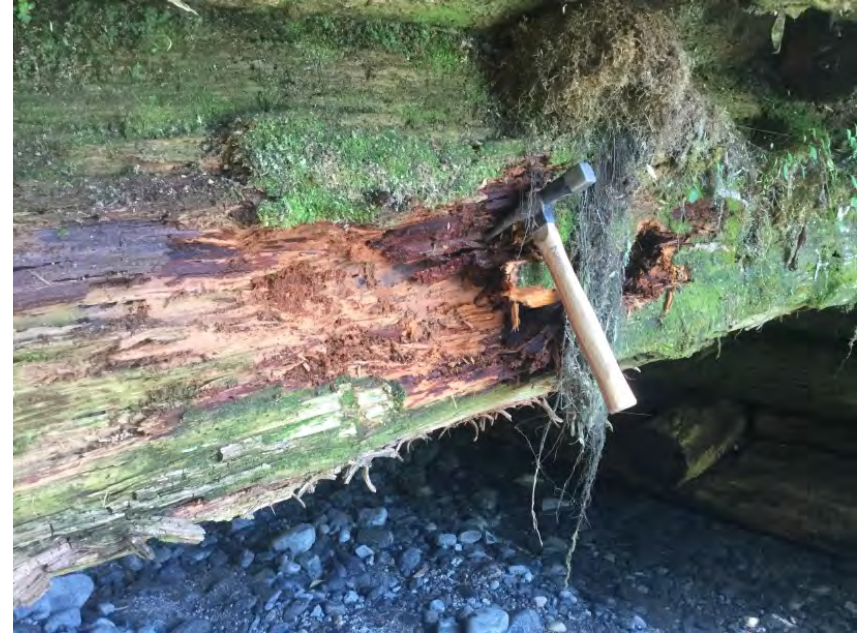
| 8 | Cw | Y | 610 | 0 | Poor | 120 sap rot @ mid span. Bug infestation. |

Stringer 7 Midspan Sap Rot & Bug Infestation

| Item | Monitor Description | Frequency |
|---|---|---|
| 1 | Monitor deterioration of bottom layer of stringers. | Routine Inspection |

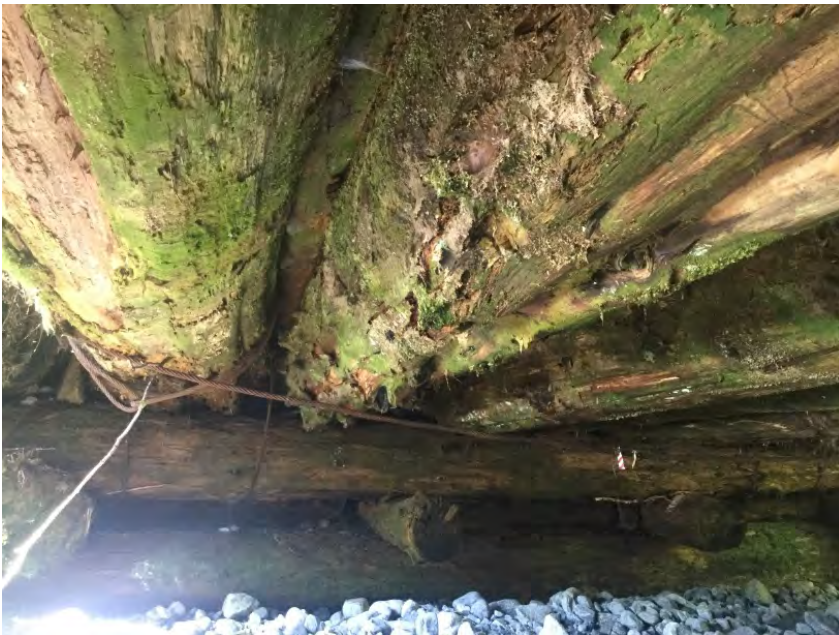
Stringer 6 Knots

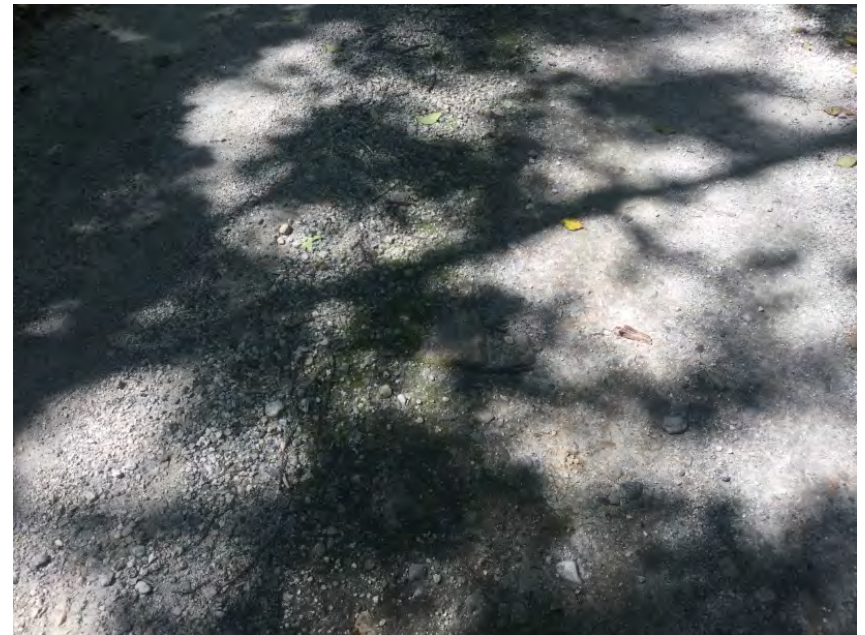
Left Abutment Exposed Stinger in Centre of Road

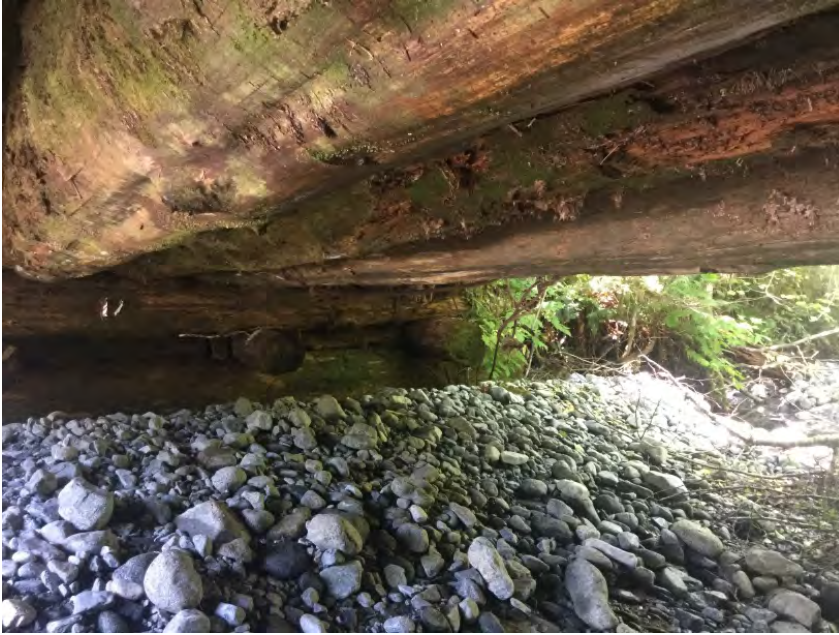
Bridge has 2 layers of stringers. Only bottom layer accessible. Stringers have continued to deteriorate since previous inspection. Currently load rated for 30 tonnes, but no posting sign in place. Inspection of top layer of stringers required. Error in App, subtract 1 for actual stringer numbers. Updated user km to 12 based on road km markings.

The structure has 2 layers of stringers and only the bottom layer can be properly assessed. The top layer of stringers were added in 2012 as a temporary measure to facilitate works at the time. The original structure was constructed in 1988 (29 years old) and is in relatively poor condition. The top layer of stringers have not properly assessed since the installation; and as such I recommend the primary road user to remove the gravel deck to expose these stringers and to complete an inspection of them prior to the 2017 inspections being completed (please contact the Ministry on when the inspection of the top layer of stringers is anticipated). Limit loading to 10 tonnes at this point. Post load rating sign and plan for a complete replacement soon.

| Item | Priority | Repair Description |
|---|---|---|
| 1 | High | Remove gravel deck to inspect top layer of stringers. Account for deterioration of bottom layer of stringers in load rating. |

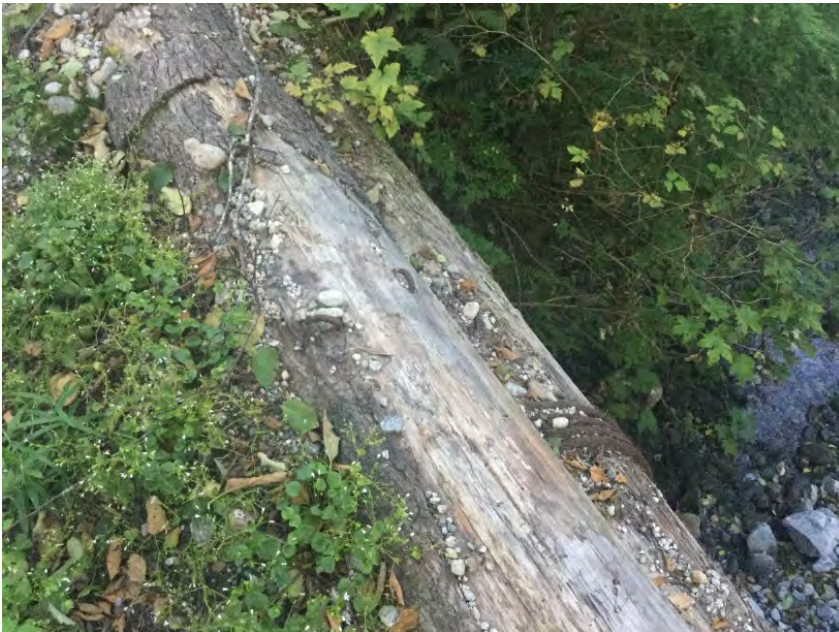
Hardware Poor Deck hardware: missing log curb lashing.

| Hardware | Fair | Abutment hardware: loose at left abutment downstream corner. |

Missing Log Curb Lashing Left Abutment Downstream Corner.
