CK-2266

STAVE RIVER 16.8km

2016 Inspection

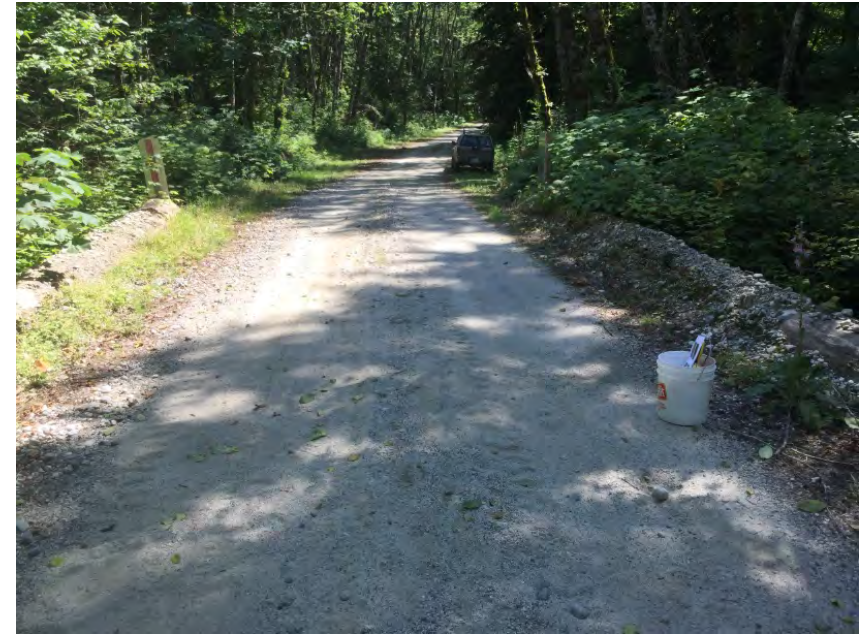
Deck

| Gravel Surface | Fair | Stringer exposed at left abutment. |

| Item | Priority | Repair Description |
|---|---|---|
| 1 | High | Remove gravel deck to facilitate inspection of top layer of stringers. |

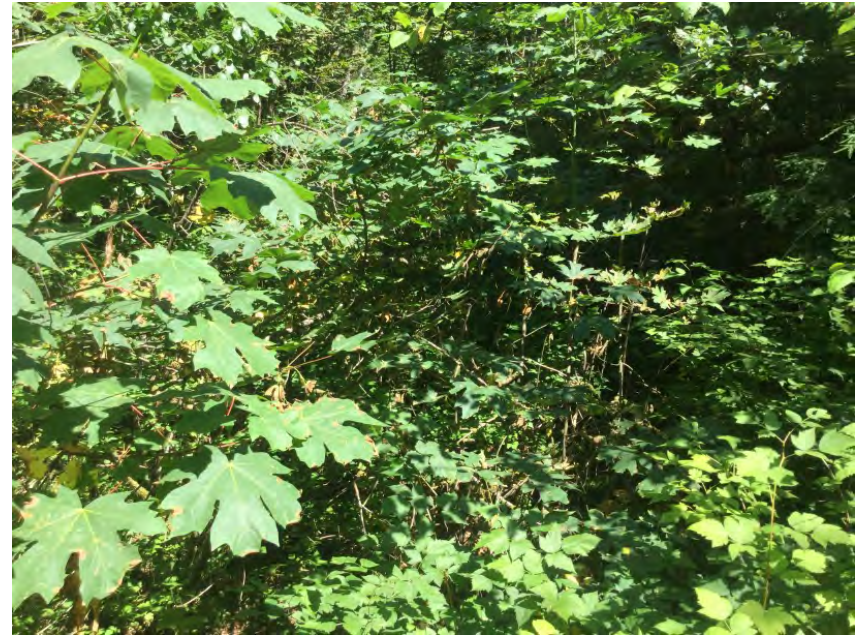
Looking Upstream

Comments Dry crossing with 900 mm opening and ~1500 mm deep sump upstream.

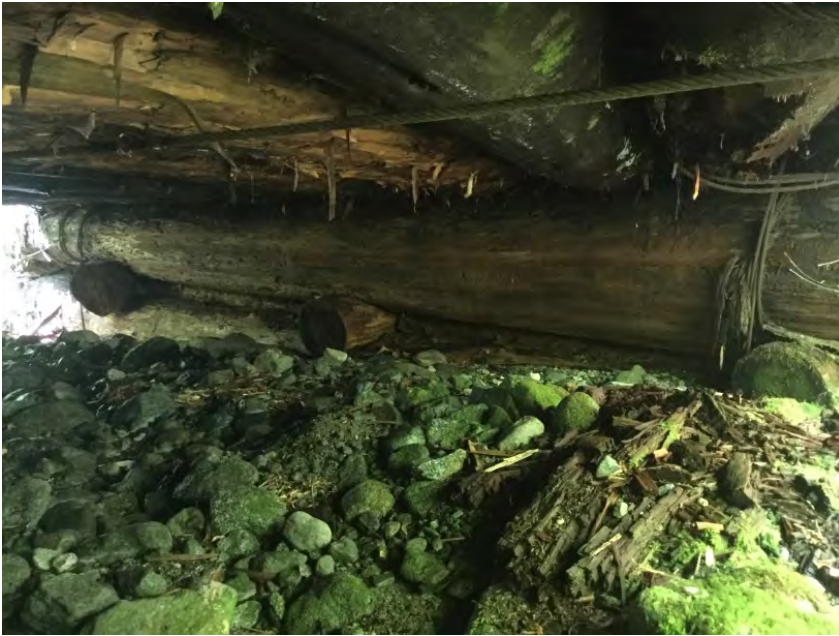
Right Bank Abutment

Log/Timber Cribs Fair Two logs at each abutment. Up to 40 mm sap rot.

Tie Backs Fair Three per abutment. Typical end splits and minor end rot.

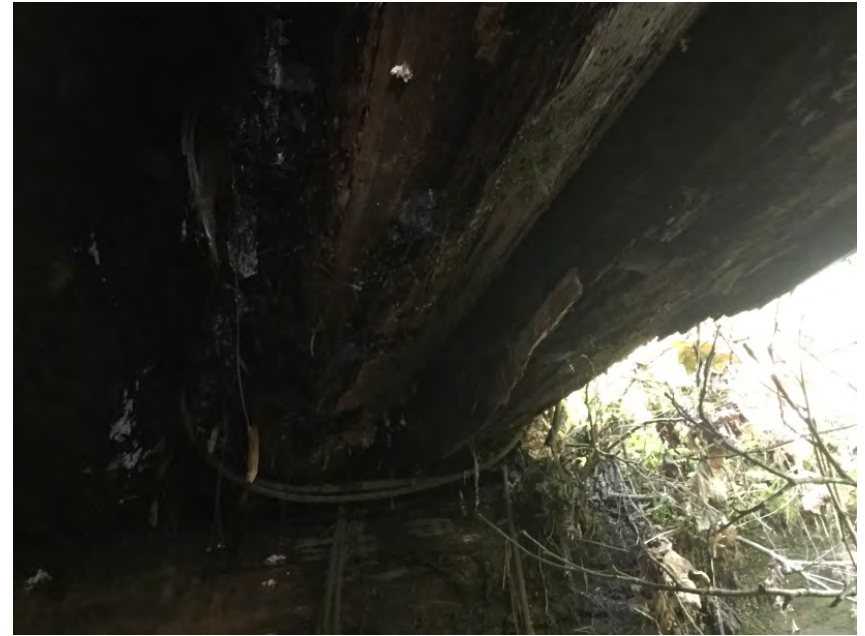
| Stringer<br>Number | Species | Peeled | Diameter<br>(mm) | Rot Depth<br>(mm) | Condition | Comment |
|---|---|---|---|---|---|---|
| 2 | Fd | Y | 480 | 130 | Poor | Conks. 220 sap rot. 2015 insp: 240 rot depth. |

Stringer 1 & 2 Rot

| Item | Monitor Description | Frequency |
|---|---|---|
| 1 | Monitor deterioration on bottom layer of stringers. | Routine Inspection |

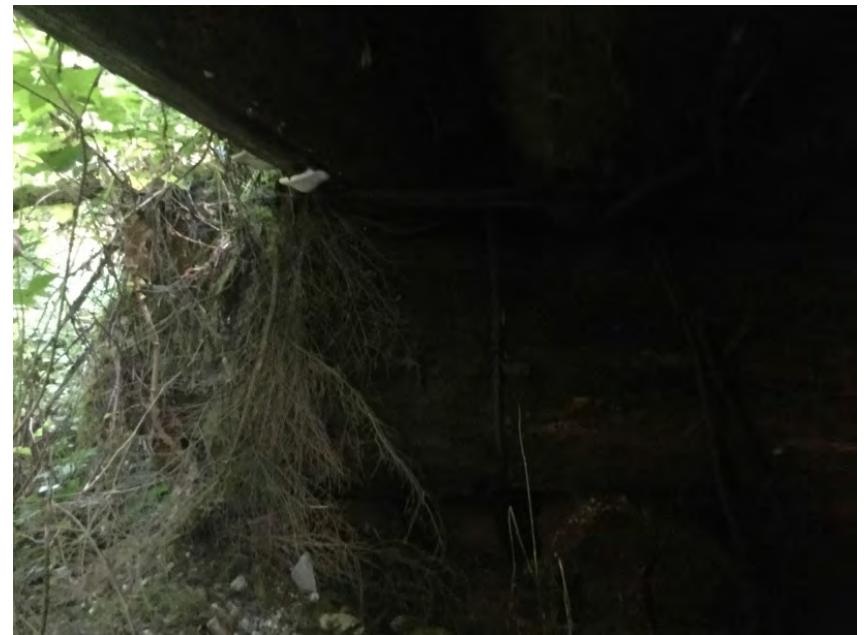
Stringer 1 Conk

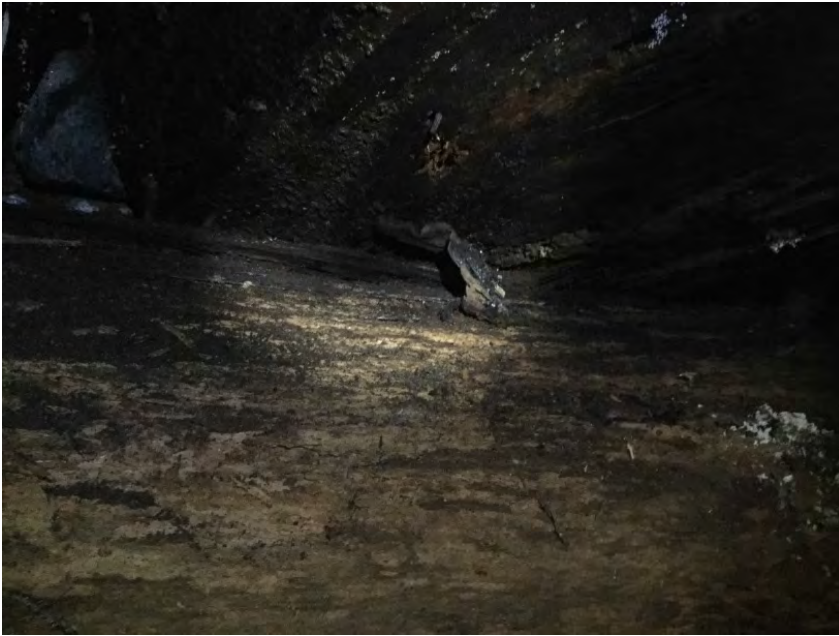
Stringer 8 Conk

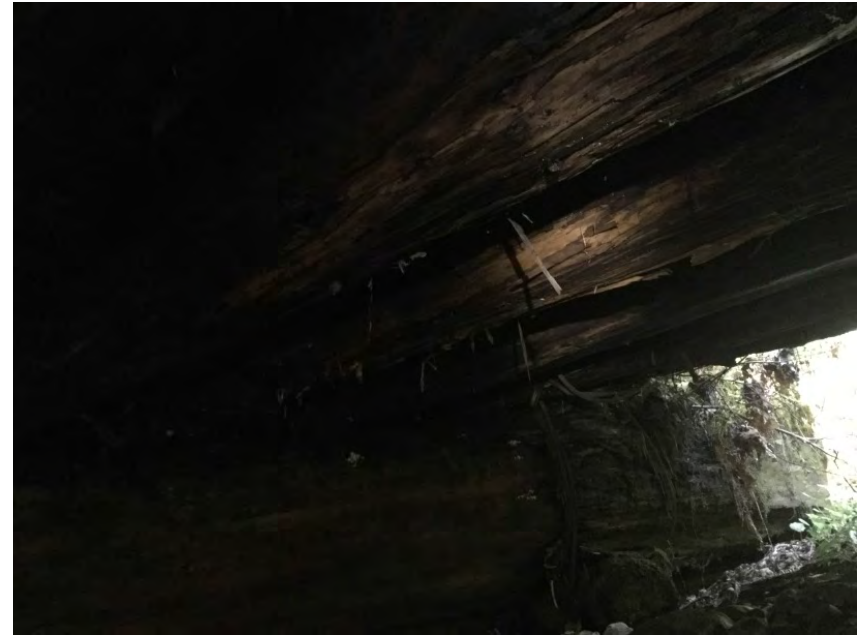
Stringers

Bridge has 2 layers of stringers, only bottom layer are accessible. Dry crossing with 900 mm opening and ~1500 mm sump upstream. Current load rating of 30 tonnes based on unknown condition of top layer of stringers, but no load posting sign in place. Updated user km to 15.8 based on road km markings. Error in App, subtract 1 for actual stringer number.

The structure has 2 layers of stringers and only the bottom layer can be properly assessed. The top layer of stringers were added in 2012 as a temporary measure to facilitate works at the time. The original structure is in relatively poor condition. The top layer of stringers have not been properly assessed since the installation; and as such I recommend the primary road user to remove the gravel deck to expose these stringers and to complete an inspection of them prior to the 2017 inspections being completed (please contact the Ministry on when the inspection of the top layer of stringers is anticipated). The present load rating of 30 tonnes can continue. Post load rating sign and plan for a complete replacement soon.

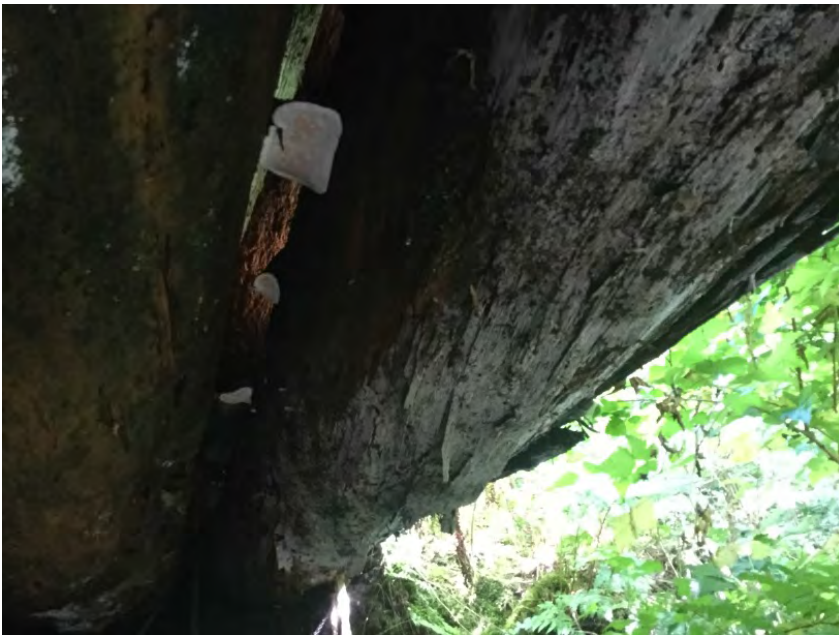
Stringer 11 Conk

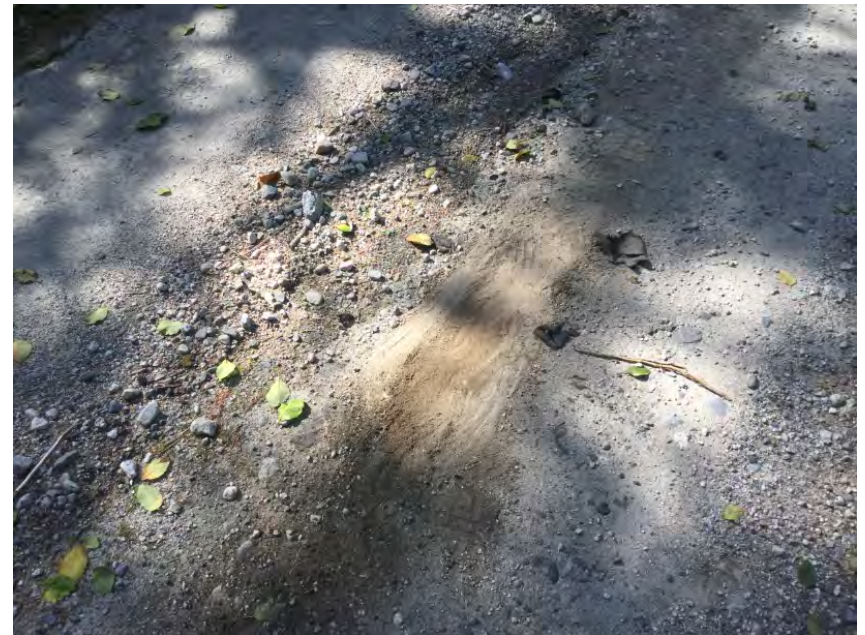
Stringer Protruding Through Deck at Left Abutment
