CK-2267

STAVE RIVER 19km

2016 Inspection

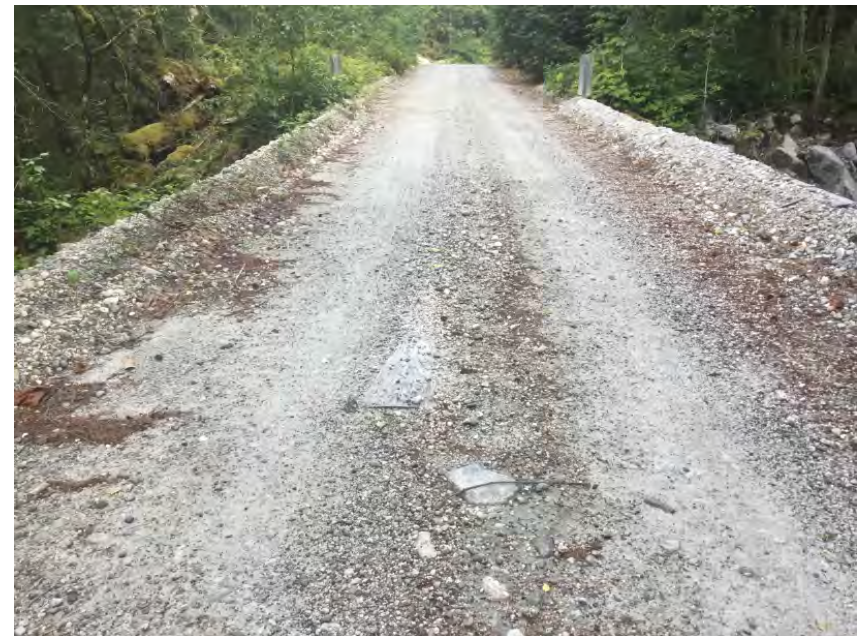
| Gravel Surface | Fair | Stringer exposed at left abutment. |

Exposed Stringer at Left Abutment

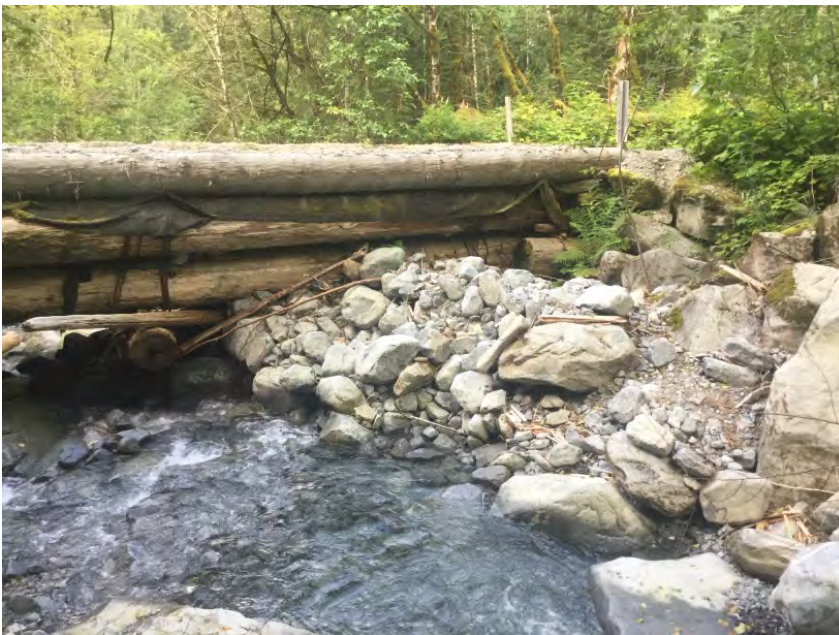
Accumulation of Rocks against Upstream Stringer

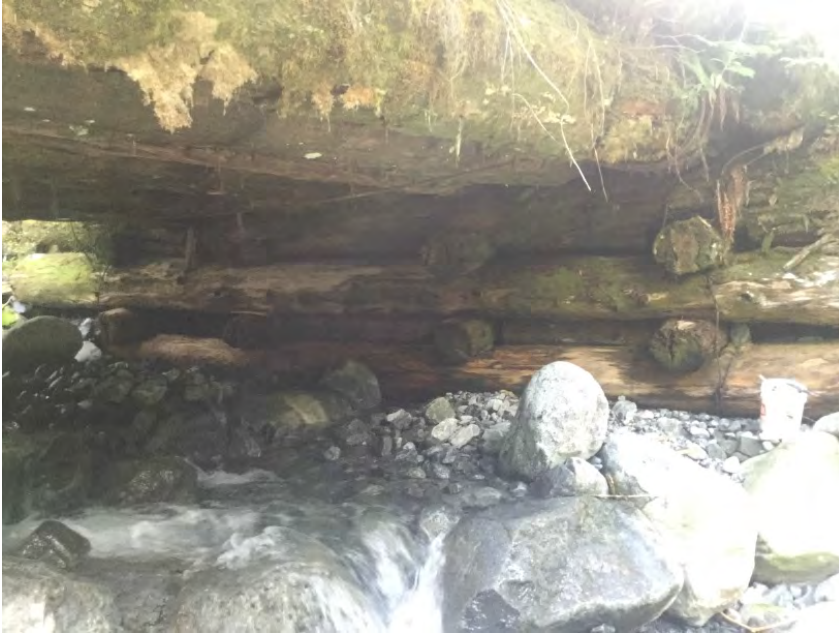
Left Bank Abutment

Top log collapsed at upstream end of left abutment. Vegetation growing out of top logs. 50 mm sap rot on lower logs.

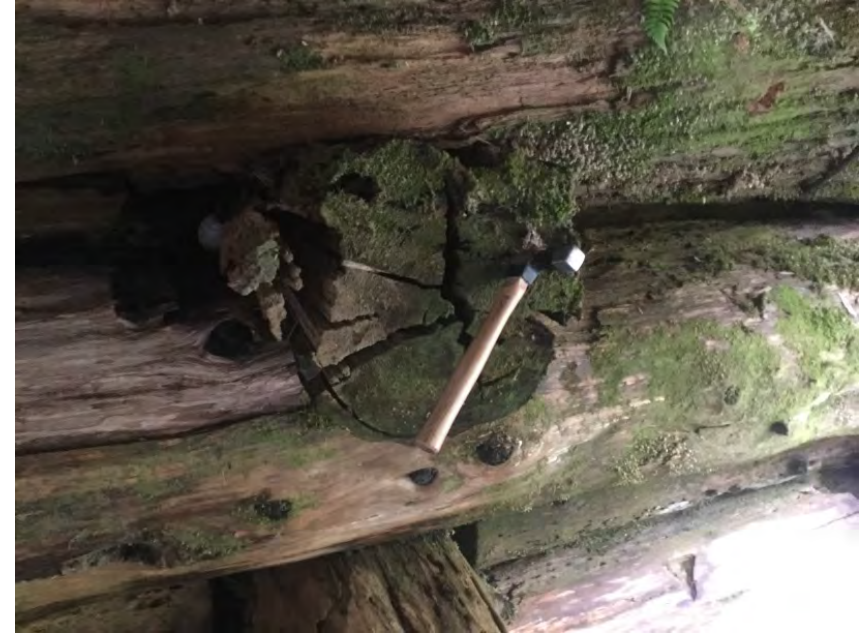
Rotten.

Tie Back Condition

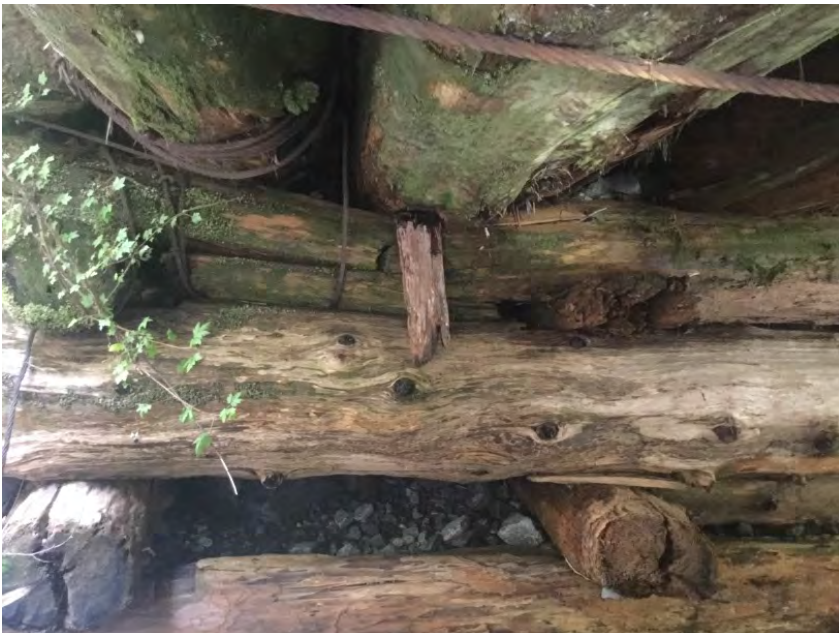
Comments Significant debris build up at upstream right corner, restricting channel flow. 300 mm of scour behind logs at left abutment upstream corner, where infill log is missing.

Left Abutment Collapsed Crib Log with Scour between Logs

| Repair Item | Priority | Repair Description |
|---|---|---|
| 3 | Medium | Reinstate fill and infill log at left abutment upstream corner. Post bridge ahead signs. |

| Item | Monitor Description | Frequency |
|---|---|---|
| 1 | Monitor condition of left abutment prior to replacement or confirmation that top logs bear on alternate abutment. | Anually |

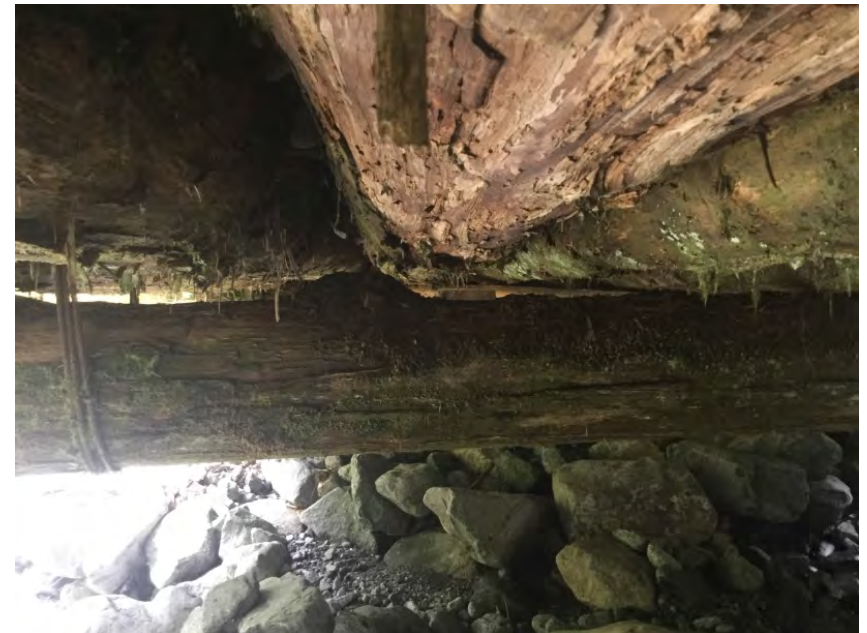
Hanging loose below bridge.

Loose lashing.

Needle Beam Loose

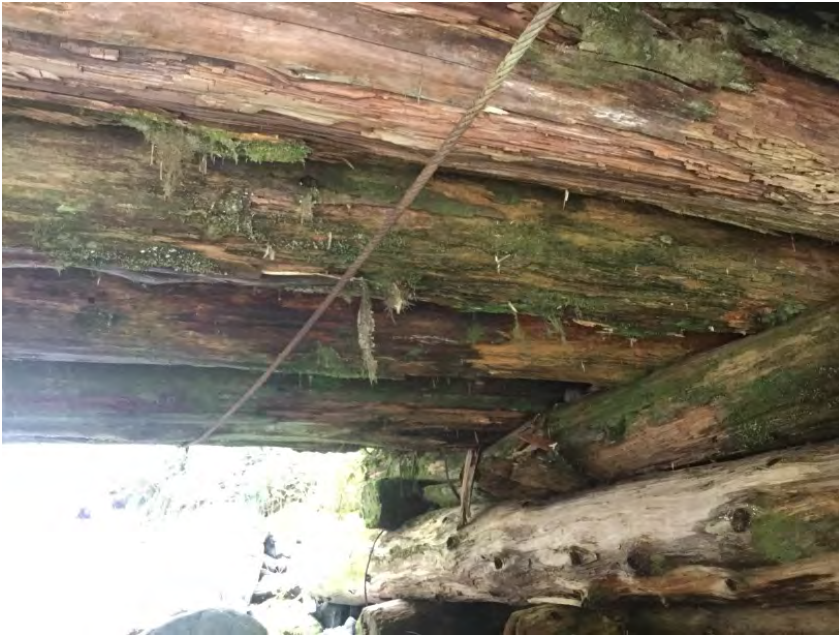
Stringers

| 2 | Cw | Y | 600 | 170 | Poor | Heart rot & 15 mm sap rot. |
| 5 | Cw | Y | 680 | 180 | Poor | Heart rot & 15 mm sap rot. |

| Repair Item | Priority | Repair Description |
|---|---|---|
| 1 | High | Remove gravel deck to facilitate inspection of top level of stringers. Replace bridge if top logs bear on original log cribs. Install load posting sign in interim period. |

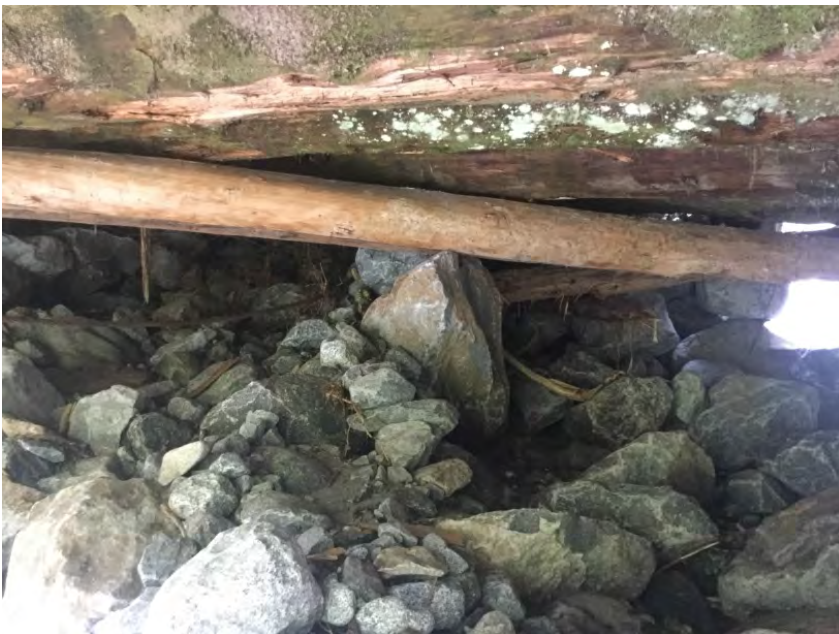
Debris Accumulation against Right Abutment

| Repair Item | Priority | Repair Description |
|---|---|---|
| 2 | High | Remove debris build up at right abutment upstream corner. High flow event may result in bridge washout. |
