CK-2269

STAVE RIVER 21.6km

2016 Inspection

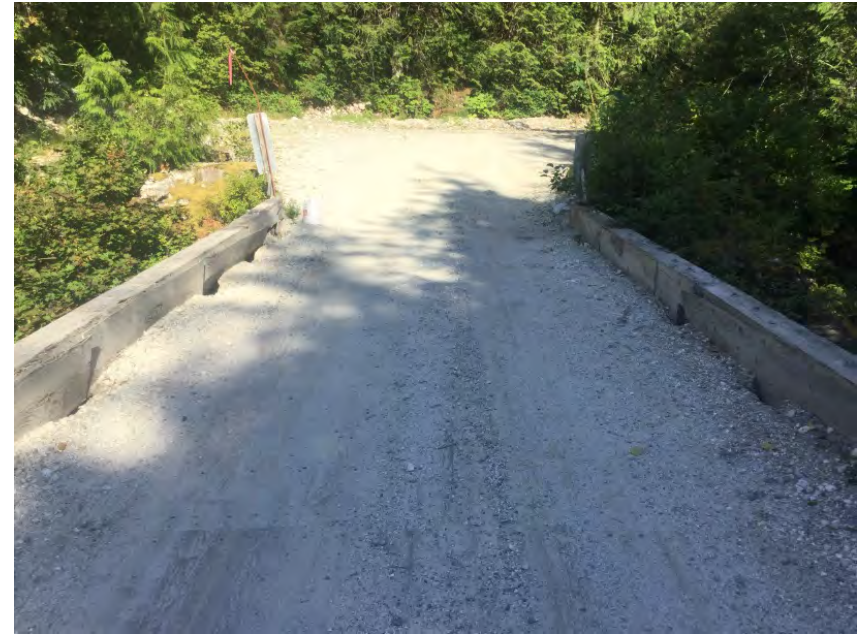
Deck

| Running Planks | Poor | Covered in debris. Moderate wear in wheel tracks with some spots of heavy wear. |

| Item | Priority | Repair Description |
|---|---|---|
| 1 | High | Clean bridge deck and replace running planks in wheel tracks. Number of planks required to be determined after cleaning. |

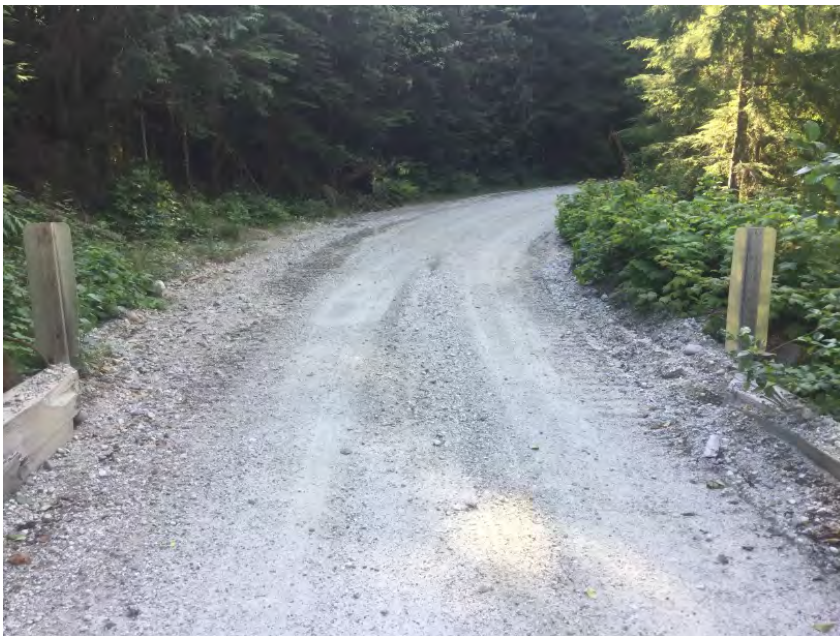
Left Approach Upstream Fender

Embankment at left approach downstream corner. CRB barriers at other corners partially over turned and covered in debris.

| Item | Priority | Repair Description |
|---|---|---|
| 3 | Medium | Install bridge ahead signs. Reposition right approach fenders and left approach upstream fender. |

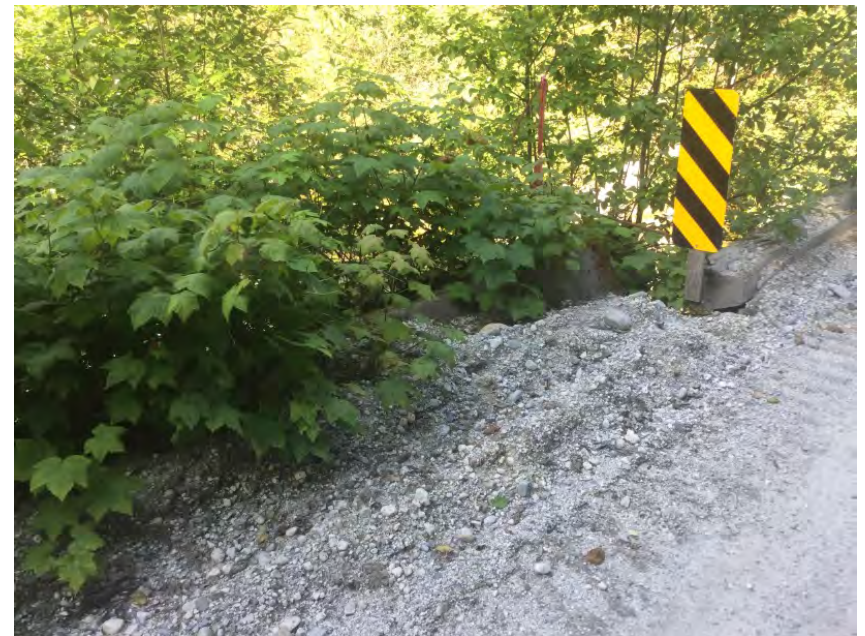
| Curb Rail/Blocks/Posts | Fair | 1 failed riser at L/B U/S corner. 1 split guardrail section. 4 end sections of guardrail have impact damage. |

Left Abutment Upstream Corner - Damaged Guardrail & Failed Riser

| Item | Priority | Repair Description |
|---|---|---|
| 2 | High | Replace damage/deteriorated guardrail sections. Requires 5 3050x250x250 mm sections and one 770x250x250 mm riser. |
