CK-2270

STAVE RIVER 23.6km

2016 Inspection

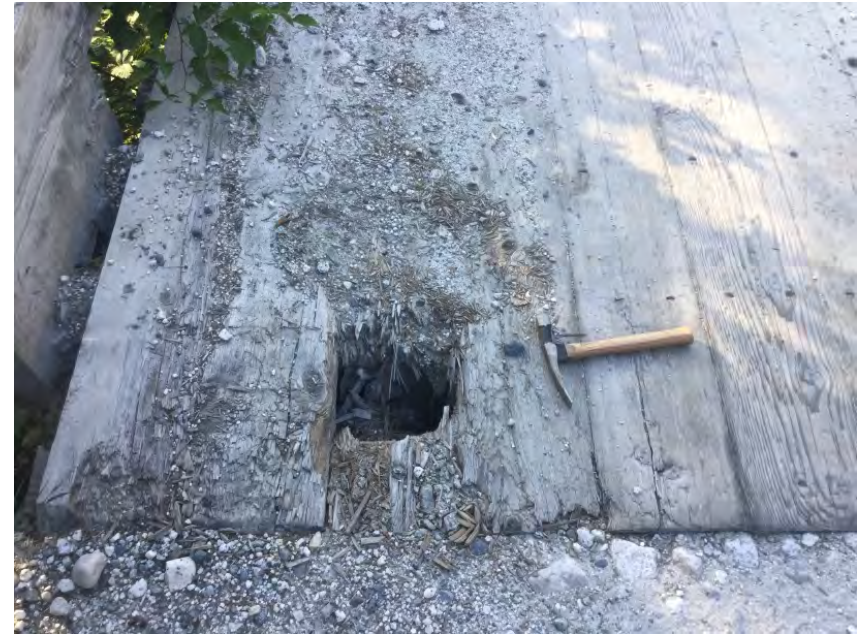
| Running Planks | Poor | 2 large holes in planks. Moderate wear in wheel tracks, heavy wear in some locations. |

Hole in Deck at Right Abutment

| Item | Priority | Repair Description |
|---|---|---|
| 1 | High | Replace running planks, ties, and guardrail. Requires materials for 4.3 m wide 18.3 m long deck. 250x200 ties @ 400 c/c, 100 mm thick running planks. Install load posting sign until repairs are performed. |

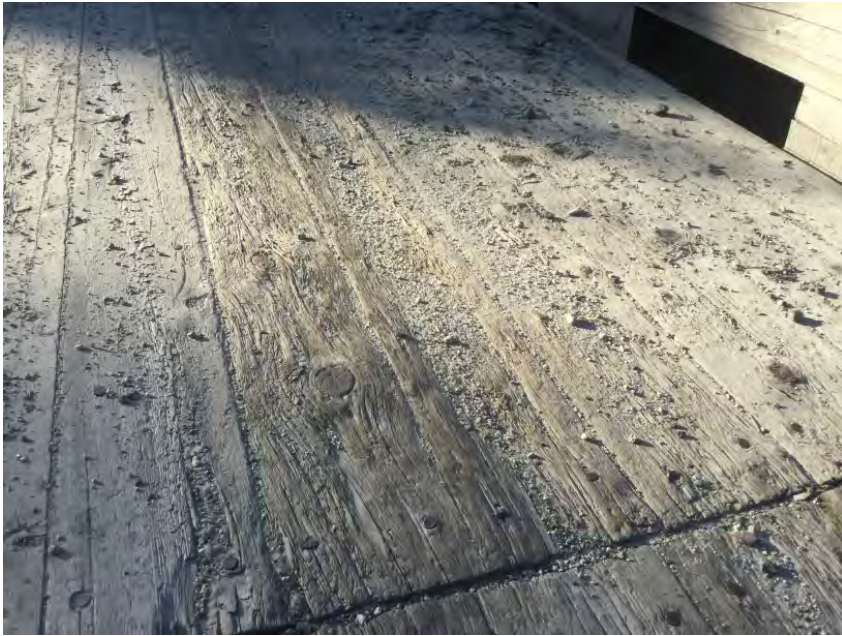
Wear in Deck

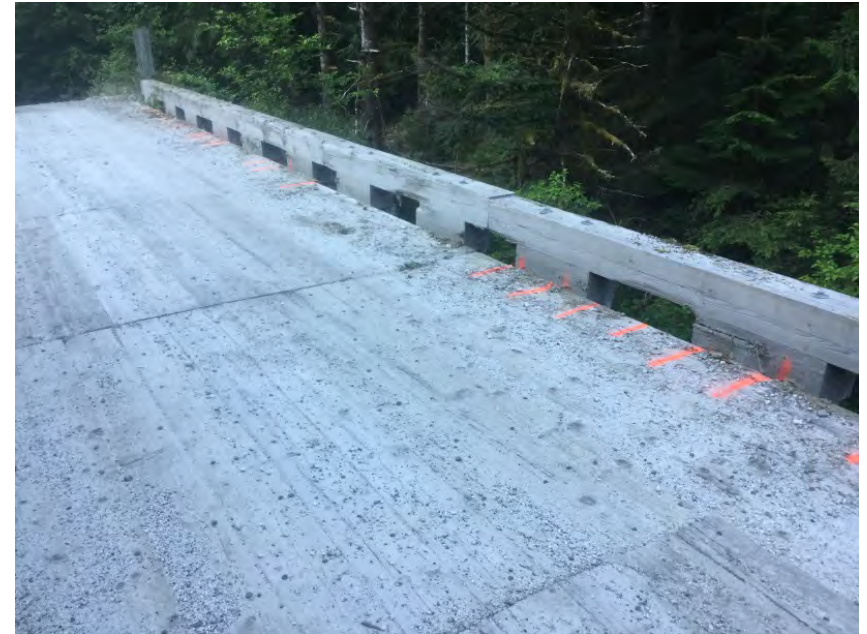
| Ties | Fair | Sample probed ties. 27 with pockets of rot adjacent to deck. Drill 8 locations over girders, limited amount of rot found, in some places up to 20 mm, one location 90 mm. |

Locations with Pockets of Rot Noted in Ties Adjacent to Riser

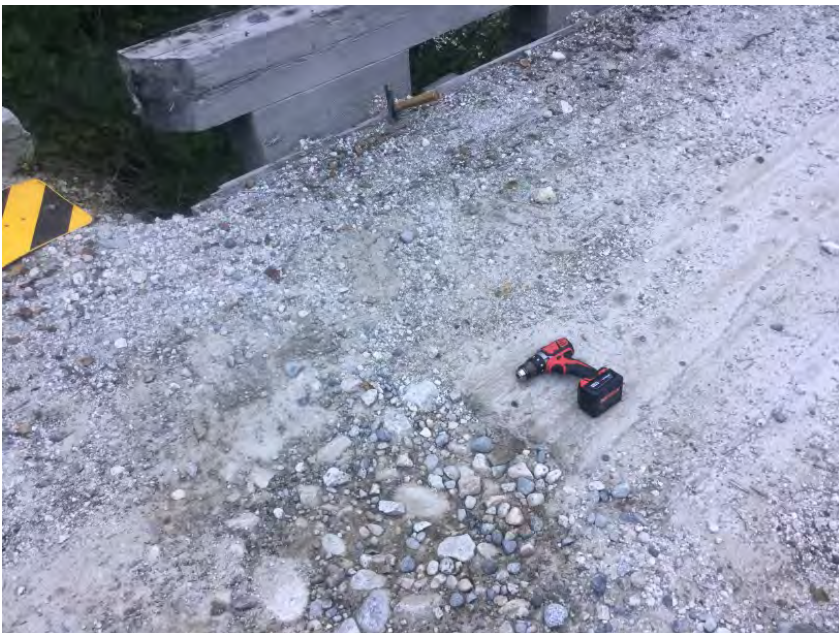
Pothole in approach has resulted in heavy wear to deck.

| Running Surface | Poor | Pothole in approach has resulted in heavy wear to deck. |

Rotten Deck Plank & Pothole in Approach Producing Heavy Wear in Deck Plank

| Item | Priority | Repair Description |
|---|---|---|
| 2 | Medium | Post bridge ahead signs. Regrade approaches. |

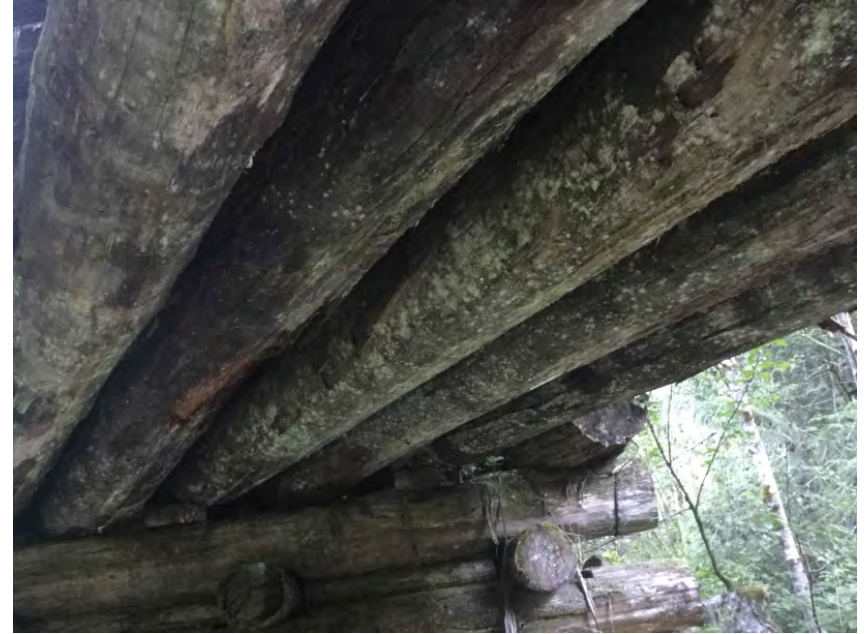
Stringers

The steel girders bear directly over top the old log crib on the upstream left and downstream right banks. The old log stringers underneath are in poor condition. The deck planks are rotting and holes are showing. Pockets of rot have been detected in the ties. Based on the condition of both structures I recommend a complete replacement. In the meantime replace the heavily worn deck planks; place fenders at all 4 corners; post bridge ahead signs; grade and brush approaches; and replace the missing delineator. Limit loading to L45 or 41 tonnes until the structure has been replaced. Post load rating signs.

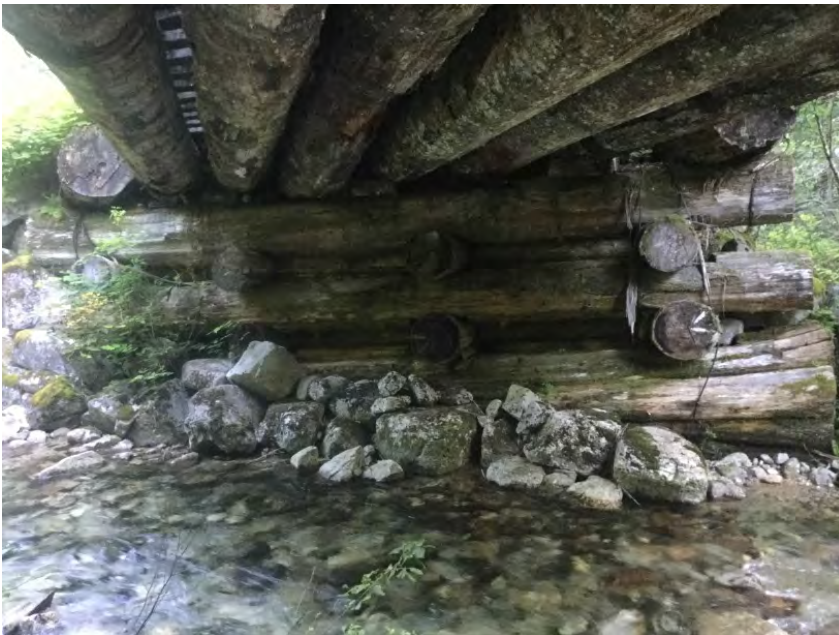
Old log crib supports stringers and steel girders. Up to 25 mm sap rot. Some minor end rot. No crushing or distress noted.

Left Bank Abutment

| Item | Monitor Description | Frequency |
|---|---|---|
| 1 | Monitor log crib abutments. | Anually |

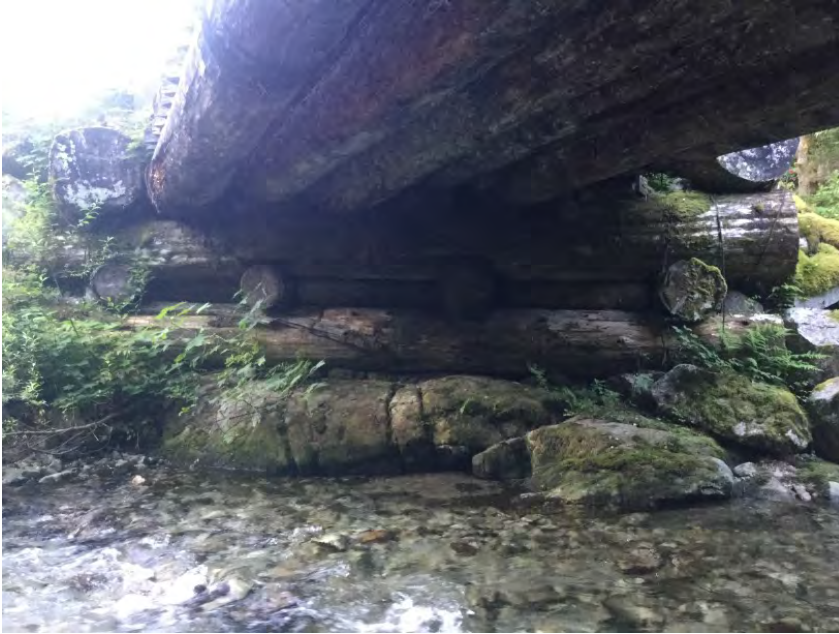
None in front of right abutment.

Right Bank Abutment

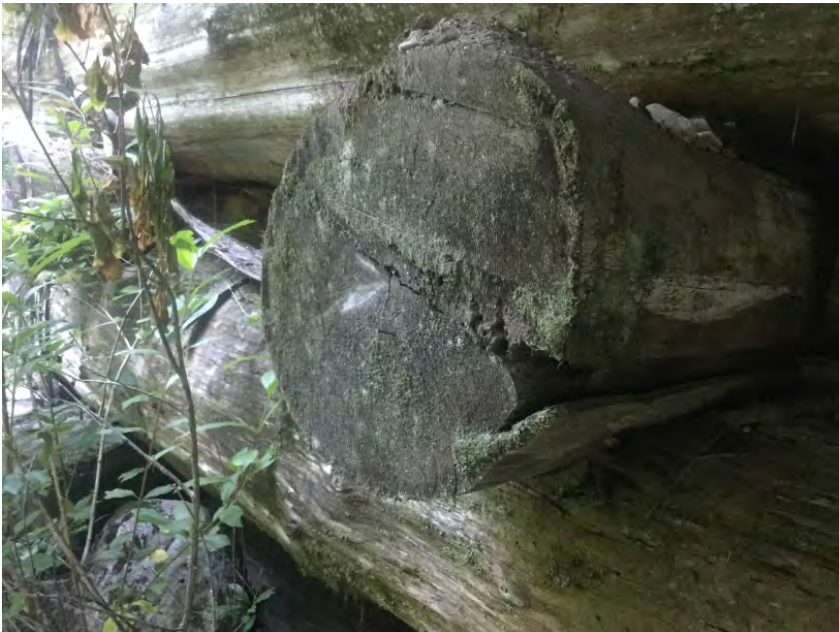
Minor sap rot in places. Some minor end rot and end splits. No crushing or distress noted.

Typical Tie Back Condition
