CK-2271

STAVE RIVER 26.2km

2016 Inspection

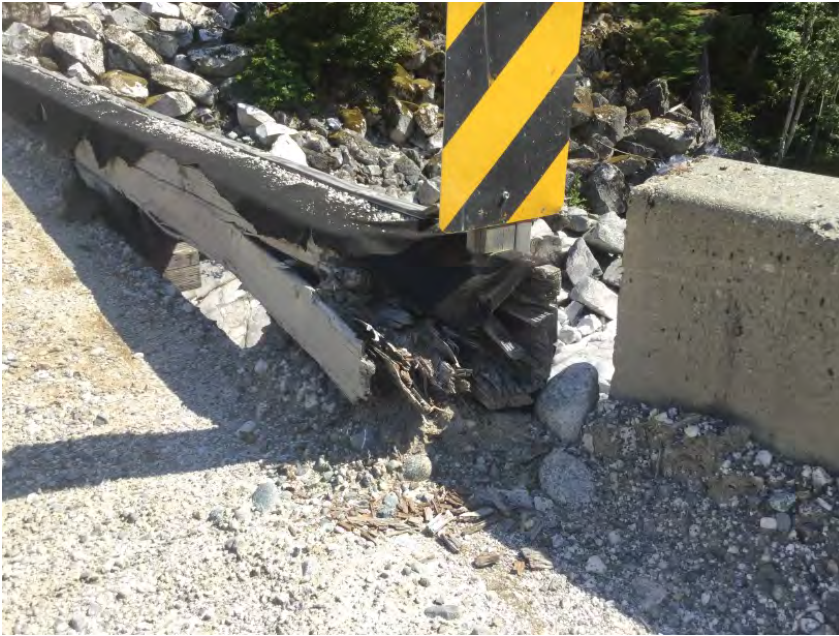
| Curb Rail/Blocks/Posts | Poor | Fabric and debris limited access. Rot in majority of risers, damage and pockets of rot in guardrail. |

Right Abutment Damaged Guardrail

| Item | Priority | Repair Description |
|---|---|---|
| 1 | High | Replace guardrail and risers. Requires 4 5200x250x250 mm and 6 4730x250x250 mm guard rail and 22 800x250x250 mm risers. |

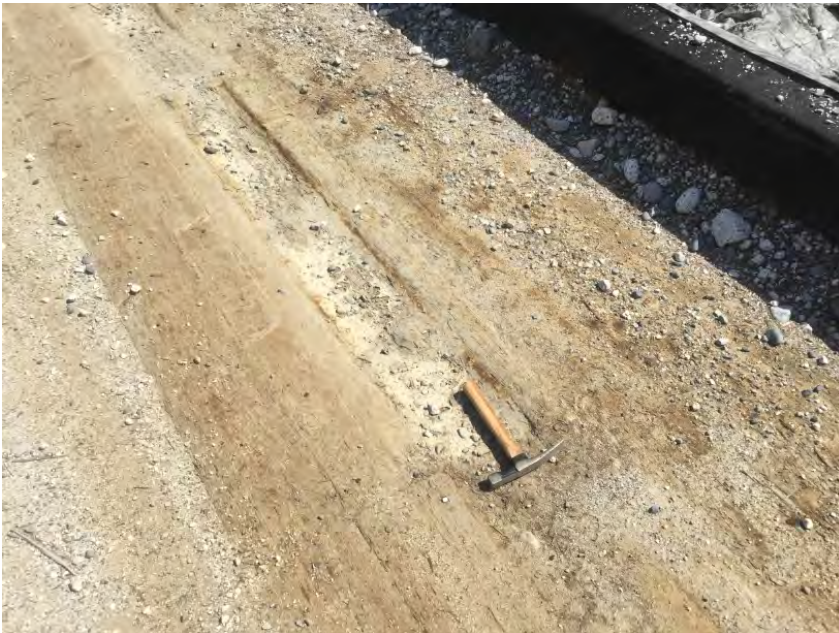
| Running Planks | Poor | Heavily worn. Debris accumulating on deck, and held in place by fabric covering guardrail. |

Heavily Worn Running Plank

| Item | Priority | Repair Description |
|---|---|---|
| 2 | High | Replace running planks. Requires planks for 90 mm x 4.3 m x 24.5 m. Replace ties. Requires 2 5000x250x200 mm ties. Install longer fender at right approach downstream corner. Install load posting sign until repairs are performed. |

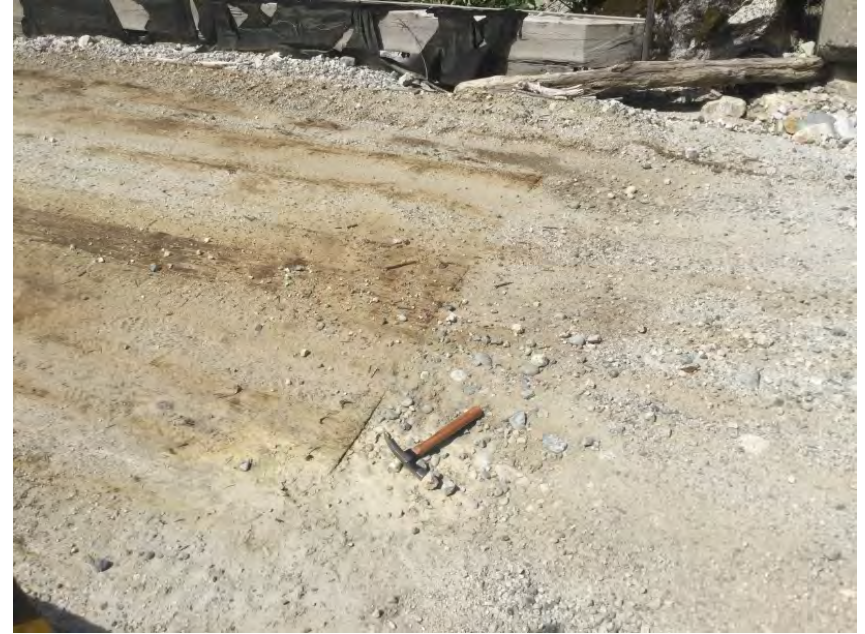
Potholes in approach have resulted in heavy wear at end of deck.

Left Approach Pothole Adjacent to Deck

| Item | Priority | Repair Description |
|---|---|---|
| 3 | Medium | Install bridge ahead signs. Regrade approach. |

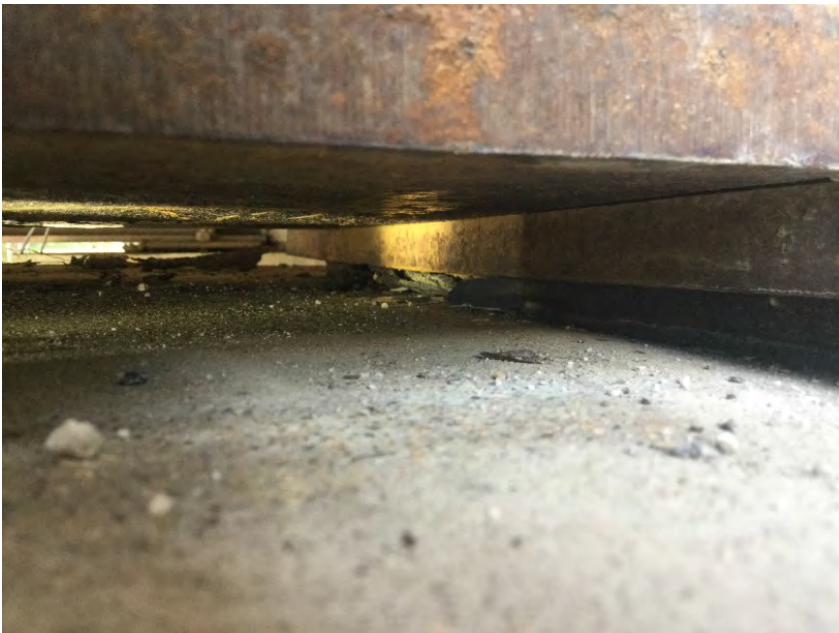
No access to R/B D/S bearing. Damage to R/B U/S bearing. L/B U/S bearing bulging.

Damage to Right Abutment Upstream Bearing

| Item | Monitor Description | Frequency |
|---|---|---|
| 1 | Monitor bearing condition. | Routine Inspection |

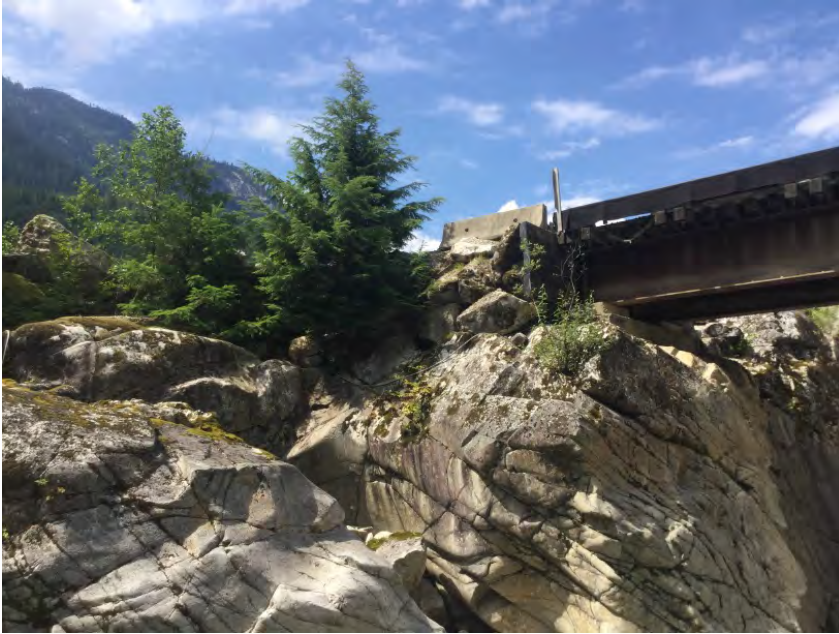
Left approach downstream guardrail is short and partially buried. Significant drop to creek.

Short Fender with Steep Drop at Right Approach Downstream Corner
